**Report: TAB Report**  
**Function: Test, Adjust, & Balance**  
**Date: 06/25/2025**  
**Completed By: National TAB**

**06-23-25 WAWA #8159 NEWTOWN, PA**

Project: 06-23-25 WAWA #8159 NEWTOWN, PA

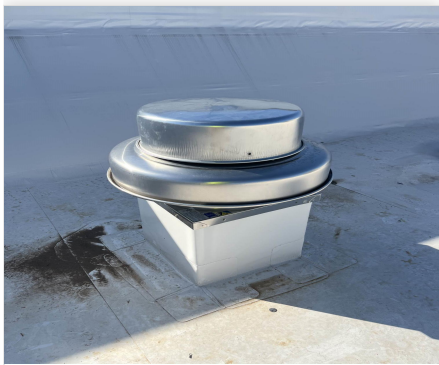
**Issue Name :** EF-2 Flow  
**Description :** Ef-2 is not operating at design flow. Fan is at max speed and Under FLA. At the current static pressure the fan is not capable of 1400CFM. Final flow with grilles balanced proportionally low 1121 CFM. Tried removing the backdraft damper and removing the speed control to rule out restriction and confirm max speed, there was no change In CFM.  
**Created By :** National TAB                      **Assigned To :** National TAB - Tyler Youells  
**Status :** Open  
**Priority :** High                                      **Asset Tag :**  
**Originated Date :** 06/25/2025 - Tyler Youells - National TAB

[1] FAN IS NOT ACHEIVING DESIGN FLOW AT FULL SPEED AND CURRENT STATIC PRESSURE. CONSULT EOR IF FAN IS NEEDED TO BE UPSIZED.

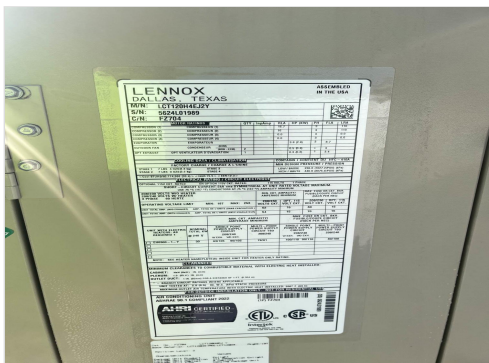
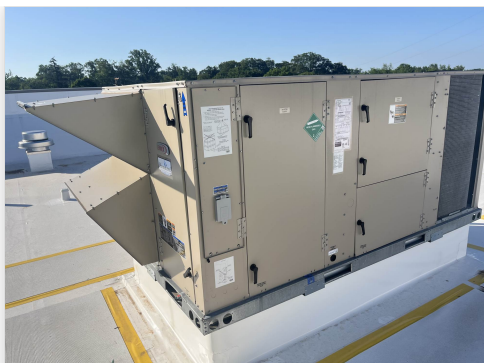
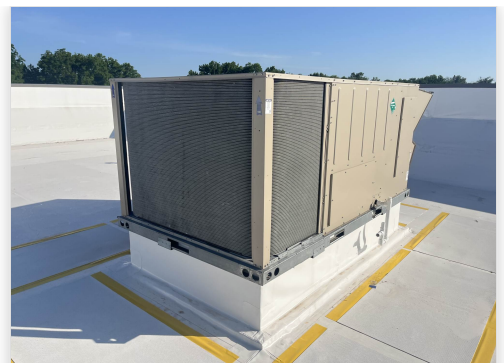
Asset: RTU1

[1] UNIT SCHEDULED FOR 3100CFM/ CONNECTED LOAD IS 3700CFM. AT 3100 CFM THE UNIT WOULD BE OUT OF THE RECOMMENDED 350-400CFM/TON THEREFORE UNIT WAS BALANCED TO THE CONNECTED LOAD

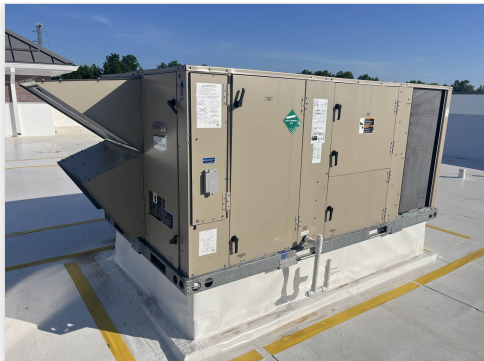
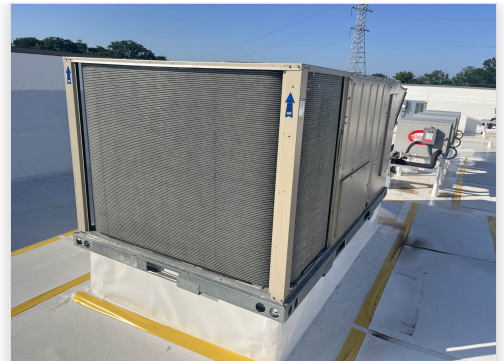
Asset: RTU2

[1] UNIT IS SCHEDULED FOR 4800CFM/ CONNECTED LOAD 5000CFM. 5000 IS WITHIN 5% OF ORIGINAL INTENT SO UNIT WAS BALANCED TO THE CONNECTED LOAD.

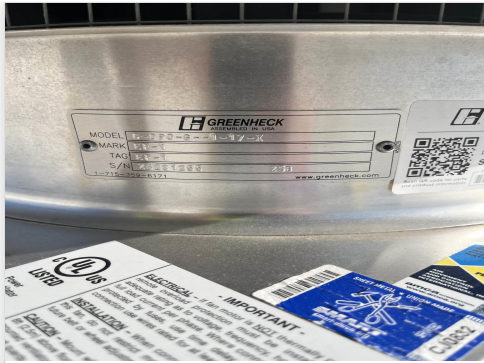
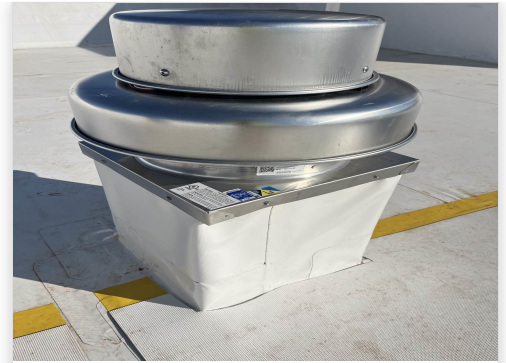
Asset: EF1

Notes:  
[1] CONNECTED LOAD 400CFM, BALANCED TO CONNECTED LOAD

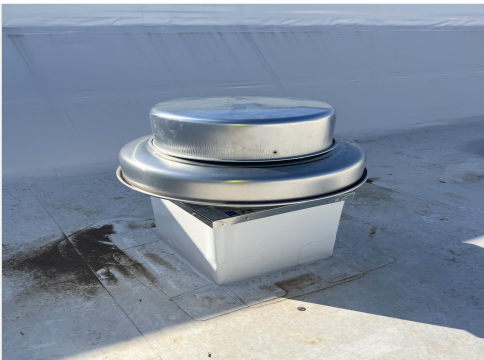
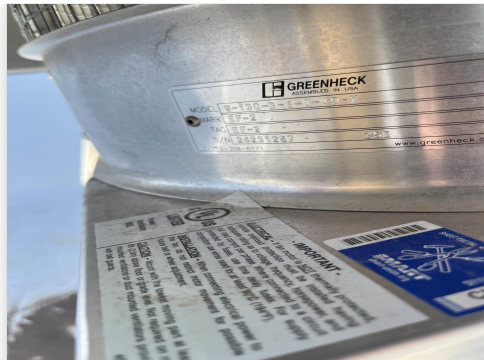
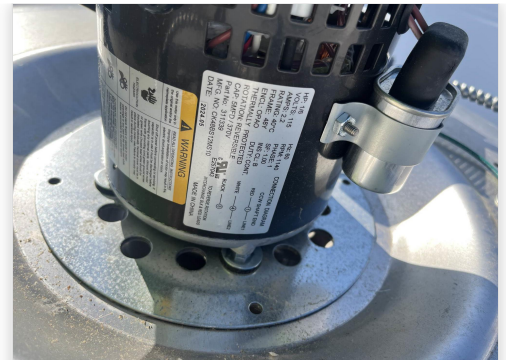
Asset: EF2

EF-2 Speed controller was removed to ensure 100% fan speed

EF-2 is not reaching design flow with the fan at full speed/FLA and at current static pressure. EF-1 was balanced to the connected load which was 50CFM higher than fan design.
