Report: TAB Report
Function: Test, Adjust, & Balance
Date: 03/11/2025
Completed By: National TAB

03-03-25 CHIPOTLE #5042 METAIRIE, LA

6940 VETERANS MEMORIAL BLVD

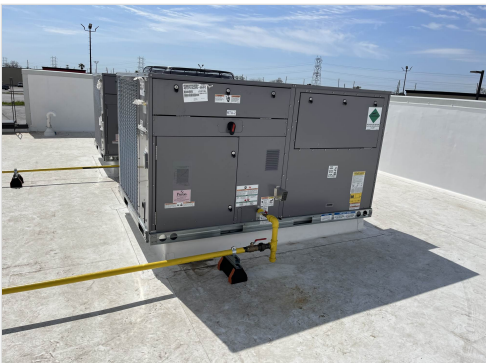
Unit Data - PHOTO LOG

Asset: RTU1

AREA: KITCHEN

Unit Data		
	Design	Actual
MFG	CARRIER	CARRIER
Serial Num	-	2323P62348
Model Num	48FCFN14	48FCFN12C2M5A6W4F0
Type	RTU	RTU
Configuration	VERTICAL	VERTICAL
Num OA Filters 1	-	1
OA Filter Size 1	-	36X20
Num Final Filter 1	-	4
Final Filter Size 1	-	20X20X2

Test Data		
	Design	Actual
SF CFM	3500	3670
SF RPM	NL	1420
RA CFM	2750	2911
OA CFM	750	759
RL Voltage	208	212/213/212
RL Amperage	NL	2.8/2.9/2.9
SF Rotation	-	CCW
SF System SetPt	-	6.7 VDC
RA Damper Position	-	80%
Min OA Damper Position	-	20%
Min OA Damper Type	-	OPPOSED BLADE
OA Enthalpy Setpt	-	ES5

Performance Data		
	Design	Actual
MA Plenum SP	-	-0.41"
Fan Suction SP	-	-0.63"
Fan Discharge SP	-	0.45"
Total ESP	0.8"	0.86"
Fan Total SP	-	1.08"

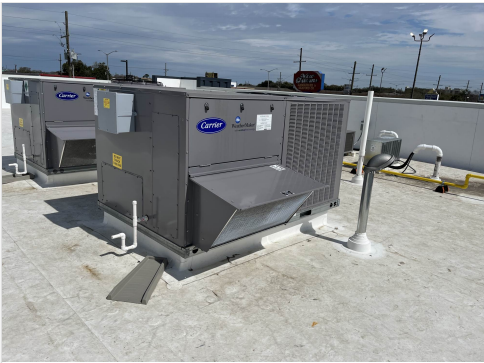
Unit Data - PHOTO LOG

Asset: RTU2

AREA:DINING

Unit Data		
	Design	Actual
MFG	CARRIER	CARRIER
Serial Num	-	0723P72864
Model Num	48FCFN14	48FCFN14C2M5A6W4F0
Type	RTU	RTU
Configuration	VERTICAL	VERTICAL
Num OA Filters 1	-	1
OA Filter Size 1	-	36X20
Num Final Filter 1	-	4
Final Filter Size 1	-	20X20X2

Test Data		
	Design	Actual
SF CFM	4400	4397
SF RPM	NL	1910
RA CFM	3650	3663
OA CFM	750	761
RL Voltage	208	112/113/113
RL Amperage	NL	7.7/7.6/7.6
SF Rotation	-	CCW
SF System SetPt	-	8.7 VDC
RA Damper Position	-	83%
Min OA Damper Position	-	17%
Min OA Damper Type	-	OPPOSED BLADE
OA Enthalpy Setpt	-	ES5

Performance Data		
	Design	Actual
MA Plenum SP	-	-0.96"
Fan Suction SP	-	-1.42"
Fan Discharge SP	-	0.61"
Total ESP	0.8	1.57"
Fan Total SP	-	2.03"

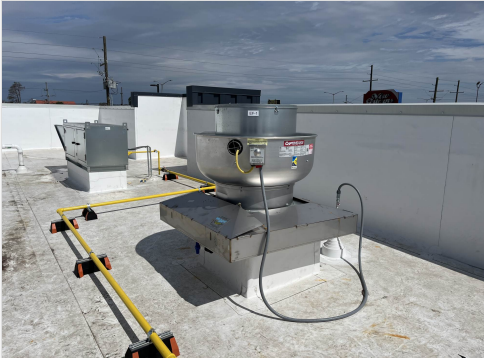
Unit Data - PHOTO LOG

Asset: EF1

AREA:HOOD

Unit Data		
	Design	Actual
MFG	CAPTIVEAIRE	CAPTIVEAIRE
Model Num	DR12HFA	DU180HFA
Serial Num	-	6614115
Type	UPBLAST	UPBLAST
Configuration	VERTICAL	VERTICAL

Test Data		
	Design	Actual
CFM	2550	2552
Fan RPM	NL	1047
Fan Rotation	-	CCW
Motor RPM	-	1047
System SetPt	-	53.7 HZ
RL Voltage	208	112 VFD
RL Amperage	NL	4.8 VFD
Total ESP	1.20"	0.78"
Fan Inlet SP	-	-0.78"
Fan Discharge SP	-	ATM

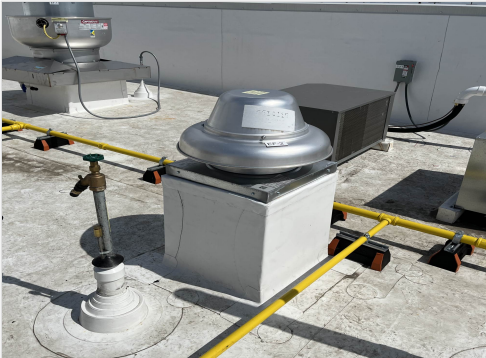
Unit Data - PHOTO LOG

Asset: EF2

AREA:RESTROOMS

Unit Data		
	Design	Actual
MFG	CAPTIVEAIRE	CAPTIVEAIRE
Model Num	DR12HFA	DR12HFA
Serial Num	-	6614115
Type	DOWNBLAST	DOWNBLAST
Configuration	VERTICAL	VERTICAL

Test Data		
	Design	Actual
CFM	150	154
Fan RPM	NL	986
Fan Rotation	-	CCW
Motor RPM	-	986
System SetPt	-	42%
RL Voltage	208	120
RL Amperage	NL	0.7
Total ESP	0.6"	0.51"
Fan Inlet SP	-	-0.51"
Fan Discharge SP	-	ATM

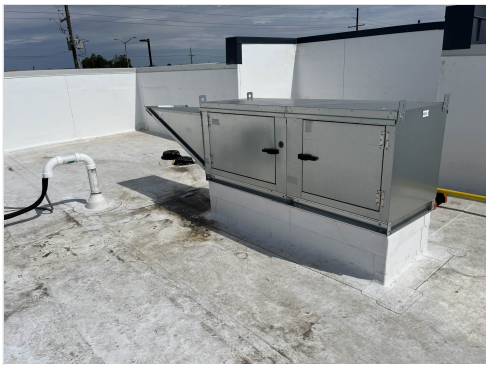
Unit Data - PHOTO LOG

Asset: MAU1

AREA:HOOD

Unit Data		
	Design	Actual
MFG	CAPTIVEAIRE	CAPTIVEAIRE
Model Num	A1-D.250-15D	A1-D.250-15D
Serial Num	-	6614115
Type	MAU	MAU
Configuration	VERTICAL	VERTICAL

Gas Heat		
	Design	Actual
Heater Operates (y/n)	-	YES
Flame Status (pass/fail)	-	YES
Inlet Air Temp SetPt	55	55
Discharge Air Temp SetPt	60	60
Air Flow Switch SP Actual	-	0.33"

Test Data		
	Design	Actual
CFM	1300	1328
SF RPM	NL	1392
Motor RPM	-	1392
SF System SetPt	-	48 HZ
RL Voltage	208	120 VFD
RL Amperage	NL	2.2 VFD
Total ESP	-	0.47"
Fan Discharge SP	-	ATM

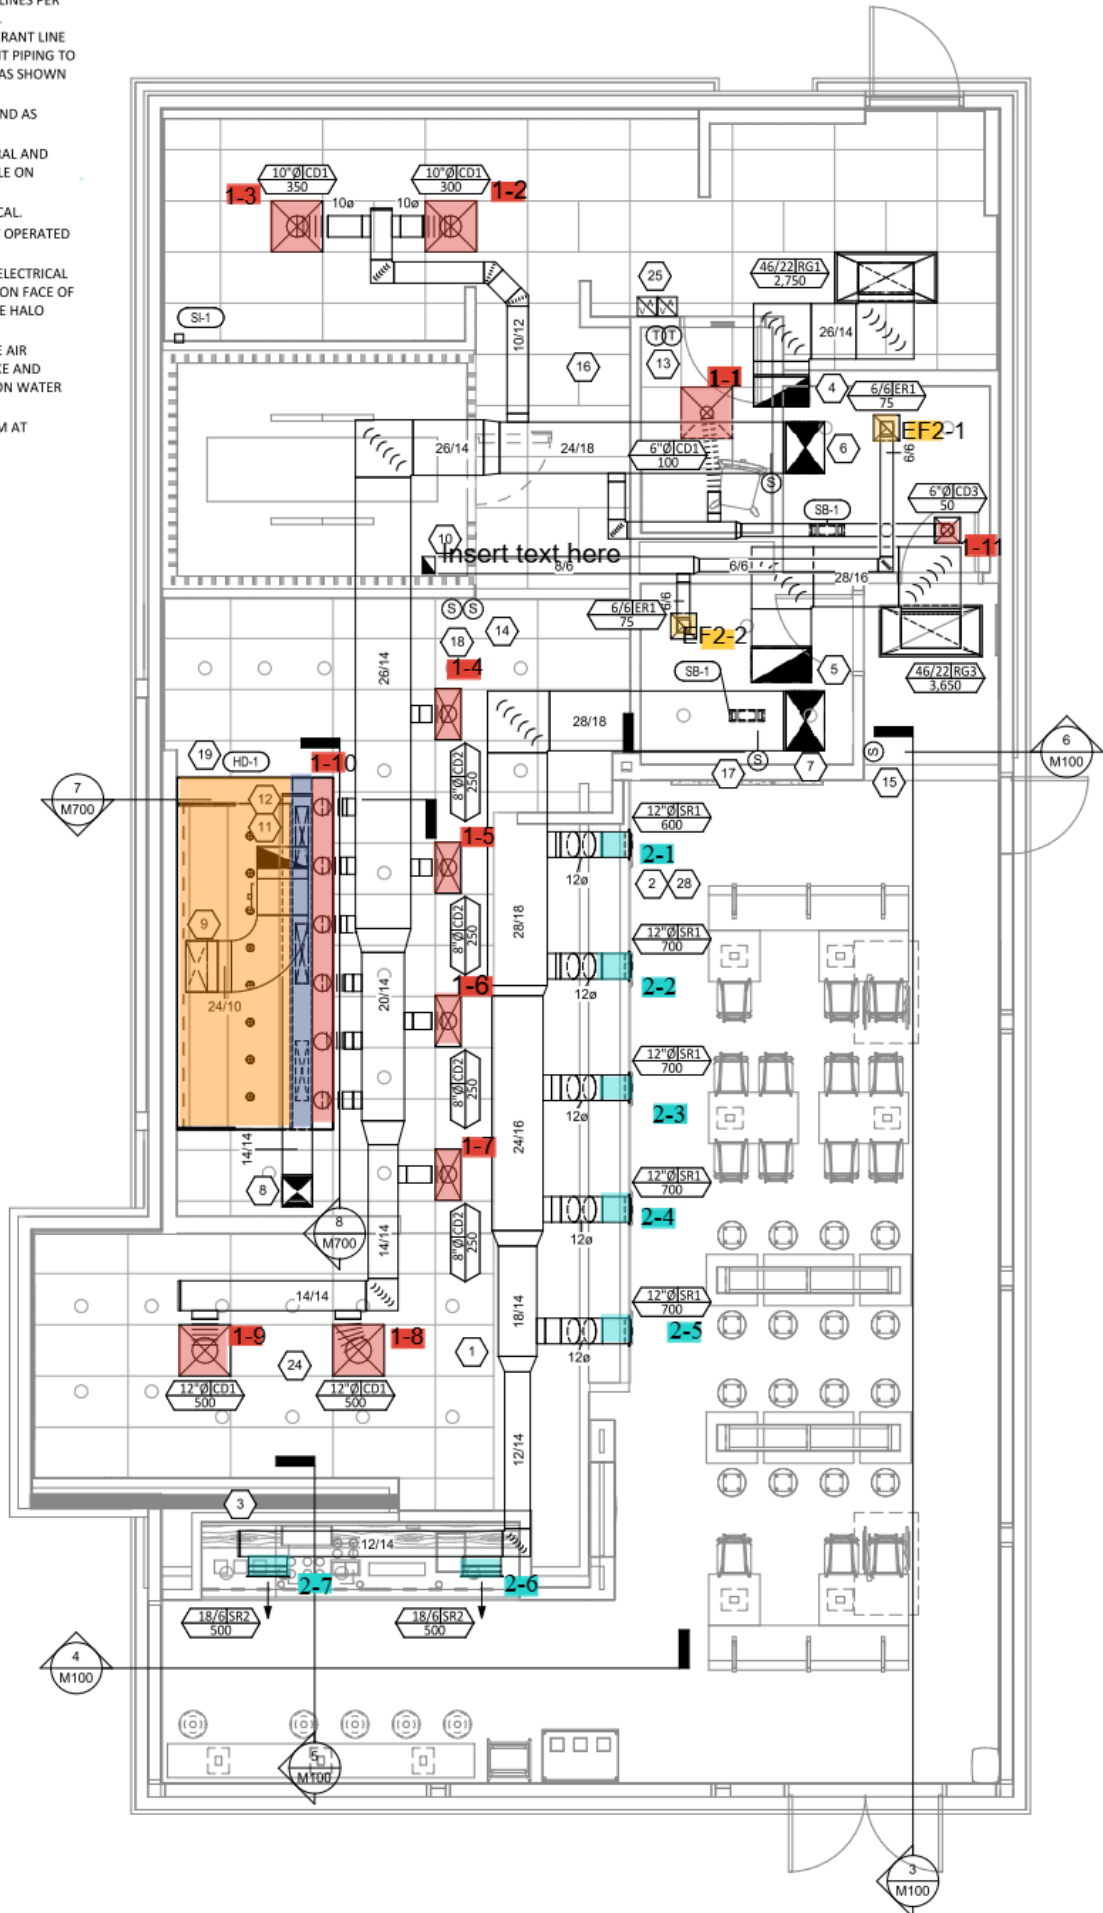
System/Unit: Kitchen Hood Type I

Asset: HD1

AREA:KITCHEN
