**Report: REVIVE REPORT
Function: Test, Adjust, & Balance
Date: 03/10/2023**

**02-20-23 FREDDY'S - MCDONOUGH, GA
(REVIVE)**

Project: 02-20-23 FREDDY'S - MCDONOUGH, GA (REVIVE)

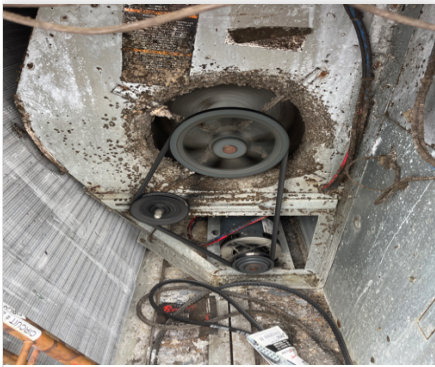
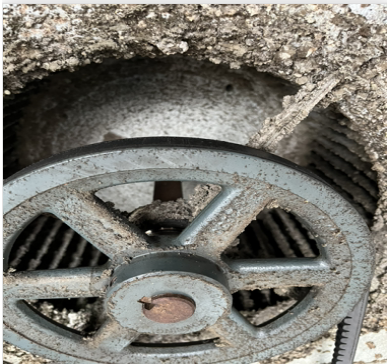
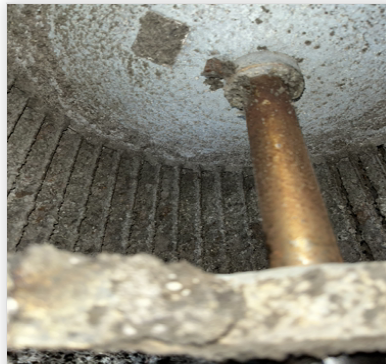
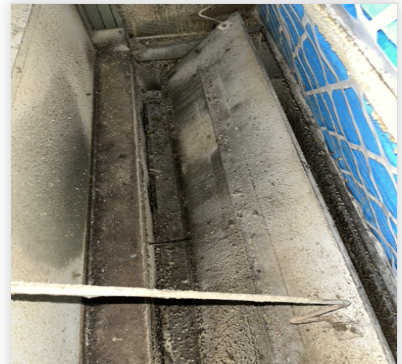
Issue Name : 02 - RTU/MUA are dirty

Description : Units are extremely dirty and need to be thoroughly cleaned. May require multiple cleanings. The condition is having a significant impact on airflow.

- **03/10/2023** National TAB - Will Turnbough
 - Typical of all units
