**Report: REVIVE REPORT
Function: Test, Adjust, & Balance
Date: 03/10/2023**

**02-20-23 FREDDY'S - MCDONOUGH, GA
(REVIVE)**

1410 HWY 20 W

MCDONOUGH , GA

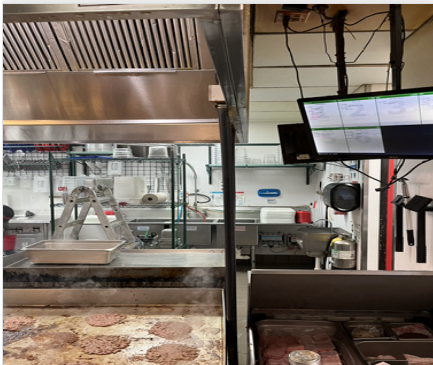
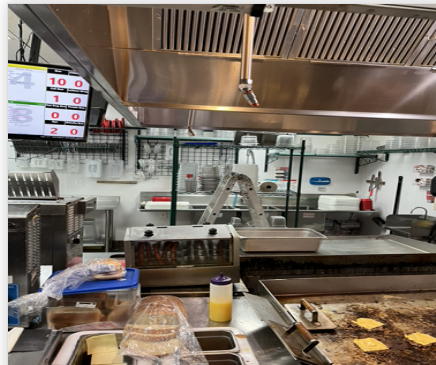
Grillright.jpeg

Issue Name : 01 - Grill not centered

Description : Grill is not centered under the hood and is primary reason for the poor smoke capture. Island hood needs 12" of overhang on all sides. The only smoke loss is noted on the side without overhang.

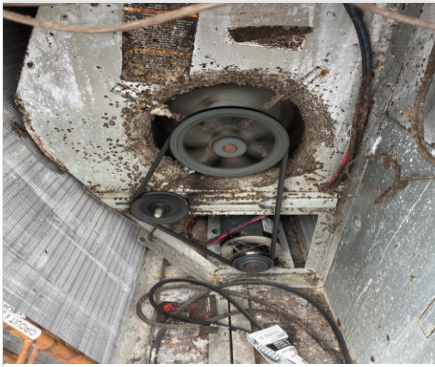
RTU3FANCABINET.jpeg

Issue Name : 02 - RTU FAN CABINET

Description : FAN CABINET DIRTY

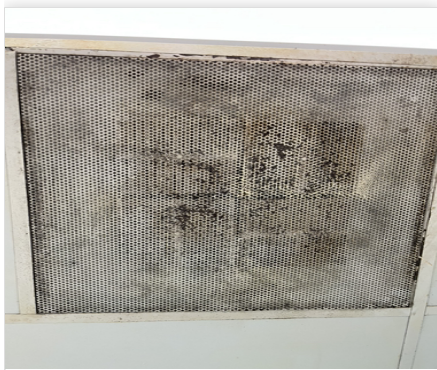
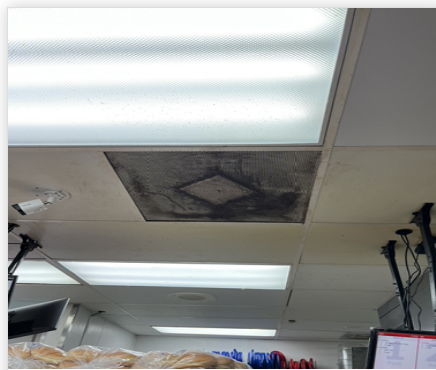
Diffuser1.jpeg

Issue Name : 04 - Diffusers throughout kitchen are dirty

Description : Recommend cleaning

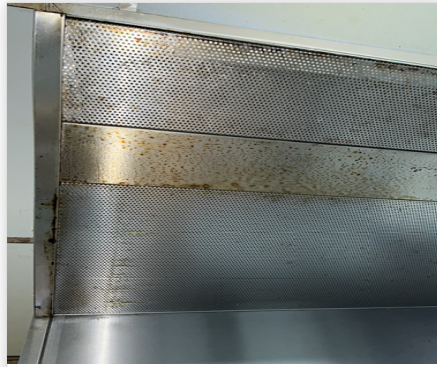
Acsp.jpeg

Issue Name : 05 - ACSPS is dirty

Description : Recommend dropping the AC-ssp portion and cleaning the top and bottom of the perforated grilles.

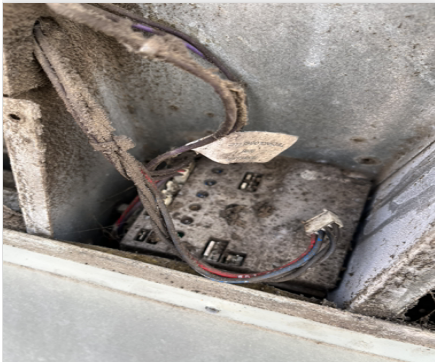
Econ3.jpeg

Issue Name : 08 - RTU3 Economizer

Description : Rtu3 economizer was found unplugged. Plugged in but damper didn't move. Recommend repair

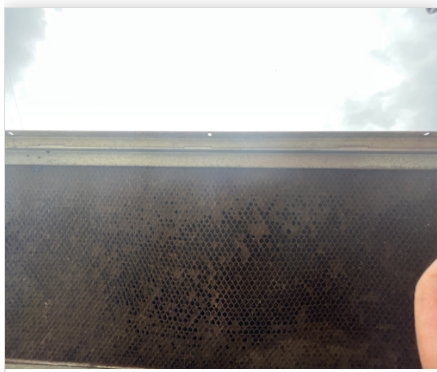
RTU3FILTER.jpeg

Issue Name : 10 - RTU-3 OA filter is dirty

Description : Recommend cleaning.

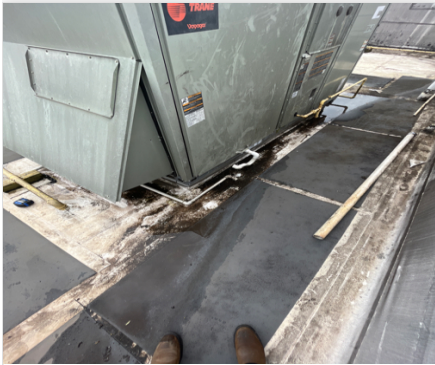
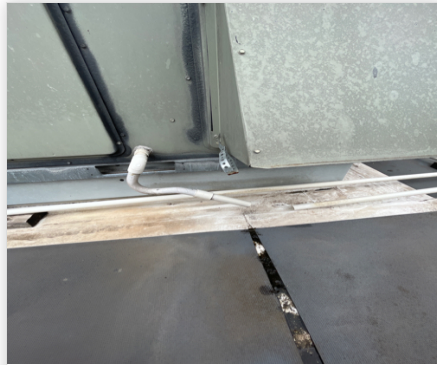
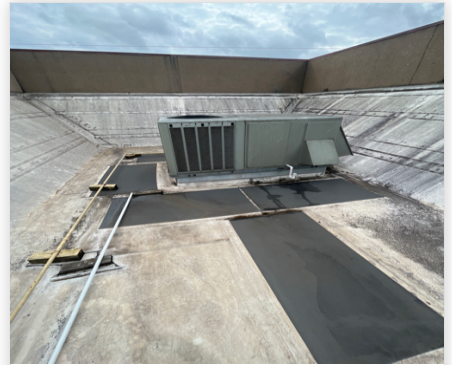
CONDENSATE-RTU3.jpeg

Issue Name : 11 - CONDENSATE LINES

Description : Condensate drain lines found disconnected for all units. Recommend reconnecting. Water is pooling on the roof.
