**Report: TAB Report**  
**Function: Test, Adjust, & Balance**  
**Date: 02/12/2026**  
**Completed By: National TAB**

**PROJECT**  
**02-23-26 QT #1045 GASTONIA, NC**

QUIKTRIP  
4705 SOUTH 129TH EAST AVENUE  
TULSA, OK 74134

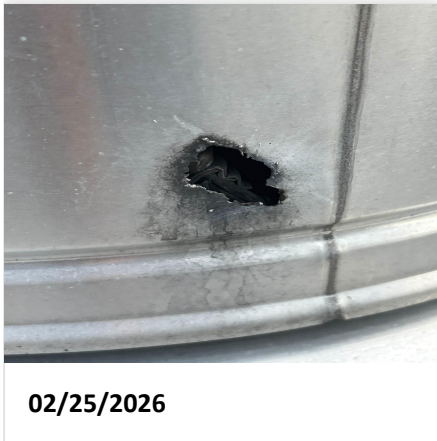
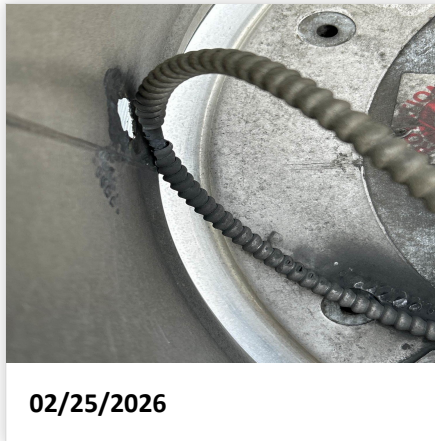
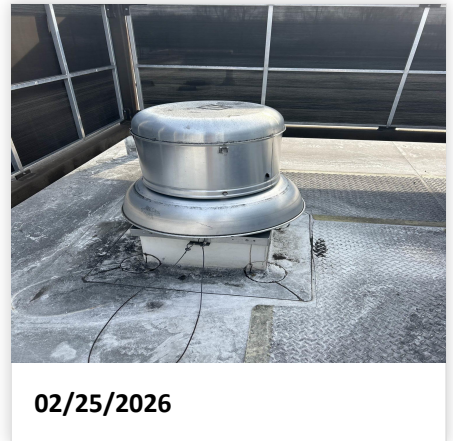
**Issue Name :** EF-2 not operational  
**Description :** EF -2 not operational. It appears to be an electrical short.  
**Created By :** National TAB                      **Assigned To :** National TAB - Dan Hertenstein  
**Status :** Open  
**Priority :** Urgent                                      **Asset Tag :** EF2  
**Originated Date :** 02/25/2026 - Jearod Ferrette - National TAB

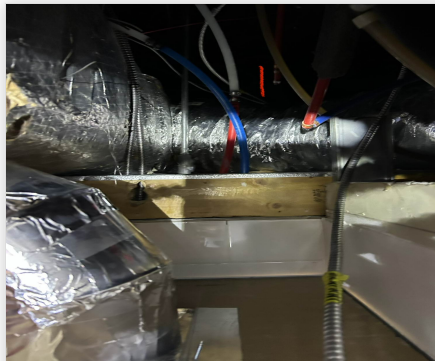
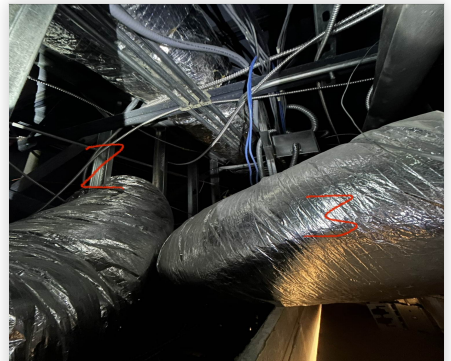
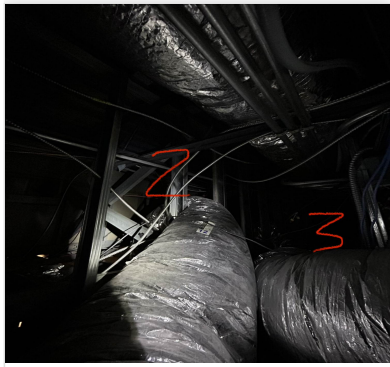
**Issue Name :** RTU 3 ductwork severely pinched  
**Description :** RTU 3 first 4 kitchen diffusers are severely pinched. Ductwork doesn't match drawings. First diffuser takeoff is above hard ceiling, and all of the ductwork are table topped on each other. The unit is currently at 43hz at 69% of design. All the air is being pushed to SGRD 3-5/ 3-6 in the BOH.  
**Created By :** National TAB                      **Assigned To :** National TAB - Dan Hertenstein  
**Status :** Open  
**Priority :** Urgent                                      **Asset Tag :** RT-3  
**Originated Date :** 02/25/2026 - Jearod Ferrette - National TAB

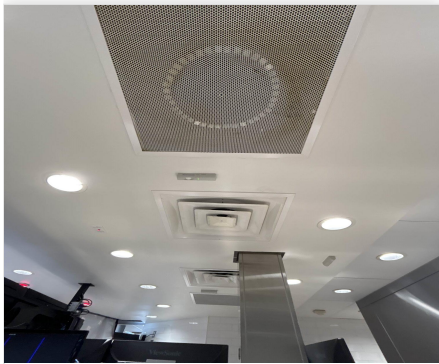
**Issue Name :** Specified diffusers not installed  
**Description :** SGRD 3-1 to 3-4 diffusers are not per design.  
**Created By :** National TAB                      **Assigned To :** National TAB - Dan Hertenstein  
**Status :** Open  
**Priority :** Medium                                      **Asset Tag :** RT-3  
**Originated Date :** 02/25/2026 - Jearod Ferrette - National TAB

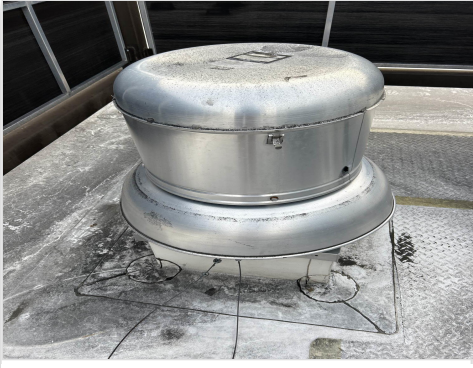
Notes:  
Not operational
