**Report: AHU-31 MRI Evaluation Rpt**

**Function: Test, Adjust, & Balance**

**Date: 11/18/2025**

## VA Hospital Eval (Indianapolis, IN)

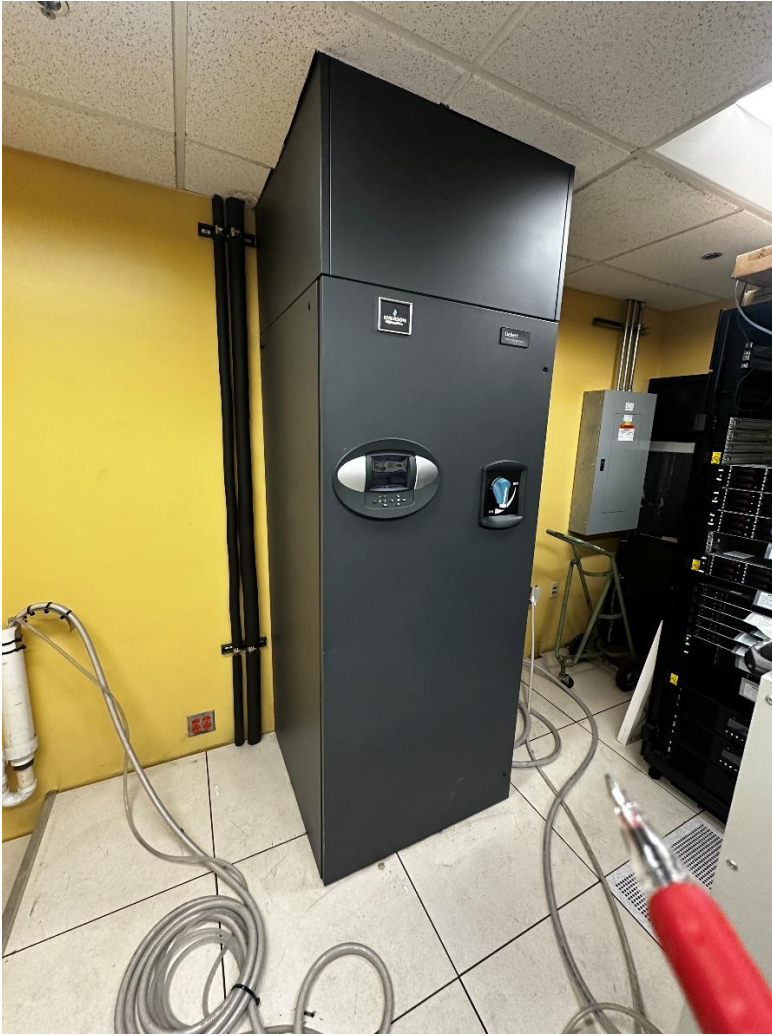
New data room with Liebert unit next to room B-3034

The space had several changes over the years. The area B033 is now a data/server room and there is a floor mounted Liebert unit in the room equipped with (4) air devices to keep the room comfortable. There is also a dehumidifier (floor mount) running in space. The MRI rooms are not allowed to have any flow hood or testing equipment inside the rooms. The only way we could access these air devices was to shut down the MRI machines which then take 24 to 48 hours to start back up. So, this was not an option. Our team traversed a VAV or air devices going into these rooms from adjacent spaces. Radiology B036 had a AC Combo unit installed to serve that room through (2) air devices. We were able to do a total traverse on the unit to determine how much total airflow was being achieved. Radiology B038 has a floor mounted Liebert installed & is more of a storage space now. The MRI team members stated that overall, its comfortable except where they sit in Radiology B037 area & up front in waiting & B046 can get warm in these spaces.

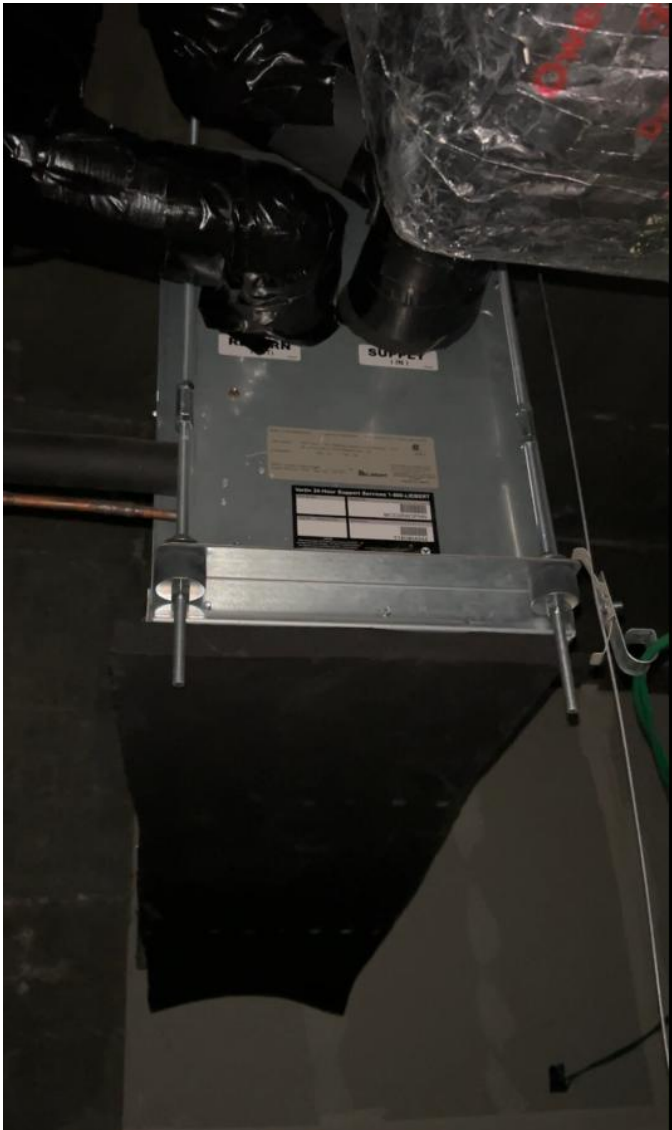
Combo Unit's that serves Radiology room B-3036

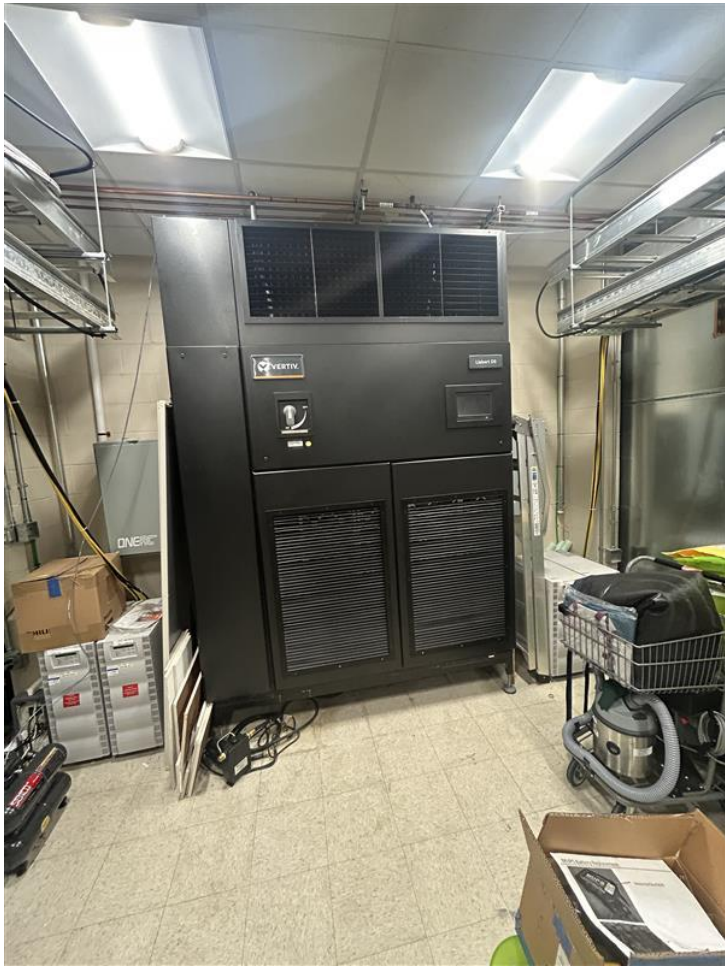
Area between the two Radiology Rooms. Now storage area that has a large Liebert system in area.

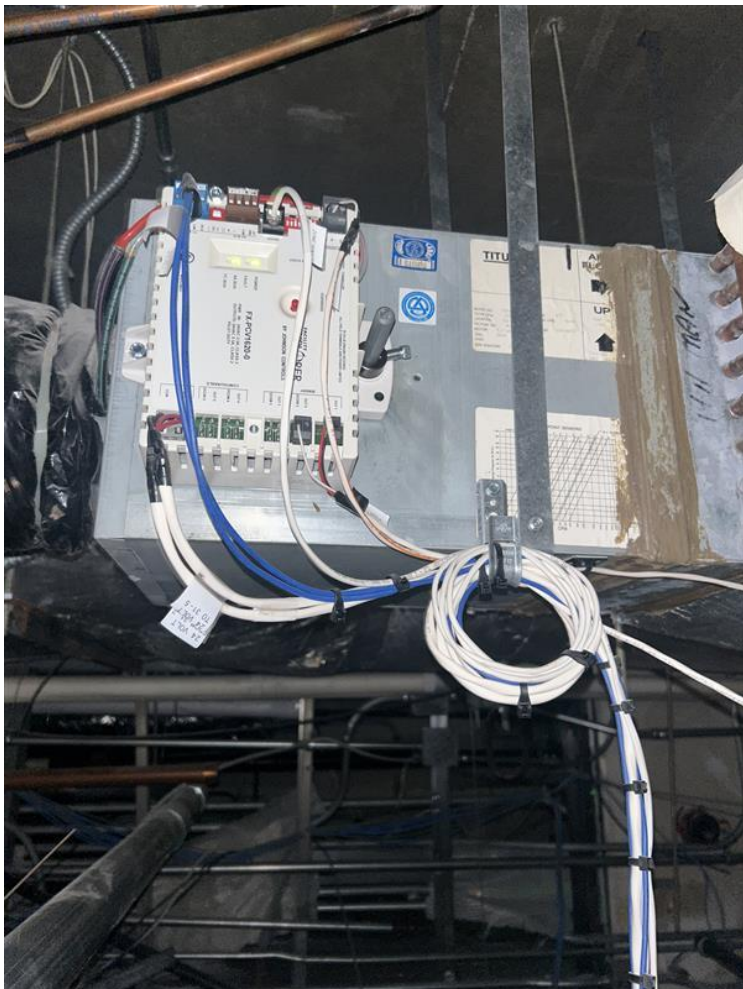
Typical VAV in MRI Areas

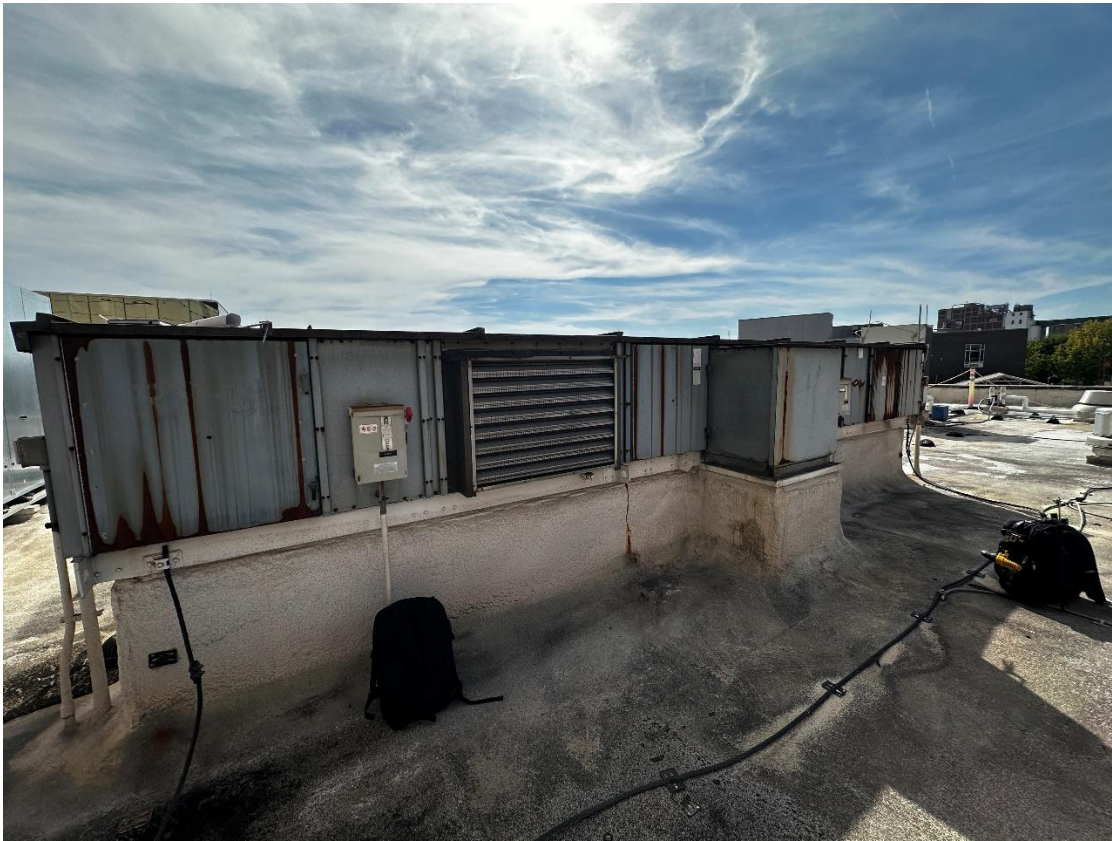
AHU-31 located up on Roof

AHU31: The unit is an older unit that sits on lower roof the supply & return is ducted down to the basement to serve the MRI area only. The Conserv BMS system is a Johnson Control (JCI) protocol. The BMS can see the unit, and it can control the VAV systems. The Return Fan was locked in on 30% Fan speed, did not modulate. The lower speed causing supply fan to have reduced performance & outside air being suck into relief/exhaust unit damper due to the fact the return cannot keep up with the supply fan. If the return fan speed can be increased, additional airflow could probably be achieved to the overall system. The 2/3 duct pressure sensor setpoint was programmed at 1.8" wc. The Airflow monitoring systems for BMS are not calibrated & are reading much lower than actual airflow.

Supply fan replaced 4 years ago. Return fan replaced 10 years ago. No unit info tag. Could not access Drive data, was not allowed to shut unit down.

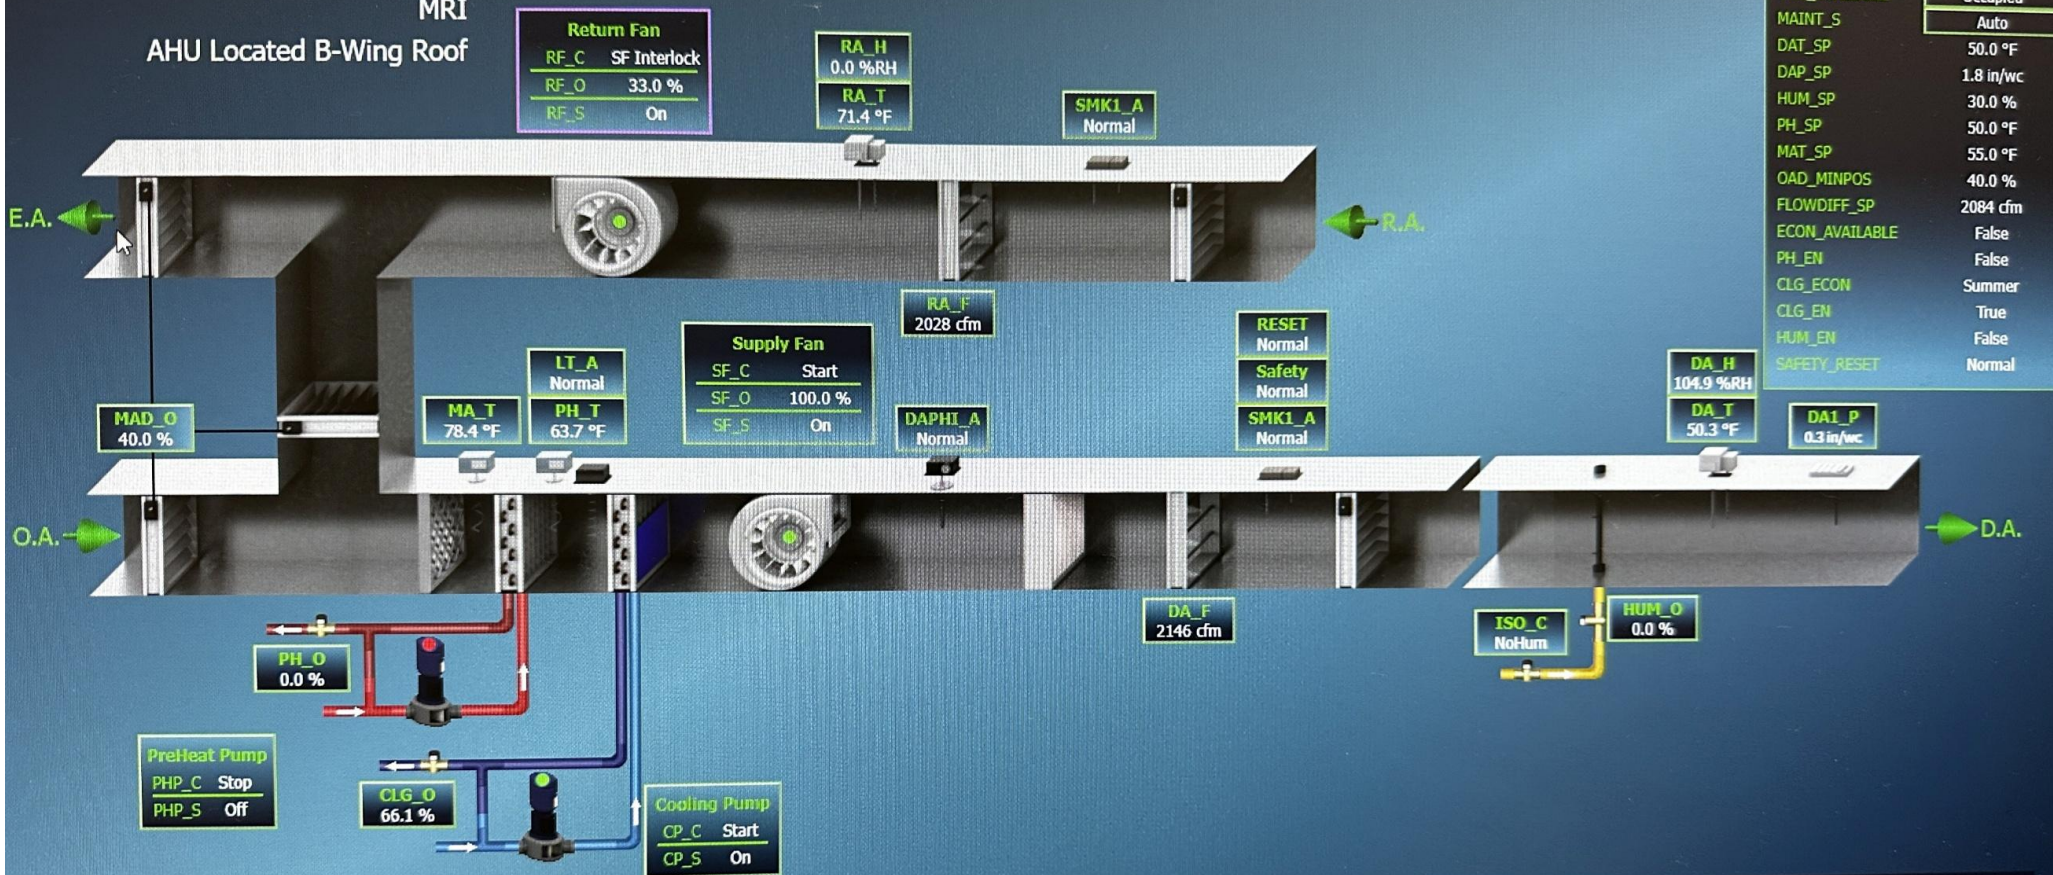
# AHU 31

Setpoints/Control	
OCC_SCHEDULE	Occupied
MAINT_S	Auto
DAT_SP	50.0 °F
DAP_SP	1.8 in/wc
HUM_SP	30.0 %
PH_SP	50.0 °F
MAT_SP	55.0 °F
OAD_MINPOS	40.0 %
FLOWDIFF_SP	2084 cfm
ECON_AVAILABLE	False
PH_EN	False
CLG_ECON	Summer
CLG_EN	True
HUM_EN	False
SAFETY_RESET	Normal

Point Page	Overrides & Notes	Drawings	Add Note
		OAT: 83.6 °F	FX60_01
		OAH: 36.6 %RH	
		WB: 65.1 °F	
		DP: 54.3 °F	
		Enth: 29.9 BTU/lb
