**Report: TAB Report**  
**Function: Test, Adjust, & Balance**  
**Date: 09/17/2024**

## 09-16-24 WAWA #8433 PISCATAWAY, NJ

451 Stelton Rd

PISCATAWAY, NJ

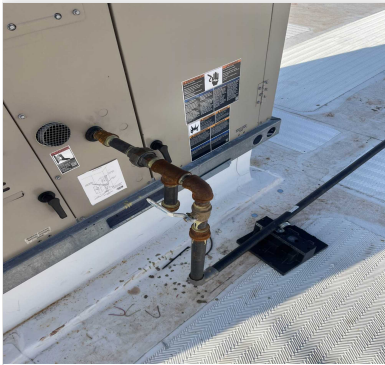
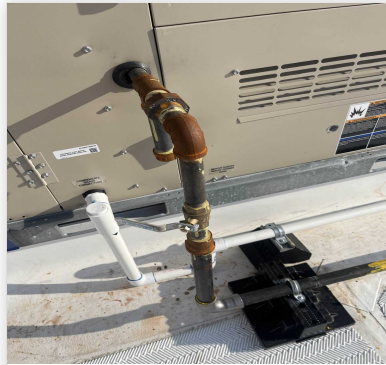
**Issue Name :** AC-1/3 Gas Valves.  
**Description :** AC-1/3 Gas valves are not on. Once building gets gas recommend MC goes through manufacturers heater startup procedure.  
**Created By :** National TAB                      **Assigned To :** National TAB - Tyler Youells  
**Status :** Open  
**Priority :** High                                      **Asset Tag :**  
**Originated Date :** 09/16/2024 - Tyler Youells - National TAB

Is gas piping installed and valves turned on?

Fail

No alarms present?

Alarms for heat failure due to gas being off

Heating mode is operational? Record EAT/LAT for each unit:

Gas is not on to the building unable to test

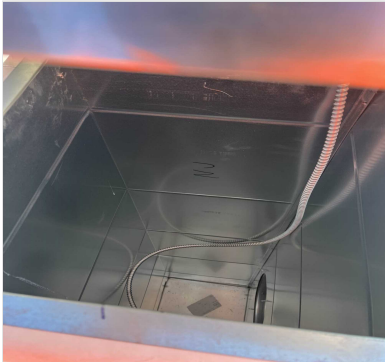
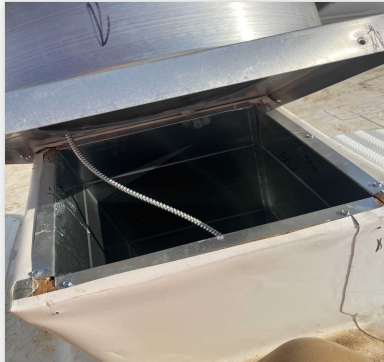
**Issue Name :** EF-1/2 Backdraft Damper  
**Description :** EF-1/2 do not have backdraft dampers installed. Recommend Mc installs so when the fan stops running outside air and pests will not enter the building.  
**Created By :** National TAB                      **Assigned To :** National TAB - Tyler Youells  
**Status :** Open  
**Priority :** Medium                                      **Asset Tag :**  
**Originated Date :** 09/16/2024 - Tyler Youells - National TAB

Back draft damper installed and can it fully open? Fail

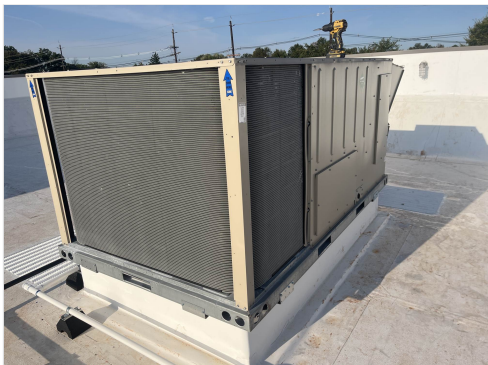
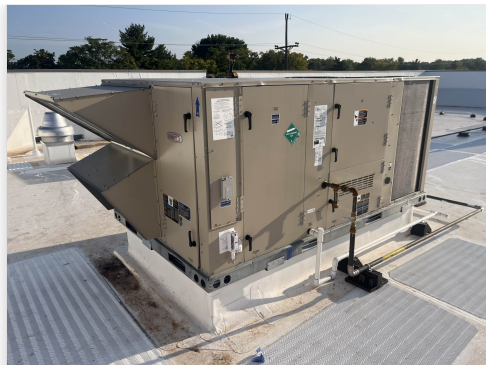
## Unit Data - PHOTO LOG

Asset: RTU1

Unit Data		
	Design	Actual
MFG	LENNOX ENLIGHT	LENNOX ENLIGHT
Serial Num	-	5624A03648
Model Num	LGT092H4E	LGT092H4ES1Y
Type	RTU	RTU
Configuration	VERTICAL	VERTICAL
Num OA Filters 1	-	2
OA Filter Size 1	-	16X25
Num Final Filter 1	-	4
Final Filter Size 1	-	20X25X2

Test Data		
	Design	Actual
SF CFM	3000	3095
SF RPM	-	1320
MOTOR RPM	-	1320
RA CFM	2450	2526
OA CFM	550	569
RL Voltage	-	209.9/209.7/208.3
RL Amperage	-	2.48/2.35/2.45
SF System SetPt	-	60%
RA Damper Position	-	MECHANICAL LINKAGE
OA Damper Position	-	25%
OA Damper Type	-	ECONOMIZER

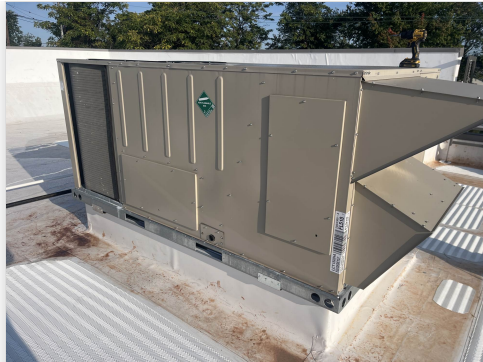
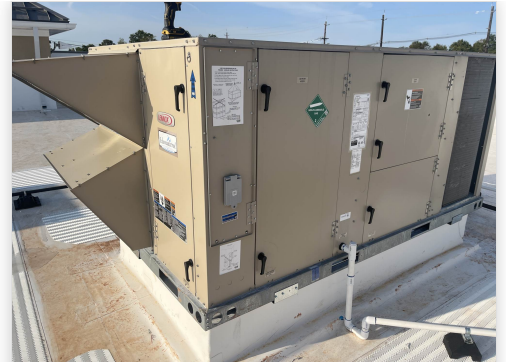
### Unit Data - PHOTO LOG

Asset: RTU2

Unit Data		
	Design	Actual
MFG	LENNOX ENLIGHT	LENNOX ENLIGHT
Serial Num	-	5624E08157
Model Num	LCT150H4E	LCT150H4EN1Y
Type	RTU	RTU
Configuration	VERTICAL	VERTICAL
Num OA Filters 1	-	2
OA Filter Size 1	-	16X25
Num Final Filter 1	-	4
Final Filter Size 1	-	20X25X2

Test Data		
	Design	Actual
SF CFM	5000	4984
SF RPM	-	1980
MOTOR RPM	-	1980
RA CFM	4050	4006
OA CFM	950	978
RL Voltage	-	209.4/209.7/209.5
RL Amperage	-	7.15/7.22/7.25
SF System SetPt	-	90%
RA Damper Position	-	MECHANICAL LINKAGE
OA Damper Position	-	33%
OA Damper Type	-	ECONOMIZER

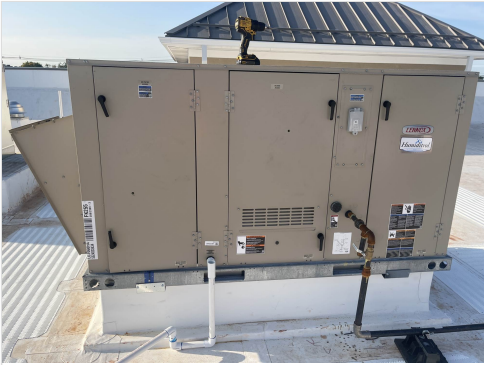
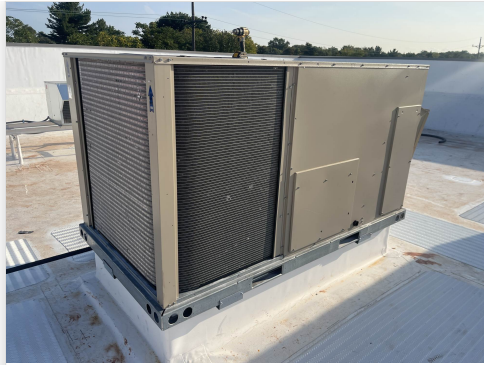
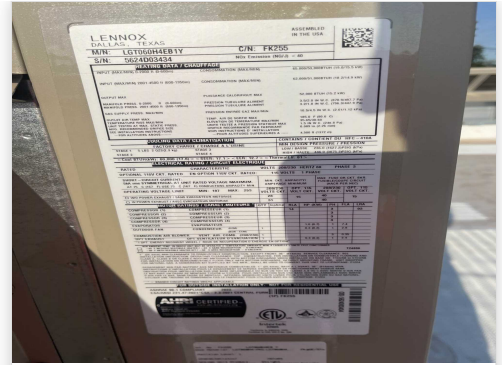
### Unit Data - PHOTO LOG

Asset: RTU3

Unit Data		
	Design	Actual
MFG	LENNOX ENLIGHT	LENNOX ENLIGHT
Serial Num	-	5624D03434
Model Num	LGT060H4E	LGT060H4EB1Y
Type	RTU	RTU
Configuration	VERTICAL	VERTICAL
Num OA Filters 1	-	1
OA Filter Size 1	-	30X16
Num Final Filter 1	-	4
Final Filter Size 1	-	20X20X2

Test Data		
	Design	Actual
SF CFM	2000	2002
SF RPM	-	767
MOTOR RPM	-	767
RA CFM	1650	1637
OA CFM	350	365
RL Voltage	-	207.7
RL Amperage	-	7.02
SF System SetPt	-	73%
RA Damper Position	-	MECHANICAL LINKAGE
OA Damper Position	-	25%
OA Damper Type	-	ECONOMIZER

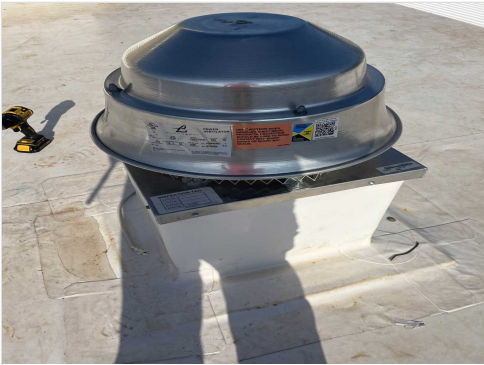
## Unit Data - PHOTO LOG

Asset: EF1

Unit Data		
	Design	Actual
MFG	PENNBARRY	PENNBARRY
Model Num	DX10R	DX10R
Serial Num	-	F24EZ73184
Type	DOWNBLAST	DOWNBLAST
Configuration	VERTICAL	VERTICAL

Test Data		
	Design	Actual
CFM	250	260
Fan RPM	1550	NA
Fan Rotation	-	CCW
Motor RPM	-	NA
System SetPt	-	MARKED ON DIAL
RL Voltage	-	119.2
RL Amperage	-	1.26
Total ESP	0.125"	0.29"
Fan Inlet SP	-	-0.29"
Fan Discharge SP	-	ATM

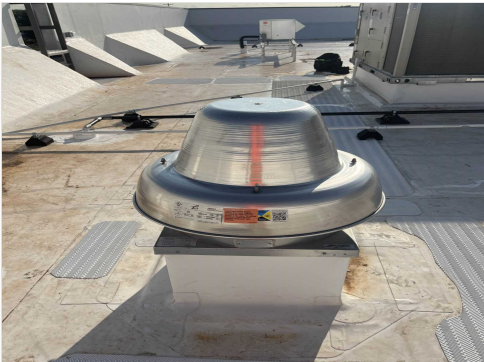
### Unit Data - PHOTO LOG

Asset: EF2

Unit Data		
	Design	Actual
MFG	PENNBARRY	PENNBARRY
Model Num	DX16S	DX16S
Serial Num	-	F24HZ35191
Type	DOWNBLAST	DOWNBLAST
Configuration	VERTICAL	VERTICAL

Test Data		
	Design	Actual
CFM	1300	1276
Fan RPM	1300	NA
Fan Rotation	-	CCW
Motor RPM	-	NA
System SetPt	-	MARKED ON DIAL
RL Voltage	-	105.7
RL Amperage	-	5.44
Total ESP	0.250"	0.50"
Fan Inlet SP	-	-0.50"
Fan Discharge SP	-	ATM
