**Report By:**

**Report: FINAL REPORT**  
**Function: Test, Adjust, & Balance**  
**Date: 09/21/2023**

**PROJECT**  
**09-18-23 CULVERS - ANDERSON, SC**

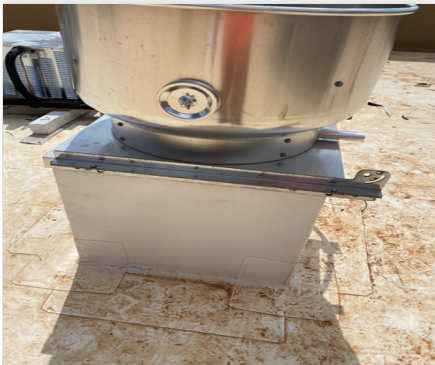
**GREASECUP**  
**09/20/2023**

**Issue Name :** GREASE CUPS  
**Description :** GREASE CUPS FOR BOTH HOODS NOT INSTALLED  
**Created By :** National TAB                      **Assigned To :** National TAB - Antonio Flores-De La Cruz  
**Status :** Open  
**Originated Date :** 09/20/2023 - Antonio Flores-De La Cruz - National TAB

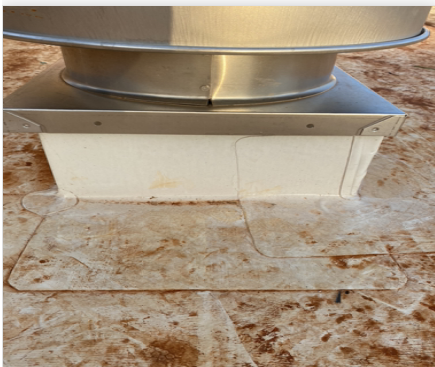
**CURBSCREWS**  
**09/20/2023**

**Issue Name :** MISSING SCREWS FOR EFs  
**Description :** ALL EXHAUST FANS ARE NOT SCREWED INTO CURBS  
**Created By :** National TAB                      **Assigned To :** National TAB - Antonio Flores-De La Cruz  
**Status :** Open  
**Originated Date :** 09/20/2023 - Antonio Flores-De La Cruz - National TAB

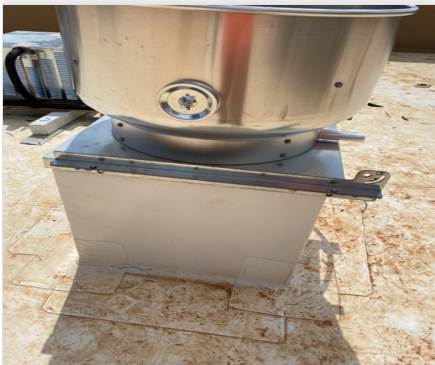
**HINGEKIT  
09/20/2023**

**Issue Name :** PRV2 & PRV3 HINGE KITS  
**Description :** HINGE KITS HAVE NOT BEEN INSTALLED FOR BOTH FANS. BASE BRACKETS ONLY INSTALLED  
**Created By :** National TAB                      **Assigned To :** National TAB - Antonio Flores-De La Cruz  
**Status :** Open  
**Originated Date :** 09/20/2023 - Antonio Flores-De La Cruz - National TAB
