Report: TAB Report
Function: Test, Adjust, & Balance
Date: 10/10/2025
Completed By: National TAB

PROJECT
09-15-25 QT #1727 EMERSON, GA

QUIKTRIP
4705 SOUTH 129TH EAST AVENUE
TULSA, OK 74134

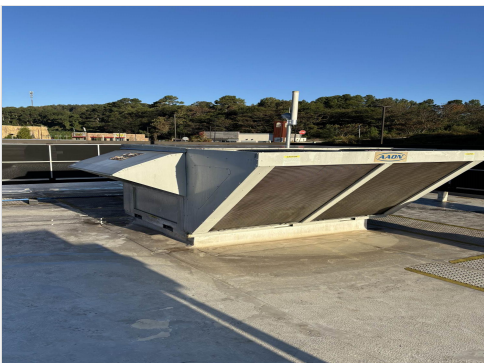
Unit Data - PHOTO LOG

Asset: RT-3

Unit Data		
	Design	Actual
MFG	NA	AAON
Serial Num	-	202009-ANEK21079
Model Num	NA	RN-013-8-0-EA0A-152
Type	-	RTU
Num OA Filters 1	-	1
OA Filter Size 1	-	45X22"

Test Data		
	Design	Actual
SF CFM	4200	4039
SF RPM	-	1291
RA CFM	3400	3296
OA CFM	800	743
RL Voltage	-	145 VFD
RL Amperage	-	7.45 VFD
SF Rotation	-	CCW
SF System SetPt	-	44.0 Hz
RA Damper Position	-	90%
Min OA Damper Position	-	10%
Min OA Damper Type	-	ECONOMIZER
