**Report: TAB Report**  
**Function: Test, Adjust, & Balance**  
**Date: 10/10/2025**  
**Completed By: National TAB**

**PROJECT**  
**09-15-25 QT #1727 EMERSON, GA**

105 OLD ALLATOONA ROAD

Project: 09-15-25 QT #1727 EMERSON, GA

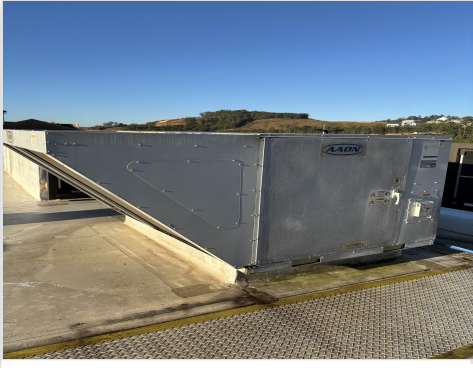
Asset: RT-1

Unit Data		
	Design	Actual
MFG	NA	AAON
Serial Num	-	202009-ANEK21078
Model Num	NA	RN-013-8-0-EA0A-152
Type	-	RTU
Num OA Filters 1	-	1
OA Filter Size 1	-	45X22"

Test Data		
	Design	Actual
SF CFM	4200	4128
SF RPM	-	1238
RA CFM	3400	3316
OA CFM	800	812
RL Voltage	-	131 VFD
RL Amperage	-	6.19 VFD
SF Rotation	-	CCW
SF System SetPt	-	42.2 Hz
RA Damper Position	-	90%
Min OA Damper Position	-	10%
Min OA Damper Type	-	ECONOMIZER

Notes:  
RTU balanced for total flow and diffusers balanced for comfort

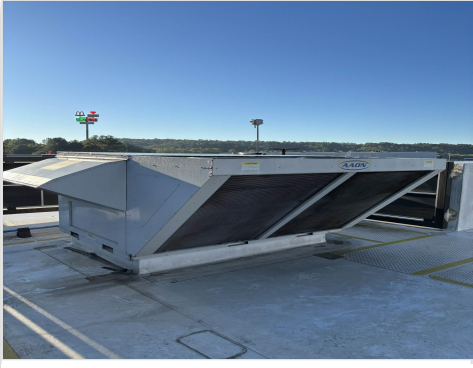
Asset: RT-2

Unit Data		
	Design	Actual
MFG	NA	AAON
Serial Num	-	202009-ANEK2180
Model Num	NA	RN-013-8-0-EA0A-152
Type	-	RTU
Num OA Filters 1	-	1
OA Filter Size 1	-	45X22"

Test Data		
	Design	Actual
SF CFM	4200	4197
SF RPM	-	1270
RA CFM	3400	3461
OA CFM	800	736
RL Voltage	-	141 VFD
RL Amperage	-	7.24 VFD
SF Rotation	-	CCW
SF System SetPt	-	43.3 Hz
RA Damper Position	-	90%
Min OA Damper Position	-	10%
Min OA Damper Type	-	ECONOMIZER

Notes:  
RTU balanced for total flow and diffusers balanced for comfort

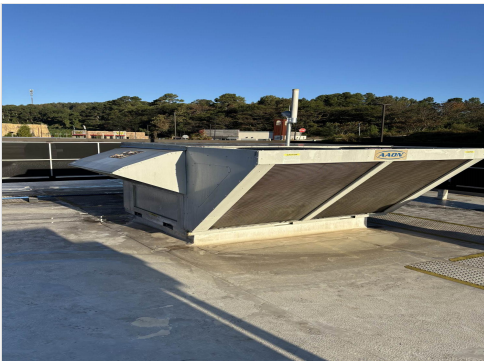
Asset: RT-3

Unit Data		
	Design	Actual
MFG	NA	AAON
Serial Num	-	202009-ANEK21079
Model Num	NA	RN-013-8-0-EA0A-152
Type	-	RTU
Num OA Filters 1	-	1
OA Filter Size 1	-	45X22"

Test Data		
	Design	Actual
SF CFM	4200	4039
SF RPM	-	1291
RA CFM	3400	3296
OA CFM	800	743
RL Voltage	-	145 VFD
RL Amperage	-	7.45 VFD
SF Rotation	-	CCW
SF System SetPt	-	44.0 Hz
RA Damper Position	-	90%
Min OA Damper Position	-	10%
Min OA Damper Type	-	ECONOMIZER

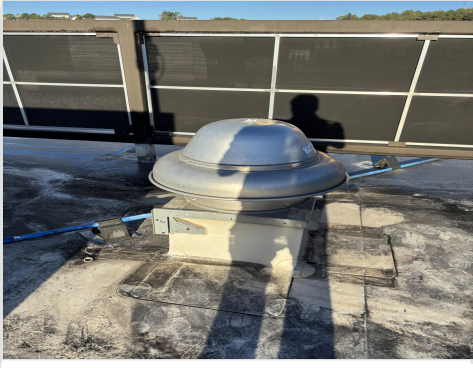
Asset: EF1

Unit Data		
	Design	Actual
MFG	NA	CAPTIVEAIRE
Model Num	NA	DR50HFA
Serial Num	-	4639275
Type	-	DOWNBLAST
Configuration	-	VERTICAL

Test Data		
	Design	Actual
CFM	750	803
Fan Rotation	-	CCW
System SetPt	-	LOW
RL Voltage	-	[1]
RL Amperage	-	[1]
Total ESP	-	-0.16"
Fan Inlet SP	-	-0.16"
Fan Discharge SP	-	1 ATM

[1] UNABLE TO READ VOLTS AND AMPS SAFELY

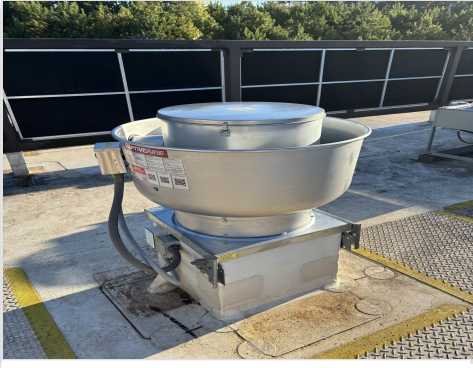
Asset: EF3

Unit Data		
	Design	Actual
MFG	NA	CAPTIVEAIRE
Model Num	NA	DU50HFA
Serial Num	-	7632101
Type	UPBLAST	UPBLAST
Configuration	VERTICAL	VERTICAL

Test Data		
	Design	Actual
CFM	1350	1302
Fan RPM	-	2394
Fan Rotation	-	CCW
Motor RPM	-	2394
System SetPt	-	79.8 Hz
RL Voltage	-	207
RL Amperage	-	14.4
Total ESP	-	-0.58"
Fan Inlet SP	-	-0.58"
Fan Discharge SP	-	1 ATM

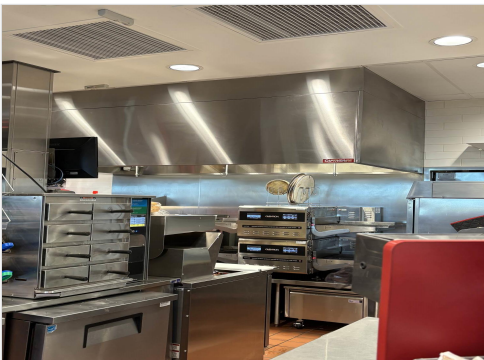
Asset: HD1

Unit Data		
	Design	Actual
MFG	CAPTIVEAIRE	CAPTIVEAIRE
Model Num	6030 ND-2-F	6030 ND-2-F
Job / Serial Num	-	7632101
Type	TYPE I CANOPY	TYPE I CANOPY
Hood length	-	109"
Hood Width	-	60"

Test Data Exhaust		
	Design	Actual
Filter Type	-	CAPTRATE
Filter Size 1	-	14X18"
Filter Qty 1	-	6
Filter AK factor size 1	-	1.75
Filter Total AK Area	-	10.5
Filter1 FPM	-	107
Filter2 FPM	-	120
Filter3 FPM	-	125
Filter4 FPM	-	144
Filter5 FPM	-	127
Filter6 FPM	-	124
Filter Ave FPM(corr)	-	124
CFM	1350	1302
