**Report: TAB REPORT**  
**Function: Test, Adjust, & Balance**  
**Date: 11/22/2022**

## 11-21 TACO BELL - BLYTHEWOOD, SC

209 BLYTHEWOOD RD

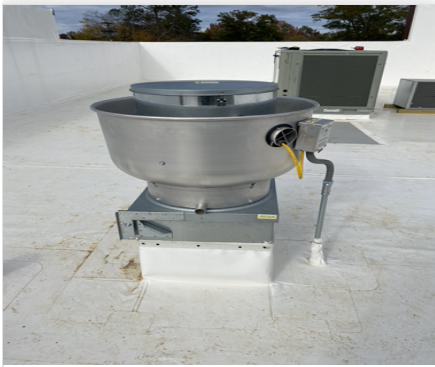
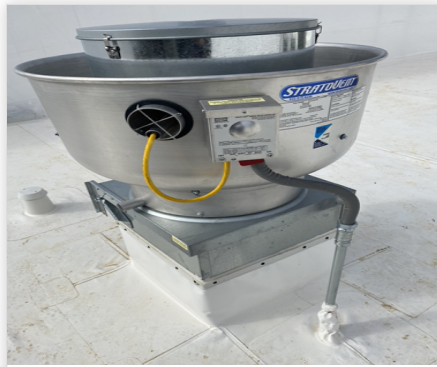
**Issue Name :** EF1 unable to be opened

**Description :** Unable to open EF1 due to connection not being long enough.

Rotation is correct?	YES
Belts are tight?	NA
Grease cup installed on hood fan?	YES
Hinge kit installed installed on hood fan?	YES
Lean fan back. Is grease duct installation adequate and is duct ran all the way to the base of the fan?	NO, HINGE NOT ABLE TO BE USED. MECHANICAL NEEDS TO MOVE HINGE KIT TO THE SIDE WHERE THE DISCONNECT IS

Flex conduit is long enough so that fan can be completely tilted back?	CURRENTLY NO
There is no major leakage around base of fan?	YES
Is the motor operating below the motor FLA rating?	YES
For restroom fan(s) is the back draft damper installed and can it fully open?	YES
Unit free of noticeable noise and vibration?	YES
<b>MUA</b>	
Rotation is correct?	NA
Gas piping is installed and valves are in on position?	NA
Heater tested and is functional?	NA
Internal motorized damper is fully opening?	NA
Motor is operating below the FLA rating?	NA
Unit free of noticeable noise and vibration?	NA
<b>HOODS</b>	
Kitchen equipment installed in proper places?	YES
Can kitchen equipment be turned on for final smoke test?	YES
<b>DOCUMENTATION</b>	
Have trades/general contractor been notified about any issues and are they created on FaciliBuild?	YES
