Report: TAB Report
Function: Test, Adjust, & Balance
Date: 12/16/2024
Completed By: National TAB

01-06-25 WAWA #6302 HINESVILLE, GA

Project: 01-06-25 WAWA #6302 HINESVILLE, GA

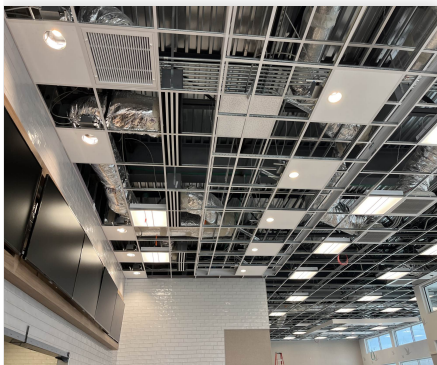
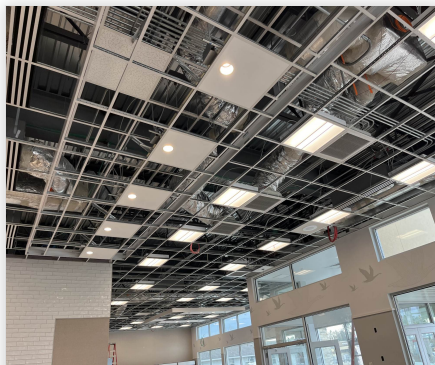
Issue Name : Ceiling Tiles Not Installed
Description : The ceiling tiles have not yet been installed. This prevents NTi technicians from being able to balance any of the linear diffusers throughout the space. As a result only the total flows will be set at this time.
Created By : National TAB **Assigned To :** National TAB - Stephen Tassinaro
Status : Open
Priority : Urgent **Asset Tag :**
Originated Date : 12/09/2024 - Stephen Tassinaro - National TAB

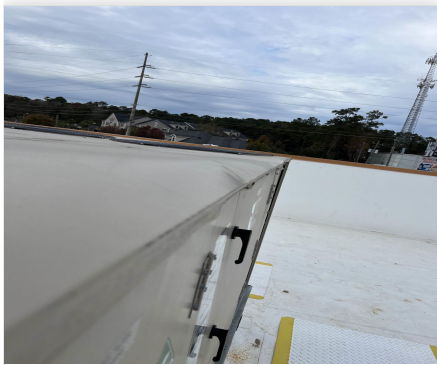
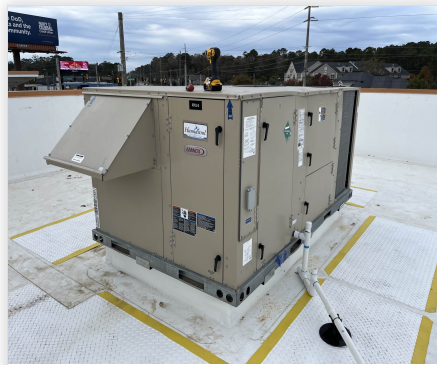
Issue Name : RTU 3 Damaged Panels
Description : The damaged top panel on RTU 3 is preventing the blower door from being opened. Recommend repairing or replacing panel.
Created By : National TAB **Assigned To :** National TAB - Stephen Tassinaro
Status : Open
Priority : High **Asset Tag :**
Originated Date : 12/10/2024 - Stephen Tassinaro - National TAB

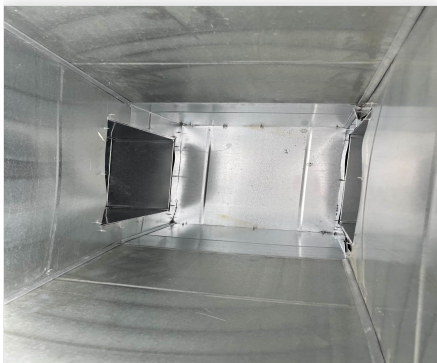
Issue Name : RTUs 2 & 3 No Turning Vanes In Supply Drops
Description : There are no turning vanes installed in the bottom of the supply drops for RTUs 2 & 3. Recommend verifying with the EOR that these are not required. HVAC GENERAL NOTES Note 12.
Created By : National TAB **Assigned To :** National TAB - Stephen Tassinaro
Status : Open
Priority : Urgent **Asset Tag :**
Originated Date : 12/09/2024 - Stephen Tassinaro - National TAB

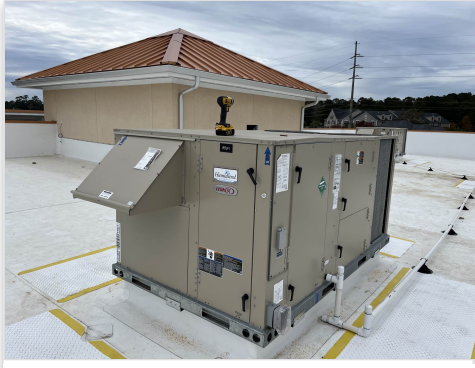
Unit Data - PHOTO LOG

Asset: RTU1

Unit Data		
	Design	Actual
MFG	LENNOX ENLIGHT	LENNOX ENLIGHT
Serial Num	-	5624G03843
Model Num	LCT102H4E	LCT102H4EG1Y
Type	RTU	RTU
Configuration	VERTICAL	VERTICAL
Num OA Filters 1	-	1
OA Filter Size 1	-	23X14
Num Final Filter 1	-	4
Final Filter Size 1	-	20X25X2

Test Data		
	Design	Actual
SF CFM	3400	3477
SF RPM	-	1386
RA CFM	2900	2965
OA CFM	500	512
RL Voltage	-	209/210/211
RL Amperage	-	2.7/2.6/2.8
SF System SetPt	-	63%
OA Damper Position	-	45%
OA Damper Type	-	SINGLE BLADE

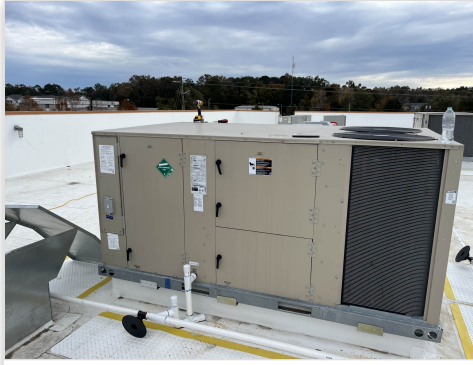
Unit Data - PHOTO LOG

Asset: RTU2

Unit Data		
	Design	Actual
MFG	LENNOX ENLIGHT	LENNOX ENLIGHT
Serial Num	-	5624G03845
Model Num	LCT150H4E	LCT150H4EN1Y
Type	RTU	RTU
Configuration	VERTICAL	VERTICAL
Num OA Filters 1	-	1
OA Filter Size 1	-	23X14
Num Final Filter 1	-	4
Final Filter Size 1	-	20X25X2

Test Data		
	Design	Actual
SF CFM	5000	5040
SF RPM	-	1914
RA CFM	4500	4526
OA CFM	500	514
RL Voltage	-	212/212/212
RL Amperage	-	6.4/6.6/6.5
SF System SetPt	-	87%
OA Damper Position	-	36%
OA Damper Type	-	SINGLE BLADE

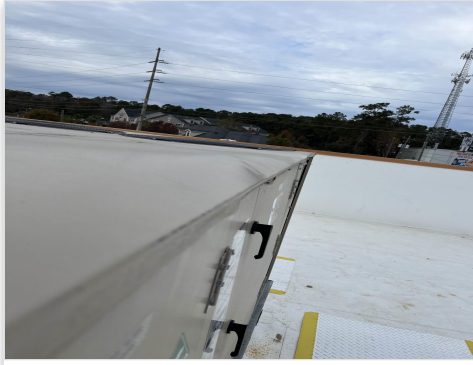
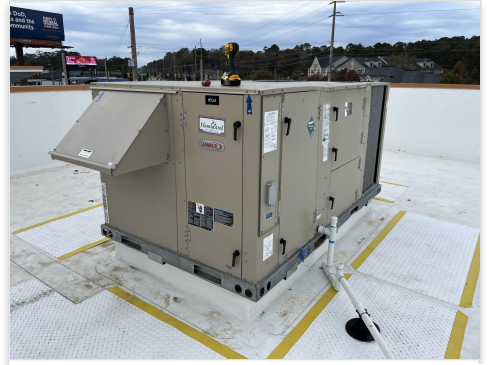
Unit Data - PHOTO LOG

Asset: RTU3

Unit Data		
	Design	Actual
MFG	LENNOX ENLIGHT	LENNOX ENLIGHT
Serial Num	-	5624G03844
Model Num	LCT092H4E	LCT092H4EG1Y
Type	RTU	RTU
Configuration	VERTICAL	VERTICAL
Num OA Filters 1	-	1
OA Filter Size 1	-	23X14
Num Final Filter 1	-	4
Final Filter Size 1	-	20X25X2

Test Data		
	Design	Actual
SF CFM	3000	3071
SF RPM	-	1320
RA CFM	2700	2766
OA CFM	300	305
RL Voltage	-	209/209/210
RL Amperage	-	2.7/2.7/2.7
SF System SetPt	-	60%
OA Damper Position	-	27%
OA Damper Type	-	SINGLE BLADE

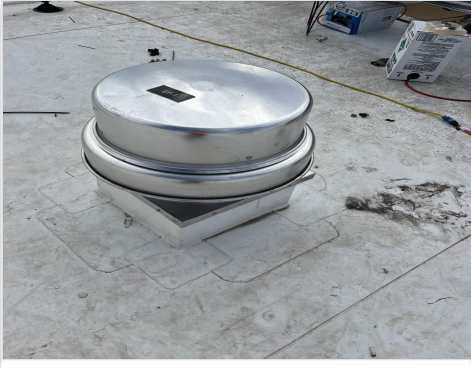
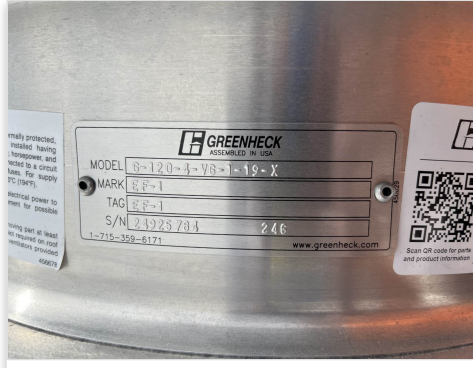
Unit Data - PHOTO LOG

Asset: EF1

Unit Data		
	Design	Actual
MFG	GREENHECK	GREENHECK
Model Num	G-120	G-120-4-VG-1-19-X
Serial Num	-	24925784 24G
Type	DOWNBLAST	CENTRIFUGAL
Configuration	VERTICAL	DOWNBLAST

Test Data		
	Design	Actual
CFM	800	776
Fan RPM	863	DD
Fan Rotation	-	CW
Motor RPM	-	DD
System SetPt	-	9
Total ESP	0.250"	0.35"
Fan Inlet SP	-	-0.35"
Fan Discharge SP	-	ATM

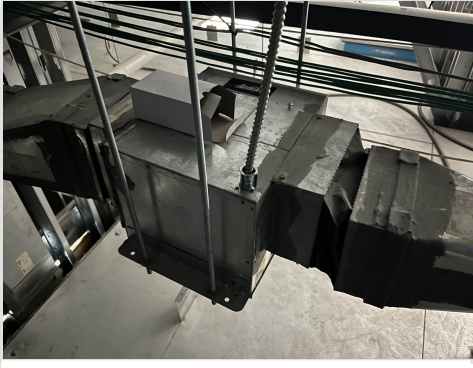
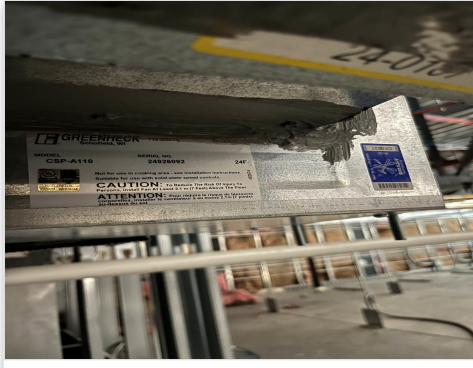
Unit Data - PHOTO LOG

Asset: EF2

Unit Data		
	Design	Actual
MFG	GREENHECK	GREENHECK
Model Num	CSP-B110	CSP-A110
Serial Num	-	24926092 24F
Type	INLINE	INLINE
Configuration	HORIZONTAL	HORIZONTAL

Test Data		
	Design	Actual
CFM	60	62
Fan Rotation	-	CORRECT
System SetPt	-	SPEED CONTROLLER
Total ESP	0.125"	0.04"
Fan Inlet SP	-	-0.02"
Fan Discharge SP	-	0.02"
