Report: TAB REPORT
Function: Test, Adjust, & Balance
Date: 08/08/2023

PROJECT
07-17-2023 CULVERS - LAKE ORION, MI

Project Summary

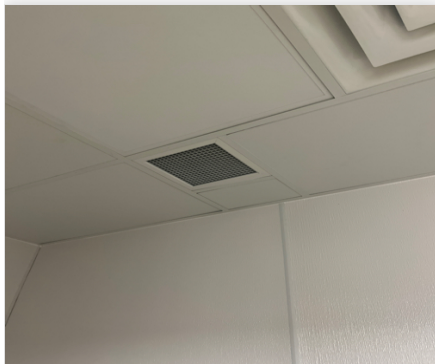
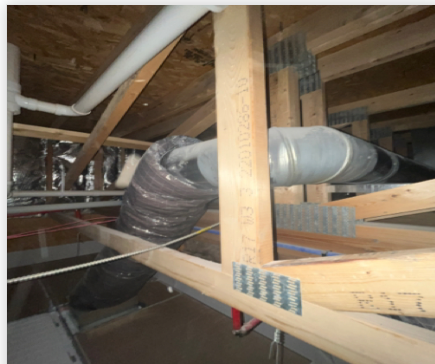
PRV13
07/19/2023

Issue Name : PRV-1 no dampers
Description : PRV-1 has no dampers installed for any of the 3 exhaust grilles in each bathroom. Diffuser 1 and 2 are in design. Diffuser 3 (kitchen restroom) is at the same as other 2 in terms of flow. But without damper I'm unable to reduce exhaust to kitchen restroom.
Created By : National TAB **Assigned To :** National TAB - Dylan Crisman
Status : Open
Originated Date : 07/19/2023 - Dylan Crisman - National TAB

Ductwork above restroom..
07/19/2023

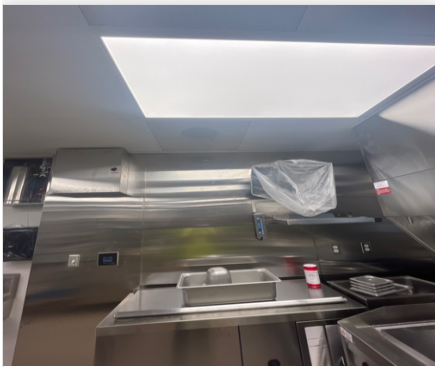
2-8
07/19/2023

Issue Name : RTU-2 damper
Description : Diffuser 2-8 damper shows very little change in flow when fully open or fully closed. Damper moves freely, tightened wingnut, no difference. Damper plate has no resistance when moved, don't suspect blockage.
Created By : National TAB **Assigned To :** National TAB - Dylan Crisman
Status : Open
Originated Date : 07/19/2023 - Dylan Crisman - National TAB

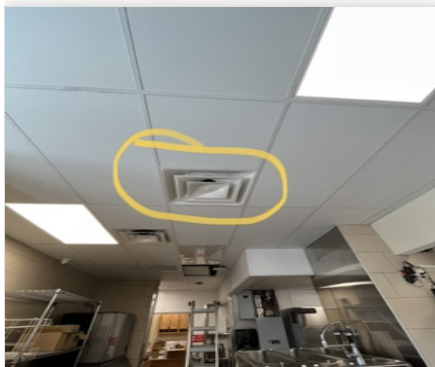
**DIFFUSER2-1circled2-2..
07/19/2023**

Issue Name : RTU-2 diffusers without dampers
Description : Damper 2-1 and 2-2 unable to locate dampers. Flow is close to design but will need them installed to properly balance.
Created By : National TAB **Assigned To :** National TAB - Dylan Crisman
Status : Open
Originated Date : 07/19/2023 - Dylan Crisman - National TAB

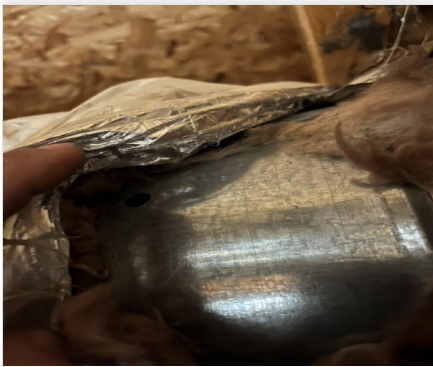
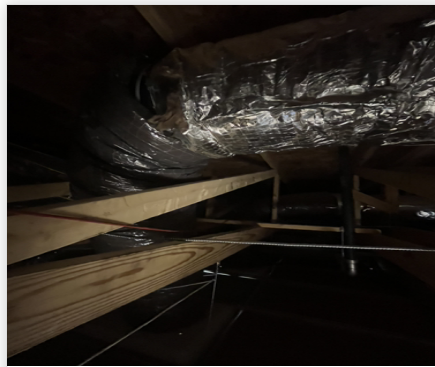
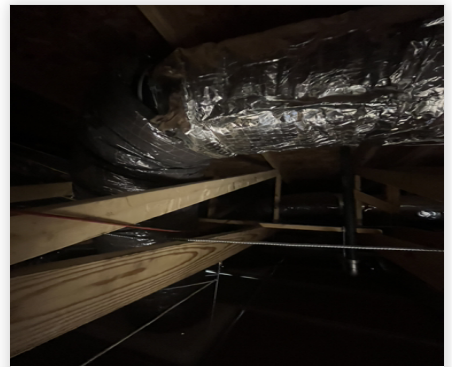
2-3missingdamper
07/19/2023

Issue Name : RTU-2 missing dampers
Description : Dampers in kitchen missing dampers 1. 2-4 has no damper flow is reading 730/375CFM 2. 2-3 damper is broken flow is in design but will need to be installed to be properly balanced.
Created By : National TAB **Assigned To :** National TAB - Dylan Crisman
Status : Open
Originated Date : 07/19/2023 - Dylan Crisman - National TAB
