Report By:

**Report: TAB REPORT**  
**Function: Test, Adjust, & Balance**  
**Date: 08/08/2023**

**PROJECT**  
**07-17-2023 CULVERS - LAKE ORION, MI**

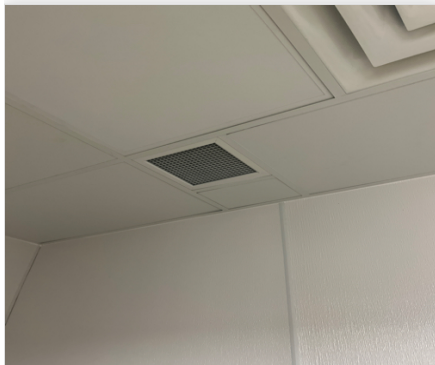
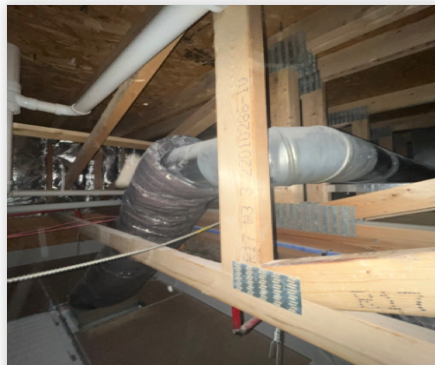
**PRV13**  
**07/19/2023**

**Issue Name :** PRV-1 (Restrooms) Dampers not installed  
**Description :** PRV-1 has no dampers installed for any of the 3 exhaust grilles in each bathroom. Unable to balance all grilles to design as a result.  
**Created By :** National TAB                      **Assigned To :** National TAB - Dylan Crisman  
**Status :** Open  
**Originated Date :** 07/19/2023 - Dylan Crisman - National TAB

**Ductwork above restroom..**  
**07/19/2023**

Asset	Notes	Date	Written By
PRV1-EGRD1	Dampers not installed for all three grilles.	08/09/2023	Will Turnbough

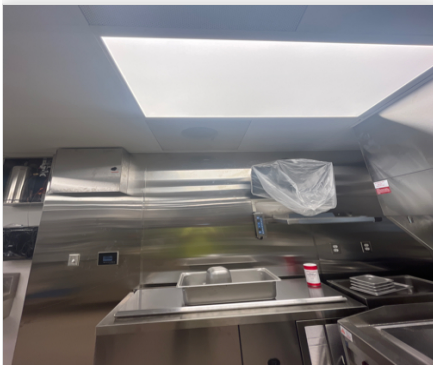
2-8  
07/19/2023

**Issue Name :** RTU-2 (Kitchen) Diffuser 2-8 damper issue  
**Description :** Diffuser 2-8 airflow not changing when damper is adjusted. Recommend mechanical contractor inspect/repair damper.  
**Created By :** National TAB                      **Assigned To :** National TAB - Dylan Crisman  
**Status :** Open  
**Originated Date :** 07/19/2023 - Dylan Crisman - National TAB

Asset	Notes	Date	Written By
SGRD1	No damper found	08/09/2023	Will Turnbough
SGRD2	No damper found	08/09/2023	Will Turnbough
SGRD3	Damper broken.	08/09/2023	Will Turnbough
SGRD4	No damper found	08/09/2023	Will Turnbough
SGRD8	Airflow not changing when damper is adjusted. Recommend checking damper.	08/09/2023	Will Turnbough

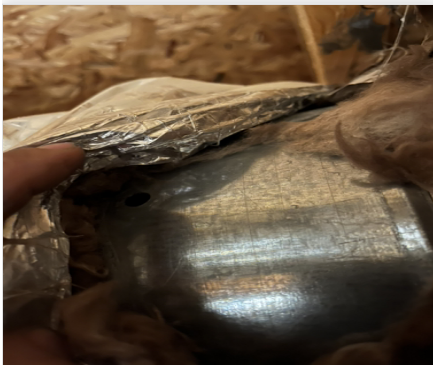
**2-3missingdamper  
07/19/2023**

**Issue Name :** RTU-2 (Kitchen) missing and broken dampers  
**Description :** 2-1, 2-2, and 2-4 dampers are missing. 2-3 damper is broken. Recommend installing and repairing.  
**Created By :** National TAB                      **Assigned To :** National TAB - Dylan Crisman  
**Status :** Open  
**Originated Date :** 07/19/2023 - Dylan Crisman - National TAB
