**Report: TAB Report**  
**Function: Test, Adjust, & Balance**  
**Date: 03/06/2026**  
**Completed By: National TAB**

**PROJECT**  
**03-16-26 QT #0488 PHOENIX, AZ**

Project: 03-16-26 QT #0488 PHOENIX, AZ

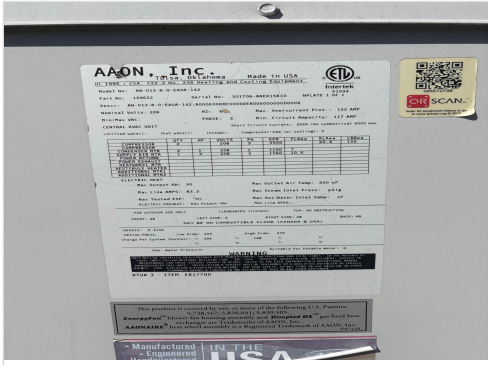
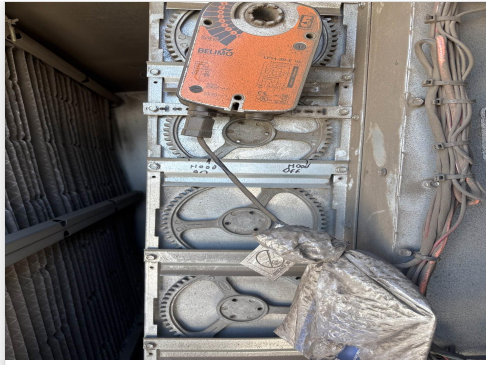
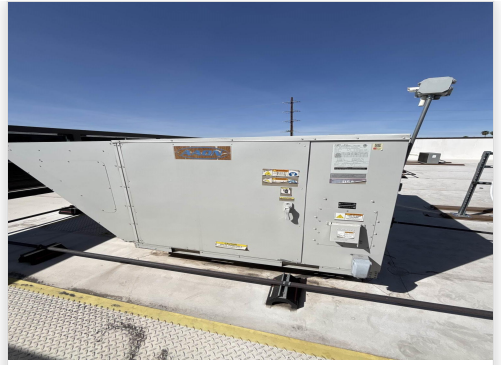
# Unit Data - PHOTO LOG

Asset: RT-3

Unit Data	
	Actual
MFG	AAON
Serial Num	201706-ANEL15810
Model Num	RN-013-8-0-EA0A-142
Num OA Filters 1	1
OA Filter Size 1	45X23
Num Final Filter 1	2
Final Filter Size 1	48X20

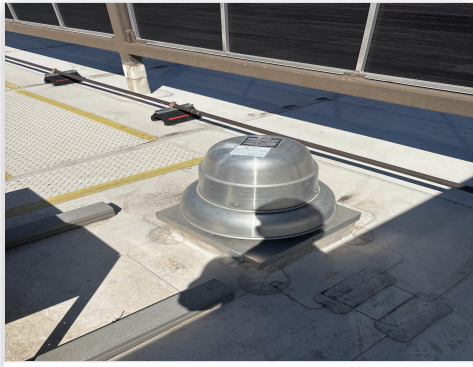
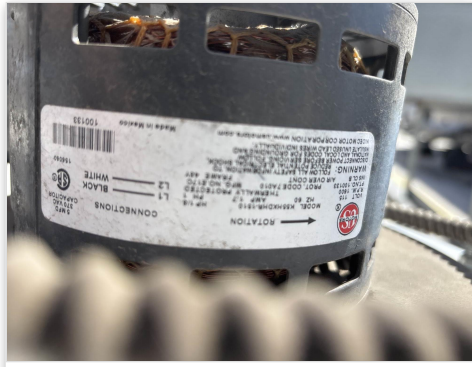
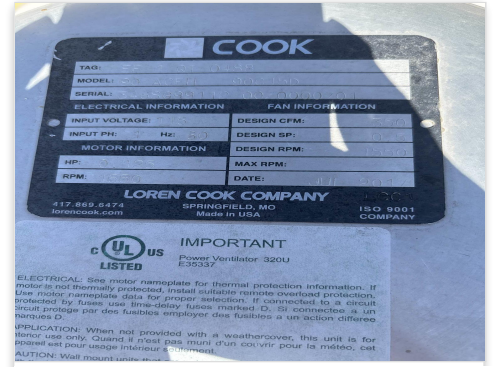
# Unit Data - PHOTO LOG

Asset: EF1

Unit Data		
	Design	Actual
MFG	NA	COOK
Model Num	NA	90 ACEH 90C15D
Serial Num	-	346SG99112 00/0000701
Type	-	DOWNBLAST
Configuration	-	VERTICAL

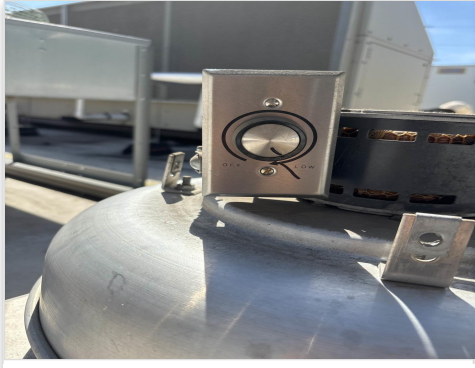
## Test Data - PHOTO LOG

Test Data		
	Design	Actual
CFM	225	221
Fan RPM	-	NA
Fan Rotation	-	CCW
Motor RPM	-	NA
System SetPt	-	DIAL
RL Voltage	-	NA
RL Amperage	-	NA
Total ESP	-	0.15"
Fan Inlet SP	-	-0.15"
Fan Discharge SP	-	ATMS

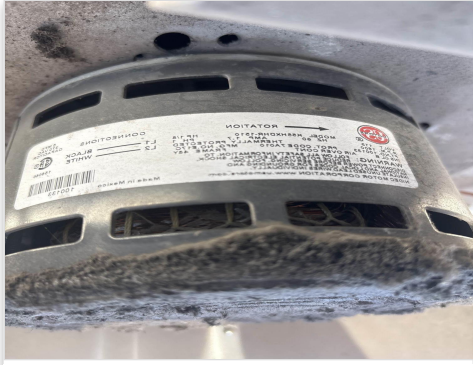
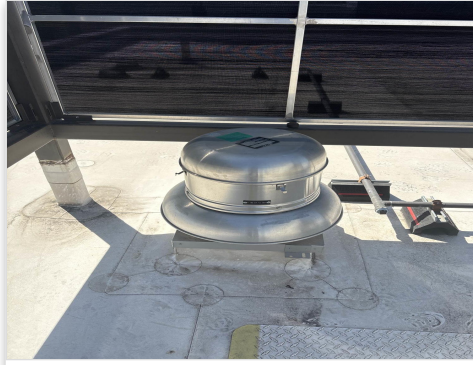
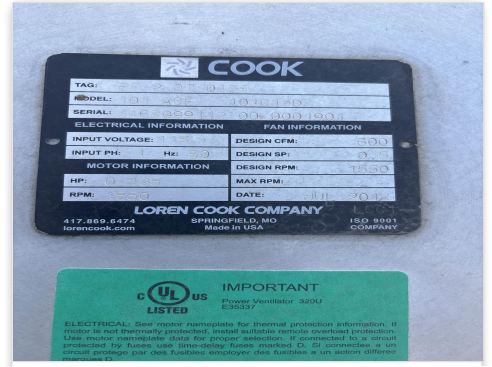
# Unit Data - PHOTO LOG

Asset: EF2

Unit Data		
	Design	Actual
MFG	NA	COOK
Model Num	NA	101 ACE 101C15D
Serial Num	-	346SG99112 00/0001901
Type	-	DOWNBLAST
Configuration	-	VERTICAL

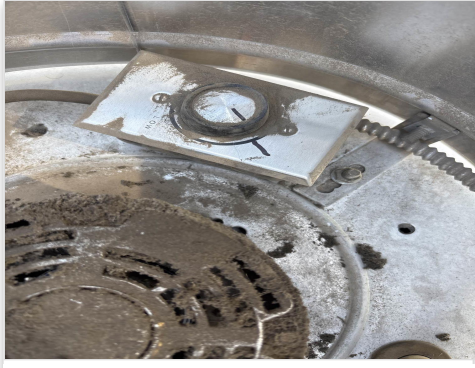
**Test Data - PHOTO LOG**

Test Data		
	Design	Actual
CFM	525	520
Fan RPM	-	NA
Fan Rotation	-	CCW
Motor RPM	-	NA
System SetPt	-	DIAL
RL Voltage	-	NA
RL Amperage	-	NA
Total ESP	-	0.39"
Fan Inlet SP	-	0.39"
Fan Discharge SP	-	ATMS
