**Report: TAB Report**  
**Function: Test, Adjust, & Balance**  
**Date: 03/06/2026**  
**Completed By: National TAB**

**PROJECT**  
**03-16-26 QT #0488 PHOENIX, AZ**

Project: 03-16-26 QT #0488 PHOENIX, AZ

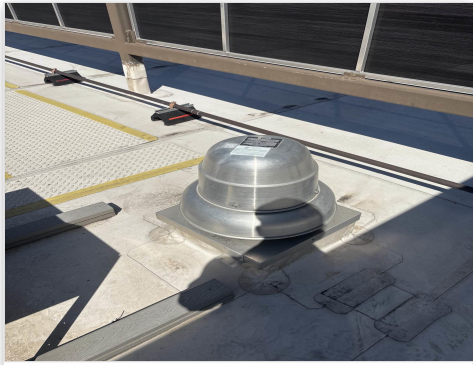
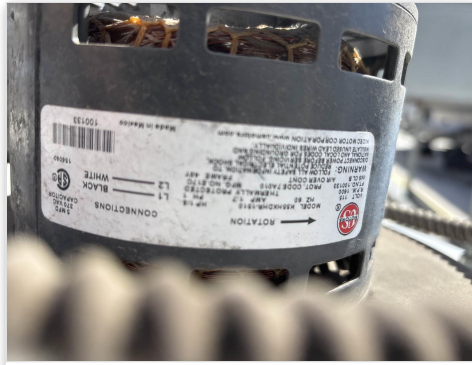
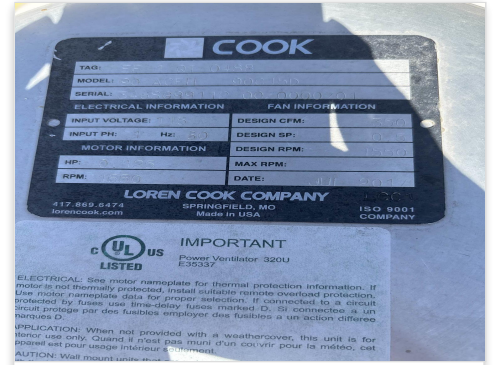
# Unit Data - PHOTO LOG

Unit Data		
	Design	Actual
MFG	NA	COOK
Model Num	NA	90 ACEH 90C15D
Serial Num	-	346SG99112 00/0000701
Type	-	DOWNBLAST
Configuration	-	VERTICAL

Motor Data		
	Design	Actual
Motor MFG	-	US MOTORS
Frame	-	48Y
Horsepower	-	1/8
Motor Rpm	-	1600
Phase	-	1
Voltage (rated)	-	115
Amperage (rated)	-	1.7
Service Factor	-	NL

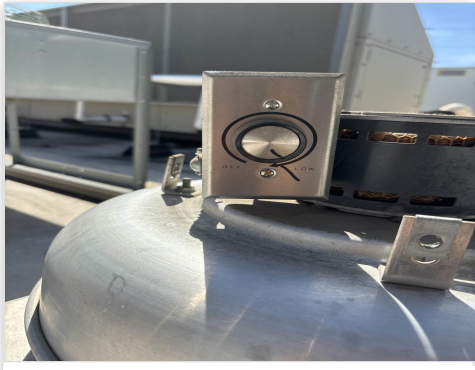
**Test Data - PHOTO LOG**

Test Data		
	Design	Actual
CFM	225	221
Fan RPM	-	NA
Fan Rotation	-	CCW
Motor RPM	-	NA
System SetPt	-	DIAL
RL Voltage	-	NA
RL Amperage	-	NA
Total ESP	-	0.15"
Fan Inlet SP	-	-0.15"
Fan Discharge SP	-	ATMS

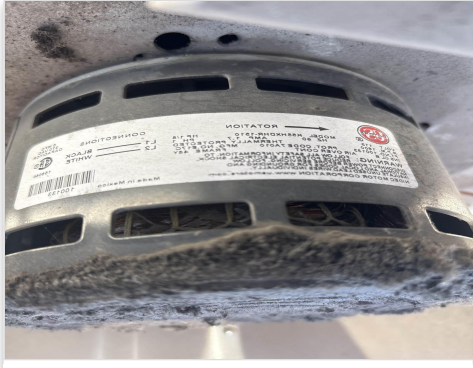
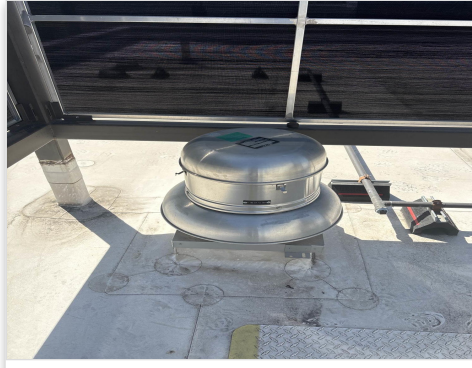
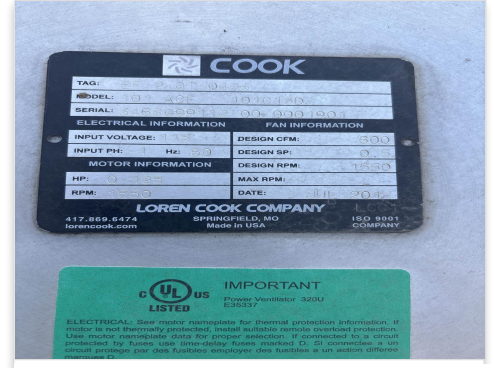
# Unit Data - PHOTO LOG

Unit Data		
	Design	Actual
MFG	NA	COOK
Model Num	NA	101 ACE 101C15D
Serial Num	-	346SG99112 00/0001901
Type	-	DOWNBLAST
Configuration	-	VERTICAL

Motor Data		
	Design	Actual
Motor MFG	-	US MOTORS
Frame	-	48Y
Horsepower	-	1/8
Motor Rpm	-	1600
Phase	-	1
Voltage (rated)	-	115
Amperage (rated)	-	1.7
Service Factor	-	NL

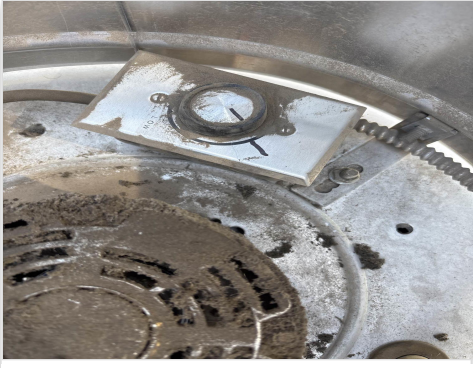
**Test Data - PHOTO LOG**

Test Data		
	Design	Actual
CFM	525	520
Fan RPM	-	NA
Fan Rotation	-	CCW
Motor RPM	-	NA
System SetPt	-	DIAL
RL Voltage	-	NA
RL Amperage	-	NA
Total ESP	-	0.39"
Fan Inlet SP	-	0.39"
Fan Discharge SP	-	ATMS

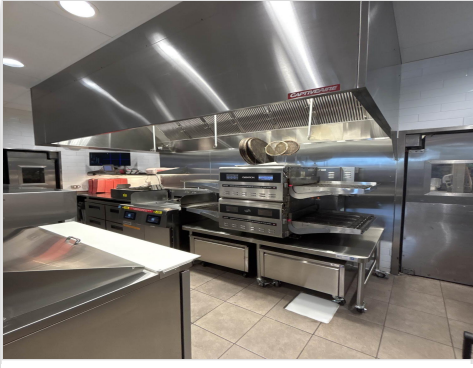
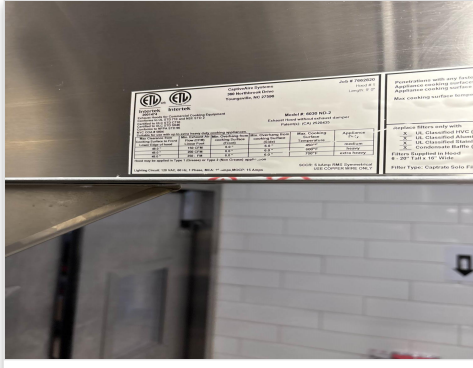
# Unit Data - PHOTO LOG

Unit Data		
	Design	Actual
MFG	CAPTIVEAIRE	CAPTIVEAIRE
Model Num	6030ND-2-F	6030ND-2
Job / Serial Num	-	7662820
Type	TYPE I CANOPY	TYPE I CANOPY
Hood length	108"	108"
Hood Width	60"	60"

Test Data Exhaust		
	Design	Actual
Filter Type	CAPTRATE SOLO FILTER	CAPTRATE SOLO FILTER
Filter Size 1	20X16	20X16
Filter Qty 1	6	6
Filter AK factor size 1	2.08	2.08
Filter Total AK Area	12.48	12.48
Filter1 FPM	-	105
Filter2 FPM	-	105
Filter3 FPM	-	120
Filter4 FPM	-	111
Filter5 FPM	-	104
Filter6 FPM	-	105
Filter Ave FPM(corr)	-	108
CFM	1350	1347
