Report: TAB Report
Function: Test, Adjust, & Balance
Date: 06/10/2024

PROJECT
08-26-24 WAWA #5443 YULEE, FL

Project: 08-26-24 WAWA #5443 YULEE, FL

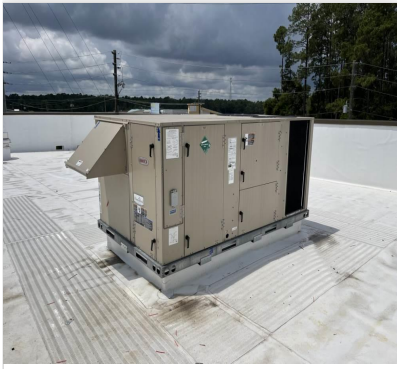
RTU-3

Issue Name : RTU 3 Alarm 227
Description : ALARM 227 SST Sensor Failure Compressor 2
Created By : National TAB **Assigned To :** National TAB - Will Turnbough
Status : Open
Priority : Low **Asset Tag :** RTU3
Originated Date : 08/27/2024 - Kristopher Passley - National TAB

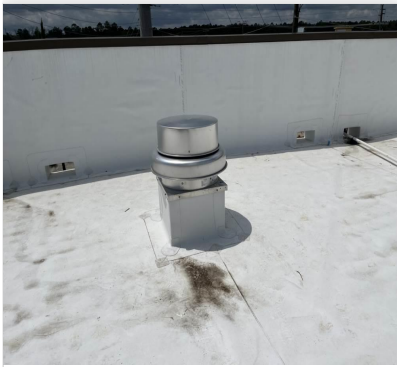
EF-1

Notes:
EXHAUST GRILLES BALANCED PROPORTIONALLY HIGH DUE TO LACK OF SPEED CONTROLLER.

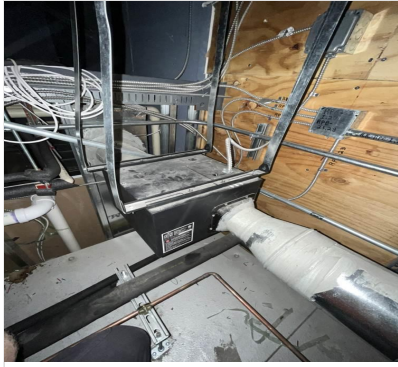
EF-2

[1] NO SPEED CONTROLLER LOCATED. MANUAL DAMPER INSTALLED ON FAN INLET. RECOMMEND REMOVING DAMPER AND INSTALLING SPEED CONTROLLER.
