Report: TAB Report
Function: Test, Adjust, & Balance
Date: 08/27/2024

PROJECT
08-26-24 WAWA #5443 YULEE, FL

Project: 08-26-24 WAWA #5443 YULEE, FL

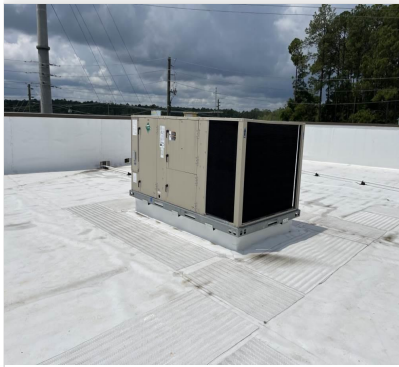
RTU-3

Issue Name : RTU 3 Alarm 227
Description : ALARM 227 SST Sensor Failure Compressor 2
Created By : National TAB **Assigned To :** National TAB - Will Turnbough
Status : Open
Priority : Low **Asset Tag :** RTU3
Originated Date : 08/27/2024 - Kristopher Passley - National TAB
