**Report: TAB REPORT**  
**Function: Test, Adjust, & Balance**  
**Date: 09/16/2025**  
**Completed By: National TAB**

**PROJECT**  
**09-15-25 CAVA KNOXVILLE, TN**  
**(CUMBERLAND AVE)**

1834 Cumberland Avenue

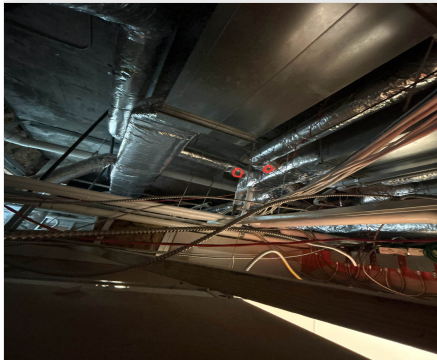
**Issue Name :** AHU 2 dampers inaccessible  
**Description :** AHU 2 dampers are above hard ceiling for the back 4 supply diffusers. unable to balance proportionately.  
**Created By :** National TAB                      **Assigned To :** National TAB - Brianna Biggs  
**Status :** Open  
**Priority :** InfoOnly                                      **Asset Tag :** AHU2  
**Originated Date :** 09/16/2025 - Jearod Ferrette - National TAB

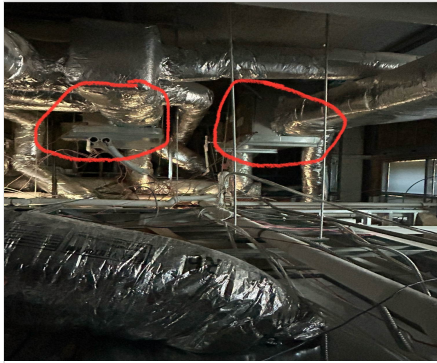
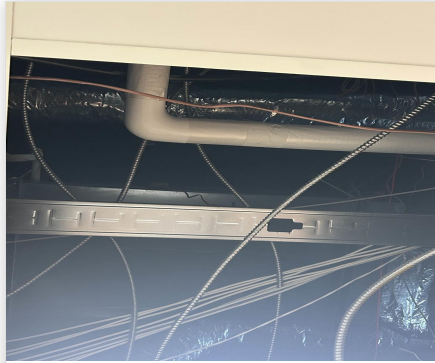
**Issue Name :** AHU's inaccessible  
**Description :** Existing units above hard ceiling inaccessible.  
**Created By :** National TAB                      **Assigned To :** National TAB - Brianna Biggs  
**Status :** Open  
**Priority :** InfoOnly                              **Asset Tag :** HVAC EQUIPMENT1  
**Originated Date :** 09/16/2025 - Jearod Ferrette - National TAB

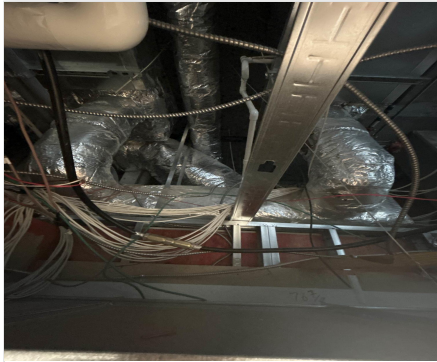
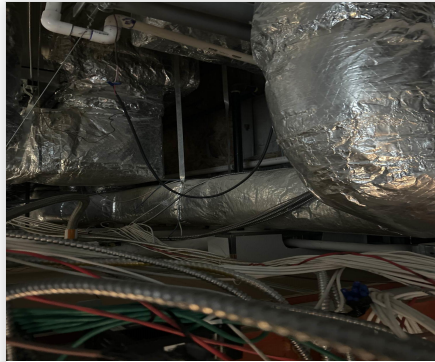
**Issue Name :** No OA duct installed for units  
**Description :** AHUs don't have an OA installed. There is a main duct that is tapped into all the units to get outside air, with 1 mechanical damper for the duct. PER MSET (M100 section 6)  
**Created By :** National TAB                      **Assigned To :** National TAB - Brianna Biggs  
**Status :** Open  
**Priority :** InfoOnly                              **Asset Tag :** HVAC EQUIPMENT1  
**Originated Date :** 09/16/2025 - Jearod Ferrette - National TAB

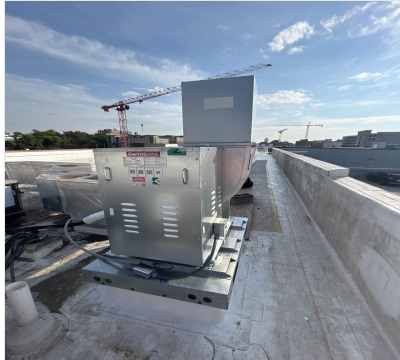
Exhaust fans have external disconnects and are connected to allow full hinging of each exhaust fan

Exhaust fan does not hinge

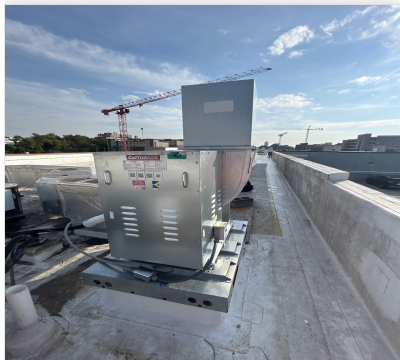
Fan is properly hinged and supported when hinged fully back for grease duct access (for Halton fans, ensure the base mounted disconnect is not hitting the fan base/curb when fully hinged back)

Exhaust fan does not hinge

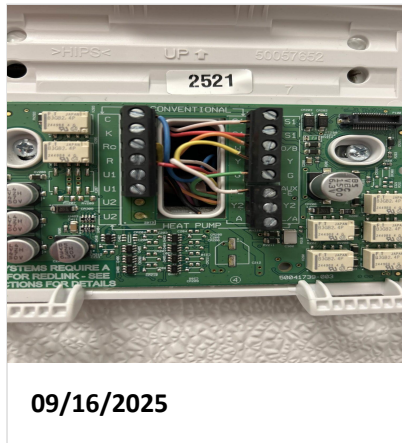
Existing units, Y2 not used

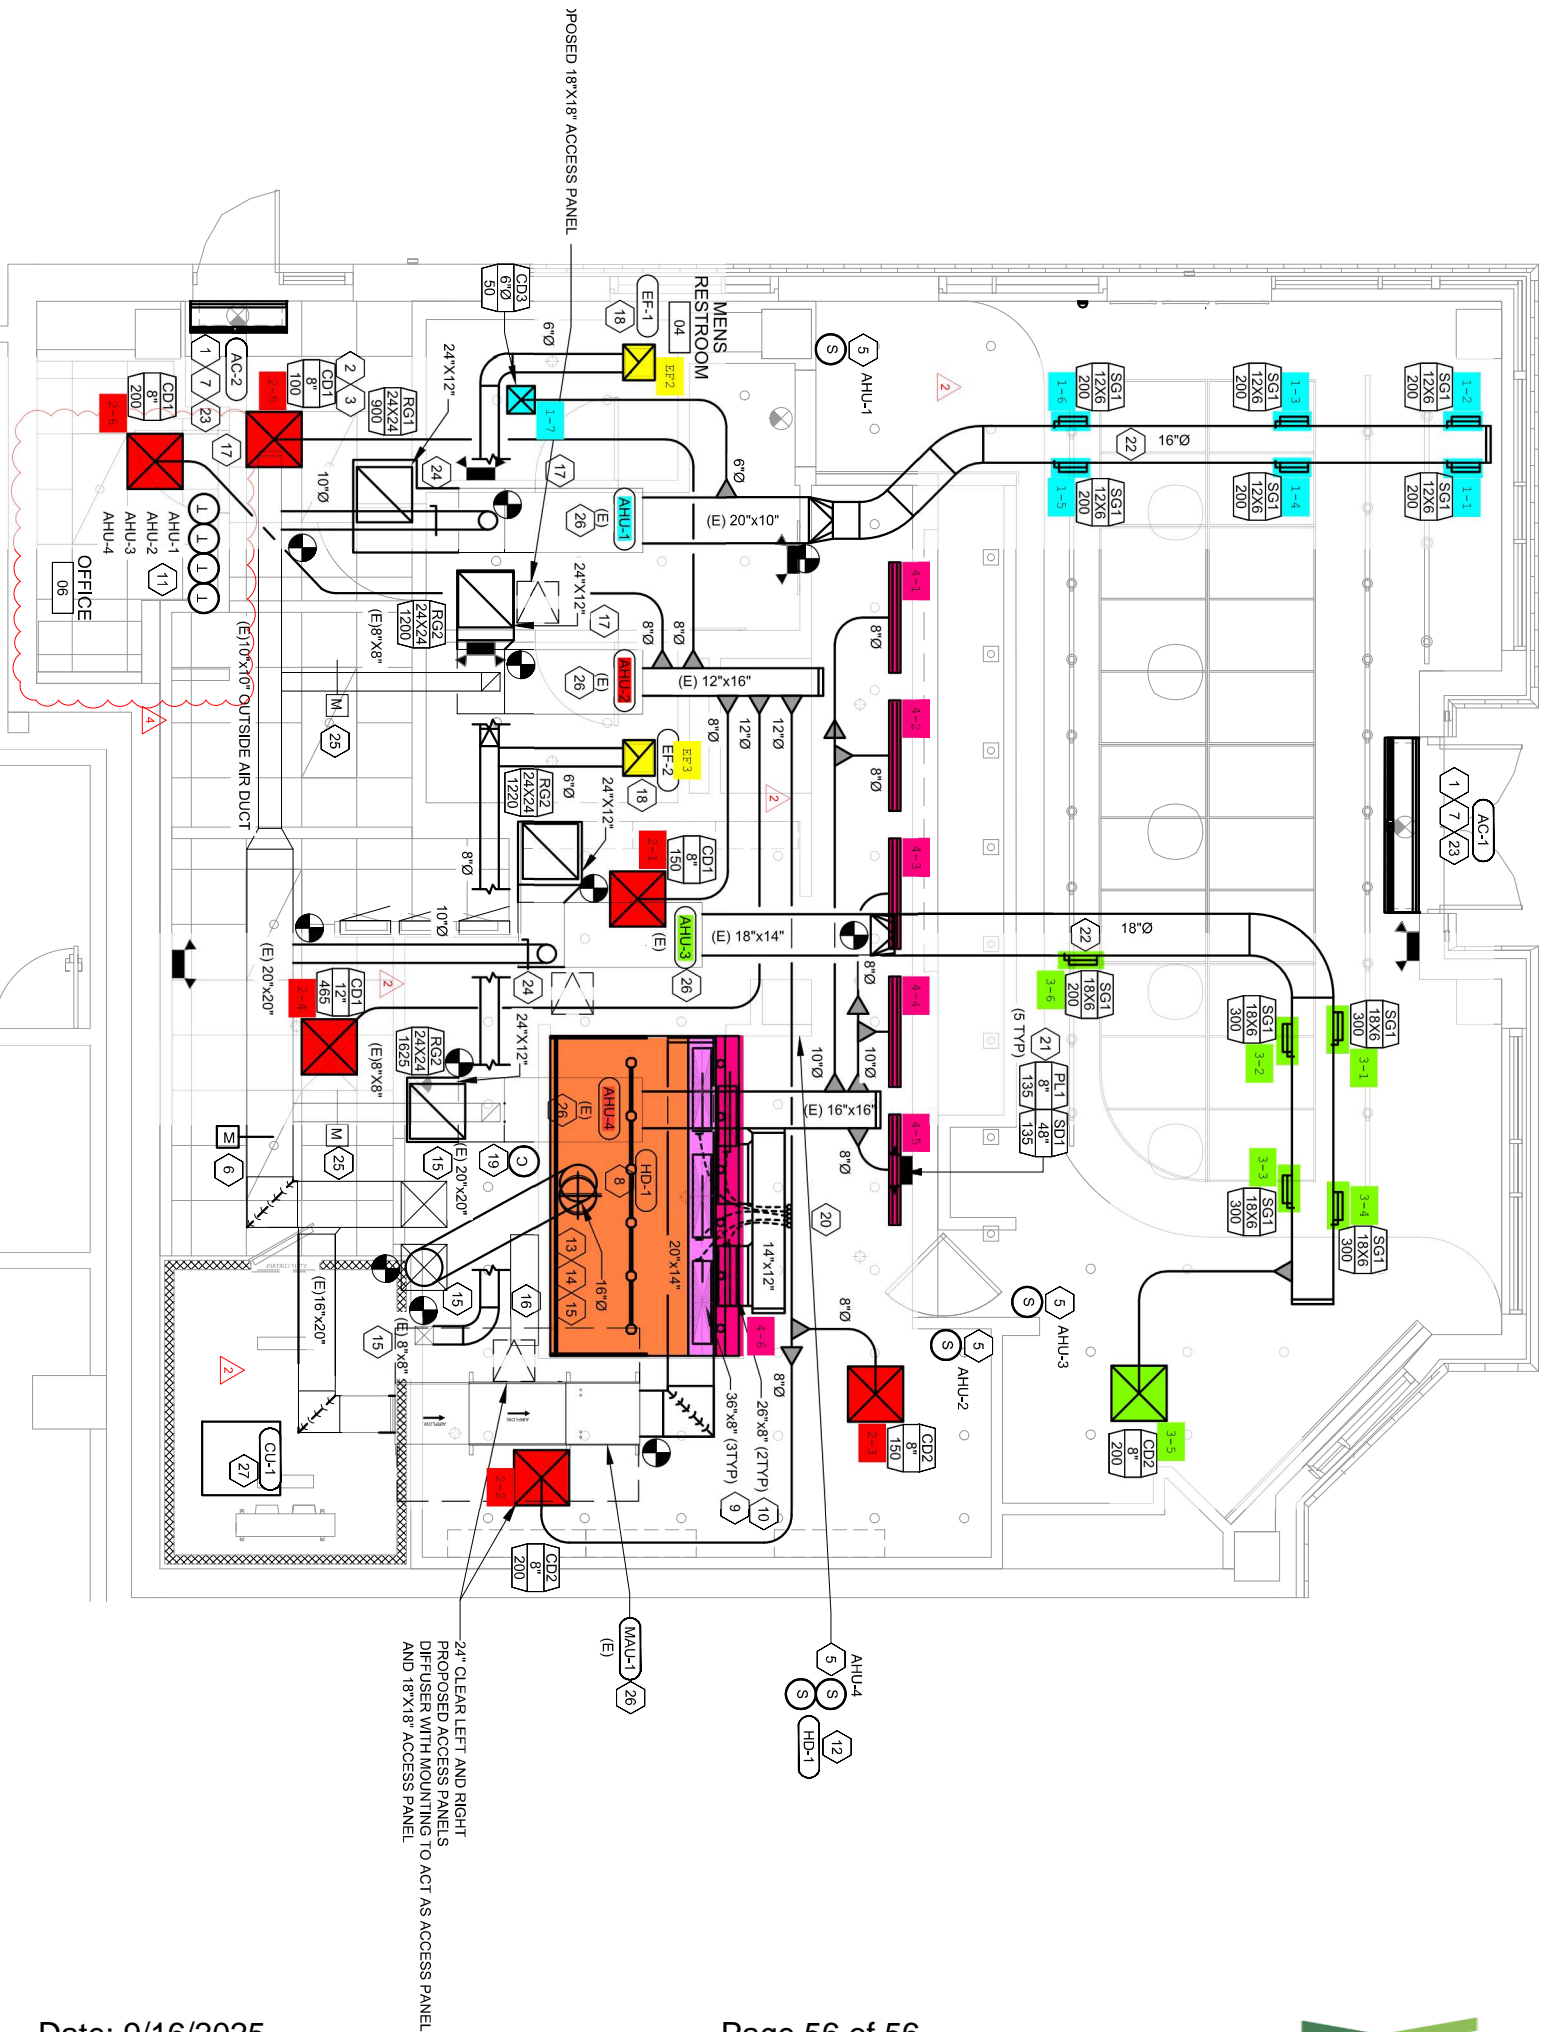
PROPOSED 18"X18" ACCESS PANEL

24" CLEAR LEFT AND RIGHT PROPOSED ACCESS PANELS DIFFUSER WITH MOUNTING TO ACT AS ACCESS PANEL AND 18"X18" ACCESS PANEL
