Report: TAB REPORT
Function: Test, Adjust, & Balance
Date: 09/16/2025
Completed By: National TAB

PROJECT
09-15-25 CAVA KNOXVILLE, TN
(CUMBERLAND AVE)

Project: 09-15-25 CAVA KNOXVILLE, TN (CUMBERLAND AVE)

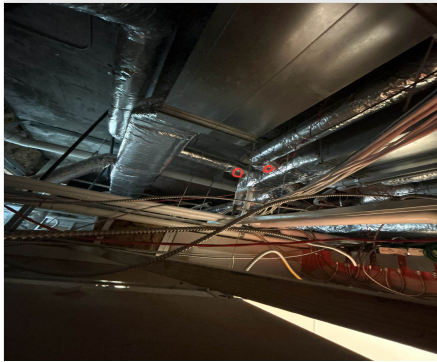
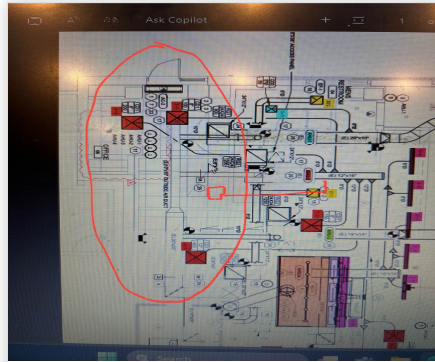
Issue Name : AHU 2 dampers inaccessible
Description : AHU 2 dampers are above hard ceiling for the back 4 supply diffusers. unable to balance proportionately.
Created By : National TAB **Assigned To :** National TAB - Brianna Biggs
Status : Open
Priority : InfoOnly **Asset Tag :** AHU2
Originated Date : 09/16/2025 - Jearod Ferrette - National TAB

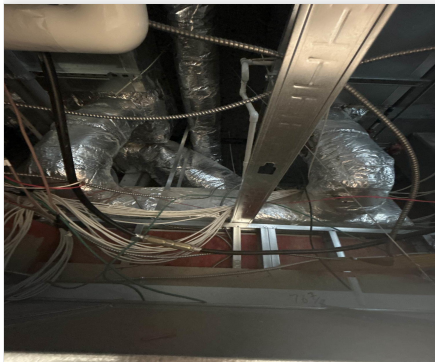
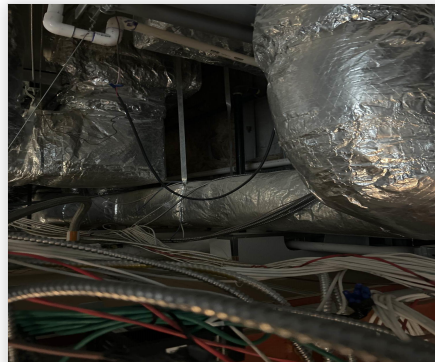
Issue Name : No OA duct installed for units
Description : AHUs don't have an OA installed. There is a main duct that is tapped into all the units to get outside air, with 1 mechanical damper for the duct. PER MSET (M100 section 6)
Created By : National TAB **Assigned To :** National TAB - Brianna Biggs
Status : Open
Priority : InfoOnly **Asset Tag :** HVAC EQUIPMENT1
Originated Date : 09/16/2025 - Jearod Ferrette - National TAB

Comment:	
Gas line connected per specification (size, painting, supports, shut-off valves, traps)	N/A
Comment:	
OA hood & filters installed	Fail
Comment: NO OA INSTALLED, UNITS ARE TAPPED INTO 1 MAIN DUCTWORK TO GET OUTSIDE AIR	
Economizer wired to control board	N/A

OA not tied in traditionally, see remarks
