Report: TAB Report
Function: Test, Adjust, & Balance
Date: 11/11/2025
Completed By: National TAB

PROJECT
11-10-25 WAWA #8485 PISCATAWAY, NJ

88 CENTENNIAL AVE
PISCATAWAY, NJ 08854

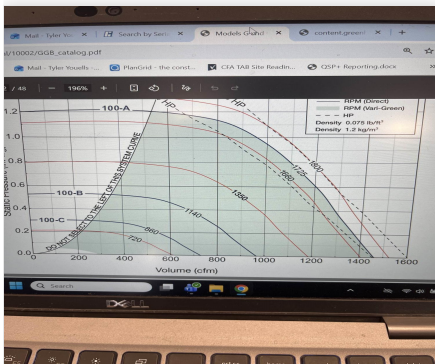
Issue Name : EF-2 Not reaching Design
Description : EF-2 is not reaching Design CFM (1159/1300CFM) design static is 0.25". Actual is 0.60". Ductwork also matches the print. Per the fan curve fan is around 1200cfm ruling out leakage or mechanical issue. Recommend upsizing fan to meet higher static requirement.
Created By : National TAB **Assigned To :** National TAB - Will Turnbough
Status : Open
Priority : High **Asset Tag :**
Originated Date : 11/11/2025 - Tyler Youells - National TAB

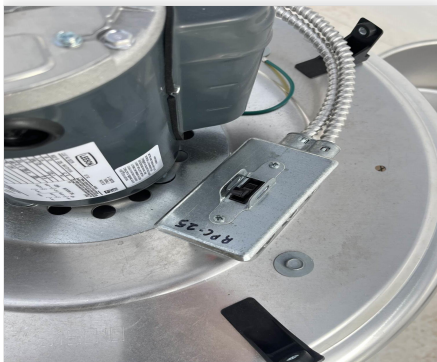
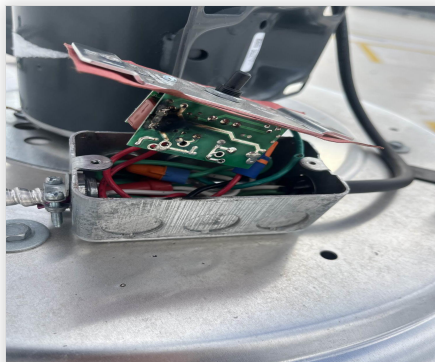
Issue Name : EF-2 Speed Switch/Disconnect
Description : Ef-2 speed switch shorted out when attempting to read fan amp draw. Speed switch was missing typical protective cover, and disconnect switch was not actually wired allowing power at the speed control when power was thought to be de-energized. Recommend replacing the speed switch and wiring the disconnect switch.

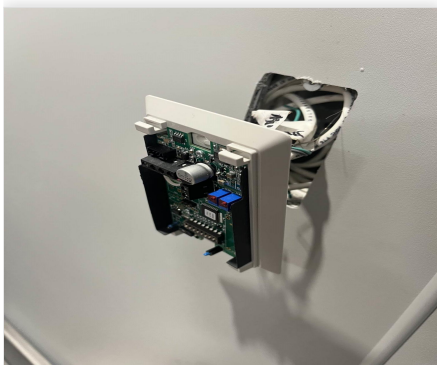
Issue Name : RTU-3 Sensor issues
Description : After reconnecting humidity wiring, RTU-3 is not displaying the space humidity. The temperature reading is also 75F+ which space is more like 67F. MC to recheck wiring connections and sensor operation
Created By : National TAB **Assigned To :** National TAB - Will Turnbough
Status : Open
Priority : High **Asset Tag :**
Originated Date : 11/11/2025 - Tyler Youells - National TAB

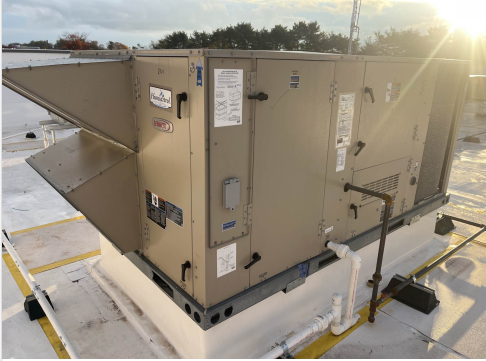
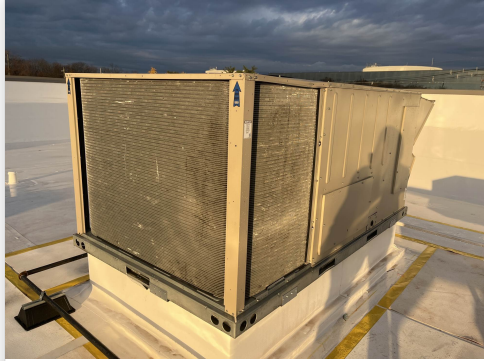
Asset: RTU1

Unit Data		
	Design	Actual
MFG	LENNOX	LENNOX
Serial Num	-	5624L01958
Model Num	LGT092H4E	LGT092H4ES2Y
Type	RTU	RTU
Configuration	VERTICAL	VERTICAL
Num OA Filters 1	-	2
OA Filter Size 1	-	15.5X25"
Num Final Filter 1	-	4
Final Filter Size 1	-	20X25X2

Test Data		
	Design	Actual
SF CFM	3000	2966
SF RPM	-	1050
MOTOR RPM	-	1050
RA CFM	2450	2396
OA CFM	550	570
RL Voltage	-	209.7/209.3/209.6
RL Amperage	-	2.2/2.3/2.2
SF System SetPt	-	59%
RA Damper Position	-	MECHANICAL LINKAGE
OA Damper Position	-	27%
OA Damper Type	-	ECONOMIZER

Performance Data		
	Design	Actual
MA Plenum SP	-	-0.20"
Fan Suction SP	-	-0.48"
Fan Discharge SP	-	0.52"
Total ESP	0.5"	0.72"
Fan Total SP	-	1.0"

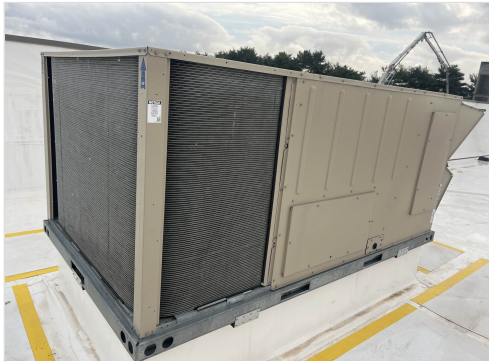
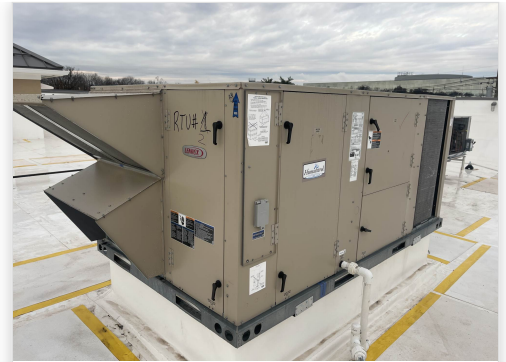
Asset: RTU2

Unit Data		
	Design	Actual
MFG	LENNOX	LENNOX
Serial Num	-	5624L04011
Model Num	LCT150H4E	LCT150H4EN2Y
Type	RTU	RTU
Configuration	VERTICAL	VERTICAL
Num OA Filters 1	-	2
OA Filter Size 1	-	25X15.5"
Num Final Filter 1	-	4
Final Filter Size 1	-	20X25X2

Test Data		
	Design	Actual
SF CFM	5000	4930
SF RPM	-	1584
MOTOR RPM	-	1584
RA CFM	4050	3991
OA CFM	950	939
RL Voltage	-	208.2/208.8/209.0
RL Amperage	-	6.1/6.2/6.1
SF System SetPt	-	89%
RA Damper Position	-	MECHANICAL LINKAGE
OA Damper Position	-	29%
OA Damper Type	-	ECONOMIZER

Performance Data		
	Design	Actual
MA Plenum SP	-	-0.36"
Fan Suction SP	-	-1.09"
Fan Discharge SP	-	0.69"
Total ESP	0.5"	1.05"
Fan Total SP	-	1.78"

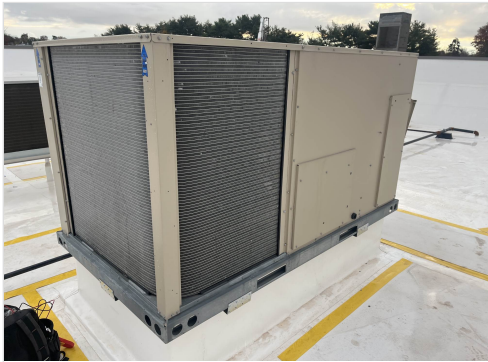
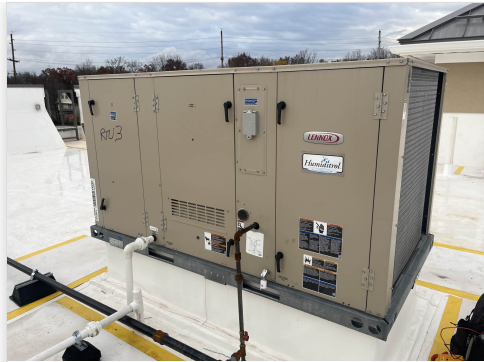
Asset: RTU3

Unit Data		
	Design	Actual
MFG	LENNOX	LENNOX
Serial Num	-	5624L05416
Model Num	LGT060H4E	LGT060H4EB1Y
Type	RTU	RTU
Configuration	VERTICAL	VERTICAL
Num OA Filters 1	-	1
OA Filter Size 1	-	30X16
Num Final Filter 1	-	4
Final Filter Size 1	-	20X20X2

Test Data		
	Design	Actual
SF CFM	2000	2023
SF RPM	-	788
MOTOR RPM	-	788
RA CFM	1600	1622
OA CFM	400	401
RL Voltage	-	209.2
RL Amperage	-	5.2
SF System SetPt	-	75%
RA Damper Position	-	MECHANICAL LINKAGE
OA Damper Position	-	27%
OA Damper Type	-	ECONOMIZER

Performance Data		
	Design	Actual
MA Plenum SP	-	-0.25"
Fan Suction SP	-	-0.41"
Fan Discharge SP	-	0.34"
Total ESP	0.5"	0.59"
Fan Total SP	-	0.75"

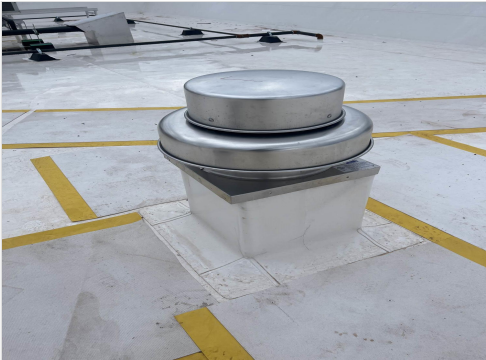
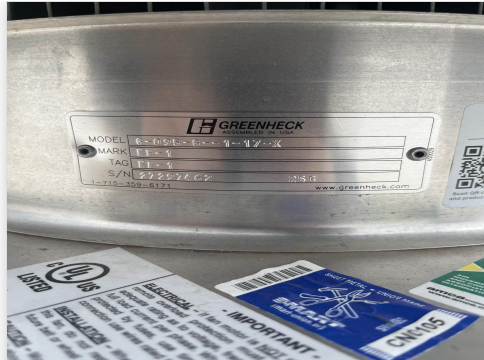
Asset: EF1

Unit Data		
	Design	Actual
MFG	PENNBARRY	GREENHECK
Model Num	DX10R	G-095-G-1-17-X
Serial Num	-	27297462
Type	DOWNBLAST	DOWNBLAST
Configuration	VERTICAL	VERTICAL

Test Data		
	Design	Actual
CFM	300	309
Fan RPM	1550	NA
Fan Rotation	-	CW
Motor RPM	-	NA
System SetPt	-	MARKED ON DIAL
RL Voltage	-	122.6
RL Amperage	-	2.2
Total ESP	0.250"	0.40"
Fan Inlet SP	-	-0.40"
Fan Discharge SP	-	ATM

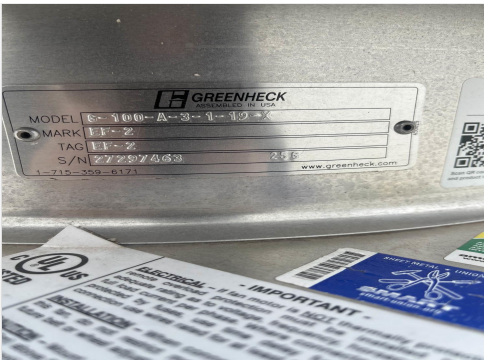
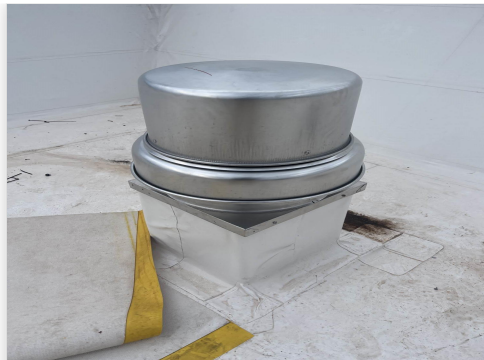
Asset: EF2

Test Data		
	Design	Actual
CFM	1300	1159
Fan RPM	1300	1725
Fan Rotation	-	CW
Motor RPM	-	1725
System SetPt	-	MAX SPEED/MARKED ON DIAL
RL Voltage	-	122.1
RL Amperage	-	2.4
Total ESP	0.250"	0.60"
Fan Inlet SP	-	-0.60"
Fan Discharge SP	-	ATM

[1] Fan is not reaching design CFM, Ductwork is per the print. ESP is 0.60", while design is 0.25". Fan is at maximum speed. Recommend upsizing fan to meet CFM requirements.

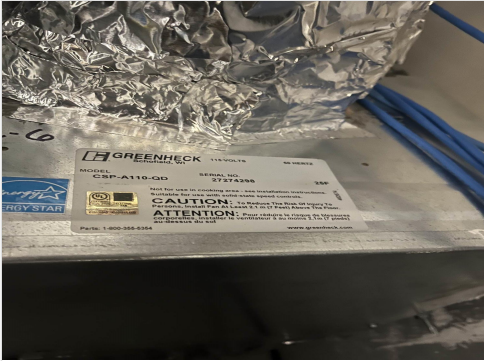
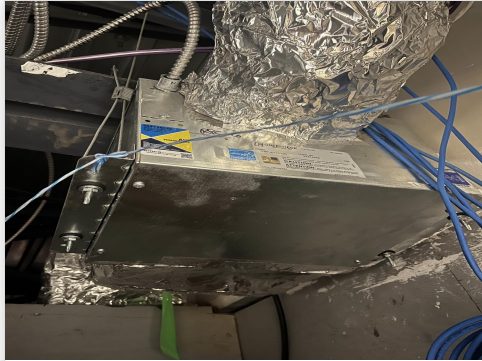
Asset: EF3

Unit Data		
	Design	Actual
MFG	PENNBARRY	GREENHECK
Model Num	Z3H	CSP-A110-QD
Serial Num	-	27274298
Type	IN-LINE	INLINE
Configuration	HORIZONTAL	HORIZONTAL

Test Data		
	Design	Actual
CFM	60	63
System SetPt	-	MARKED ON DIAL
