Report: TAB Report
Function: Test, Adjust, & Balance
Date: 03/10/2026
Completed By: National TAB

PROJECT
03-23-26 QT #1036 CHARLOTTE, NC

QUIKTRIP
4705 SOUTH 129TH EAST AVENUE
TULSA, OK 74134

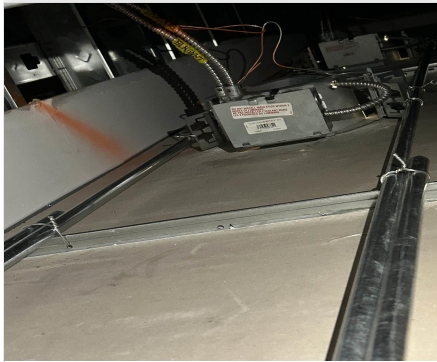
Issue Name : RTU 3 no access to dampers
Description : Unable to access kitchen dampers, electrical conduit wired to ceiling pads.
Created By : National TAB **Assigned To :** National TAB - Dan Hertenstein
Status : Open
Priority : Medium **Asset Tag :** RT-3
Originated Date : 03/25/2026 - Jearod Ferrette - National TAB

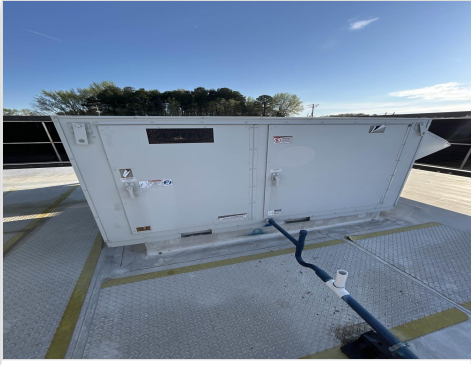
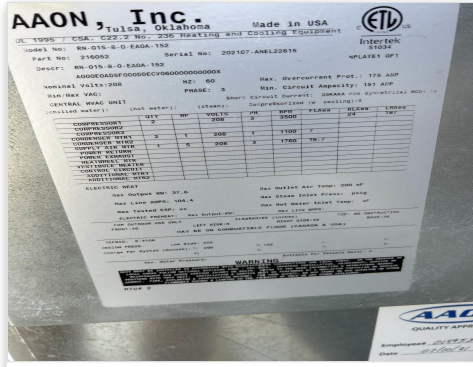
Unit Data - PHOTO LOG

Asset: RT-2

Test Data		
	Design	Actual
SF CFM	5000	5108
SF RPM	-	DD/ 56.8 HZ
OA CFM (Hoods On)	865	892
OA CFM (Hoods Off)	415	442
RL Voltage	-	212.3 VFD
RL Amperage	-	12.1 VFD
VFD Max SetPt	-	56.8 HZ
OA Damper Position (Hoods On)	-	46%
OA Damper Position (Hoods Off)	-	26%

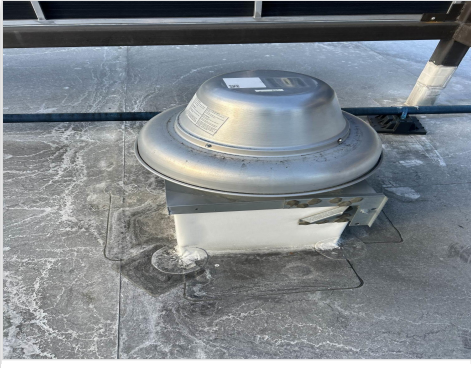
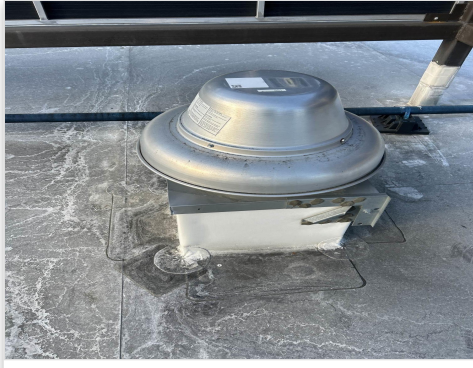
Unit Data - PHOTO LOG

Asset: EF2

Test Data		
	Design	Actual
CFM	350	361
Fan RPM	-	1380
Fan Rotation	-	CCW
Motor RPM	-	1380
System SetPt	-	72P
RL Voltage	-	NA
RL Amperage	-	NA
Total ESP	-	0.17"
Fan Inlet SP	-	-0.17"
Fan Discharge SP	-	ATMO

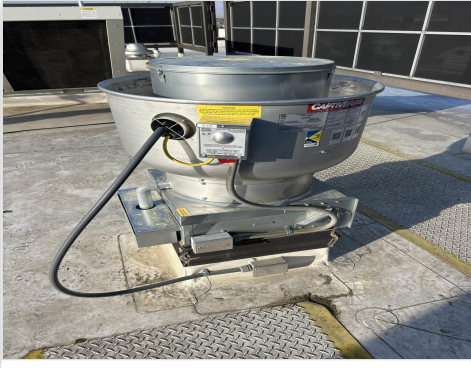
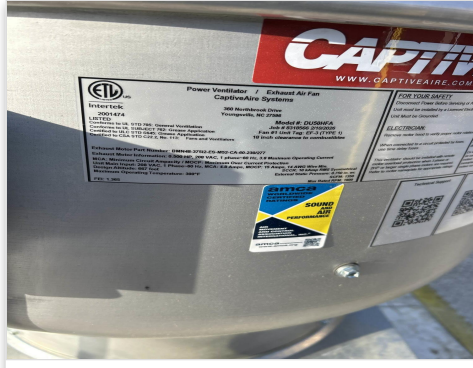
Unit Data - PHOTO LOG

Asset: EF3

Test Data		
	Design	Actual
CFM	1350	1347
Fan RPM	-	1195
Fan Rotation	-	CCW
Motor RPM	-	1195
System SetPt	-	52.8
RL Voltage	-	NA
RL Amperage	-	NA
Total ESP	-	0.30"
Fan Inlet SP	-	-0.30"
Fan Discharge SP	-	ATMO

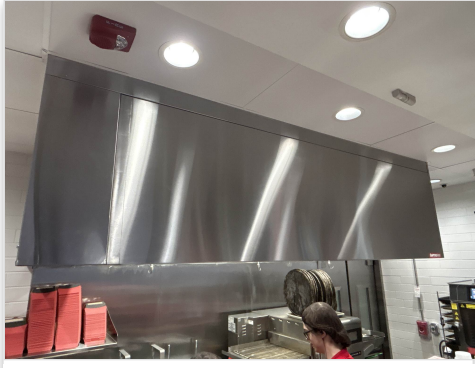
Unit Data - PHOTO LOG

Asset: HD1

Design	Actual
Filter Type	CAPTRATE SOLO FILTER	CAPTRATE SOLO FILTER
Filter Size 1	20X16	20X16
Filter Qty 1	6	6
Filter AK factor size 1	2.08	2.08
Filter Total AK Area	12.48	12.48
Filter1 FPM	-	106
Filter2 FPM	-	113
Filter3 FPM	-	114
Filter4 FPM	-	115
Filter5 FPM	-	101
Filter6 FPM	-	104
Filter Ave FPM(corr)	-	108
CFM	1350	1347
