**Report: TAB Report
Function: Test, Adjust, & Balance
Date: 11/11/2022**

11-07 WALGREENS #4133 - PASADENA, TX

Project: 11-07 WALGREENS #4133 - PASADENA, TX

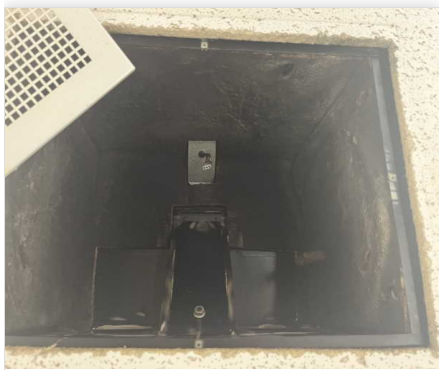
IMG_0079.jpeg

Issue Name : ISSUE 3-MISSING EF IN PHOTO LAB
Description : EF-5 IN PHOTO LAB IS NOT PRESENT.
Created By : National TAB **Assigned To :** National TAB - Wesley John
Status : Open
Originated Date : 11/11/2022 - Wesley John - National TAB

Fan rotation is correct	Pass
Pulleys are aligned and belts are tensioned properly	EXHAUST FANS ARE DIRECT DRIVE.
Speed controller installed and functional (direct drive)	CEILING FANS ARE SINGLE SPEED.
Fan is secured to the curb	Pass
Back draft damper is installed and functional	Pass
No exterior damage to the fan	Pass
No unusual noise or vibration	Pass
Controls are functional	Pass
Additional Comments:	NO EF INSTALLED IN PHOTO LAB. OFFICE EF DOES NOT OPERATE.

Unit Data		
	Design	Actual
MFG	GREENHECK	GREENHECK
Model Num	SP-260	NA
Serial Num	-	NA
Type	CEILING	NA
Configuration	VERTICAL	NA
