**Report: TAB Report
Function: Test, Adjust, & Balance
Date: 11/11/2022**

**01-02-23 WALGREENS #4133 - PASADENA,
TX**

Project: 01-02-23 WALGREENS #4133 - PASADENA, TX

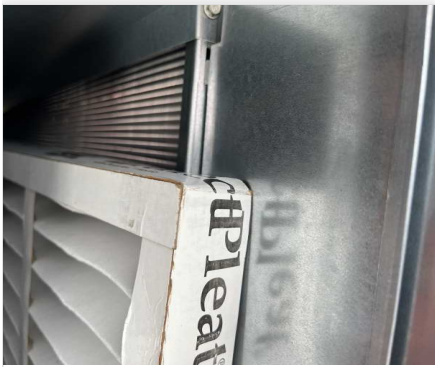
IMG_0045.jpeg

Issue Name : ISSUE 2-WRONG EVAP FILTER SIZE
Description : RTU-2 WRONG EVAPORATOR FILTER SIZE. DESIGN IS (4) 20x24x2. CURRENTLY THERE ARE (4)16x25x2.
Created By : National TAB **Assigned To :** National TAB - Wesley John
Status : Open
Originated Date : 11/11/2022 - Wesley John - National TAB

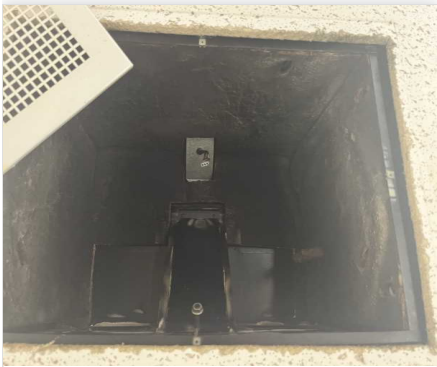
IMG_0079.jpeg

Issue Name : ISSUE 3-MISSING EF IN PHOTO LAB

Description : EF-5 IN PHOTO LAB IS NOT PRESENT.

Fan rotation is correct	Pass
Pulleys are aligned and belts are tensioned properly	EXHAUST FANS ARE DIRECT DRIVE.
Speed controller installed and functional (direct drive)	CEILING FANS ARE SINGLE SPEED.
Fan is secured to the curb	Pass
Back draft damper is installed and functional	Pass
No exterior damage to the fan	Pass
No unusual noise or vibration	Pass
Controls are functional	Pass
Additional Comments:	NO EF INSTALLED IN PHOTO LAB. OFFICE EF DOES NOT OPERATE. (EF-4 RETESTED DURING RETURN TRIP ON 1/4.)
