**Report: TAB Report  
Function: Test, Adjust, & Balance  
Date: 11/11/2022**

## **11-07 WALGREENS #4133 - PASADENA, TX**

3707 SPENCER HW

PASADENA , TX 77504

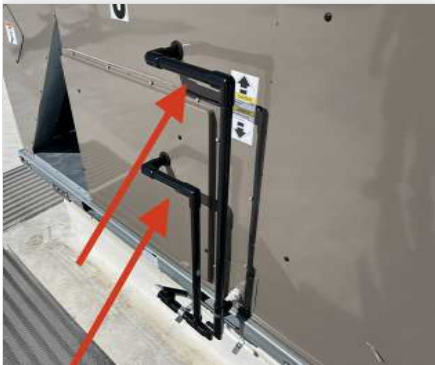
IMG\_0084.jpeg

**Issue Name :** ISSUE 1-COSTGARD

**Description :** COSTGARD CONDENSATE DRAINS ARE NOT PROPERLY SUPPORTED. ACCORDING TO COSTGARD INSTALLATION DOCUMENT PVC SHOULD BE SUPPORTED AT ARROWS IN PICTURE. TYPICAL OF ALL 4 UNITS.

Verify all required equipment has been replaced per TA and BOM.	Pass
All units are installed in the proper locations	Pass
Units are labeled correctly	Pass
Asset tag installed	Pass
Roof is clear of debris.	Pass
Maintenance access for all unit access panels is acceptable and panels open freely.	Pass
Cabinet and general installation is complete.	Pass
Unit is secure to curb and level horizontally and vertically.	Pass
Access doors close tightly with no leaks	Pass
Condensate and gas piping is properly supported.	Pass
Costgaurd is installed per scope of work and piping unions are cemented.	Fail
Additional Comments	COSTGARD CONDENSATE DRAINS ARE NOT ADEQUATELY SUPPORTED. SEE PICS IN REMARKS SECTION.

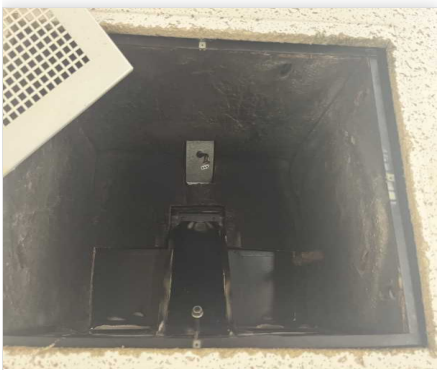
IMG\_0079.jpeg

**Issue Name :** ISSUE 3-MISSING EF IN PHOTO LAB

**Description :** EF-5 IN PHOTO LAB IS NOT PRESENT.

Fan rotation is correct	Pass
Pulleys are aligned and belts are tensioned properly	EXHAUST FANS ARE DIRECT DRIVE.
Speed controller installed and functional (direct drive)	CEILING FANS ARE SINGLE SPEED.
Fan is secured to the curb	Pass
Back draft damper is installed and functional	Pass
No exterior damage to the fan	Pass
No unusual noise or vibration	Pass
Controls are functional	Pass
Additional Comments:	NO EF INSTALLED IN PHOTO LAB. OFFICE EF DOES NOT OPERATE.

Test Data		
	Design	Actual
CFM	750	-
Fan RPM	1000	NA
Fan Rotation	-	NA
Motor RPM	-	NA
System SetPt	-	NA
RL Voltage	-	NA
RL Amperage	-	NA
Total ESP	0.375"	NA
Fan Inlet SP	-	NA
Fan Discharge SP	-	NA
