**Report: TAB Report
Function: Test, Adjust, & Balance
Date: 11/11/2022**

11-07 WALGREENS #4133 - PASADENA, TX

Project: 11-07 WALGREENS #4133 - PASADENA, TX

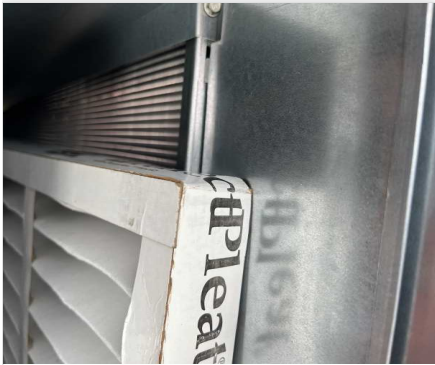
IMG_0045.jpeg

Issue Name : ISSUE 2-WRONG EVAP FILTER SIZE
Description : RTU-2 WRONG EVAPORATOR FILTER SIZE. DESIGN IS (4) 20x24x2. CURRENTLY THERE ARE (4)16x25x2.
Created By : National TAB **Assigned To :** National TAB - Wesley John
Status : Open
Originated Date : 11/11/2022 - Wesley John - National TAB
