**Report: TAB Report
Function: Test, Adjust, & Balance
Date: 11/11/2022**

11-07 WALGREENS #4133 - PASADENA, TX

Project: 11-07 WALGREENS #4133 - PASADENA, TX

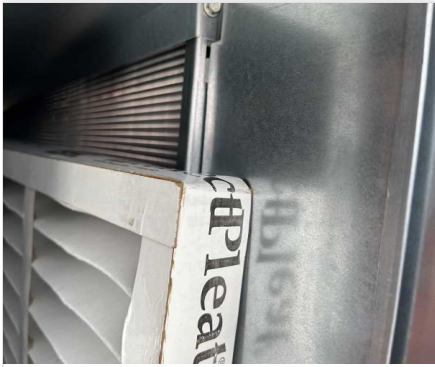
IMG_0045.jpeg

Issue Name : ISSUE 2-WRONG EVAP FILTER SIZE
Description : RTU-2 WRONG EVAPORATOR FILTER SIZE. DESIGN IS (4) 20x24x2. CURRENTLY THERE ARE (4)16x25x2.
Created By : National TAB **Assigned To :** National TAB - Wesley John
Status : Open
Originated Date : 11/11/2022 - Wesley John - National TAB

| Additional Comments: | RTU-2 HAS WRONG EVAP FILTER SIZES. ACTUAL IS (4) 20x24x2. CURRENTLY THERE ARE (4) 16x25x2. SEE PICS IN REMARKS SECTION. |
