**Report: TAB Report**  
**Function: Test, Adjust, & Balance**  
**Date: 01/12/2024**

## 01-08-23 FREDDYS - EAST DAVENPORT, IA

4521 East 53rd Street

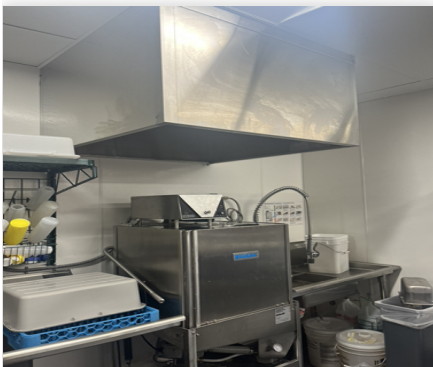
**HD-3**  
**01/08/2024**

**Issue Name :** DEF-1  
**Description :** Dishwasher Exhaust fan/Hood not operational on arrival, on at breaker. Fan Controller doesn't light up or have any function.  
**Created By :** National TAB                      **Assigned To :** National TAB - Dylan Crisman  
**Status :** Closed  
**Priority :** **Urgent**                                      **Asset Tag :**  
**Originated Date :** 01/08/2024 - Dylan Crisman - National TAB

- **01/09/2024 National TAB - Dylan Crisman**
  - Electrician arrived on site and corrected issues, fan and hood have been balanced to design. 01/09/2024

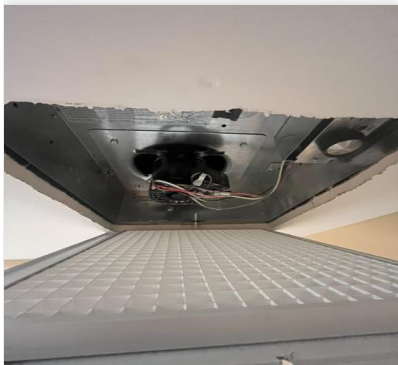
**EF-4**  
**01/09/2024**

**Issue Name :** EF-4/EF-5 low on flow  
**Description :** Design flow is 170CFM. I was unable to get either fan up to design flow after setting the speed dial as well as potentiometer to max setpoints.  
EF-4: 113/170CFM EF-5: 100/170CFM  
**Created By :** National TAB                      **Assigned To :** National TAB - Dylan Crisman  
**Status :** Open  
**Priority :**    **Asset Tag :**  
**Originated Date :** 01/09/2024 - Dylan Crisman - National TAB
