Report: TAB Report
Function: Test, Adjust, & Balance
Date: 01/12/2024

01-08-23 FREDDYS - EAST DAVENPORT, IA

Project: 01-08-23 FREDDYS - EAST DAVENPORT, IA

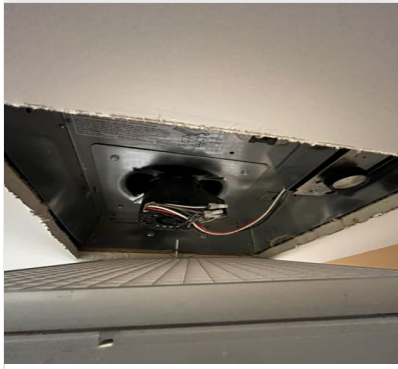
EF-5
01/09/2024

Issue Name : EF-4/EF-5 low on flow
Description : Design flow is 170CFM. I was unable to get either fan up to design flow after setting the speed dial as well as potentiometer to max setpoints.
EF-4: 113/170CFM EF-5: 100/170CFM
Created By : National TAB **Assigned To :** National TAB - Dylan Crisman
Status : Open
Priority : **Asset Tag :**
Originated Date : 01/09/2024 - Dylan Crisman - National TAB

Test Data		
	Design	Actual
CFM	170	100
Fan RPM	1100	1350
Fan Rotation	-	CCW
Motor RPM	-	1350
System SetPt	-	MAX SPEED @DIAL AND POTENTIOMETER
RL Voltage	-	NA
RL Amperage	-	NA
Total ESP	0.75	NA
Fan Inlet SP	-	NA
Fan Discharge SP	-	ATM
