Report: TAB REPORT
Function: Test, Adjust, & Balance
Date: 09/22/2023

PROJECT
09-18-23 WALGREENS #3909 - ARLINGTON,
TX

09-18-23 WALGREENS #3909 - ARLINGTON, TX

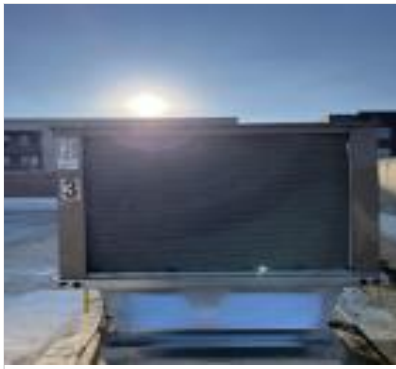
RTU3-1
09/19/2023

RTU 3 Condensate drain line to roof runoff is clogged. Creating water build up around Pharmacy.

Drain line for RTU 3 is clogged, recommended nitrogen flush.
