Report: TAB Report
Function: Test, Adjust, & Balance
Date: 01/22/2025
Completed By: National TAB

01-13-25 WAWA #6301 HINESVILLE, GA

Project: 01-13-25 WAWA #6301 HINESVILLE, GA

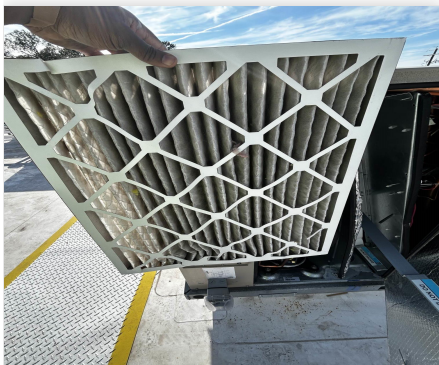
Issue Name : RTU 1 Final Filters
Description : The unit's final filters are dirty from construction. Recommend replacing filters before store opening.
Created By : National TAB **Assigned To :** National TAB - Kristopher Passley
Status : Open
Priority : **Medium** **Asset Tag :**
Originated Date : 01/15/2025 - Kristopher Passley - National TAB
