**Report: TAB Report**  
**Function: Test, Adjust, & Balance**  
**Date: 01/15/2025**  
**Completed By: National TAB**

**PROJECT**  
**01-13-25 WAWA #6301 HINESVILLE, GA**

721 VETERANS PKWY

HINESVILLE, GA 31313

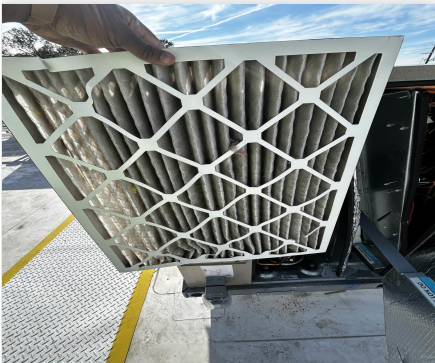
**Issue Name :** RTU 1 Final Filters  
**Description :** The unit's final filters are dirty from construction. Recommend replacing filters before store opening.  
**Created By :** National TAB      **Assigned To :** National TAB - Kristopher Passley  
**Status :** Open  
**Priority :** Medium      **Asset Tag :**  
**Originated Date :** 01/15/2025 - Kristopher Passley - National TAB

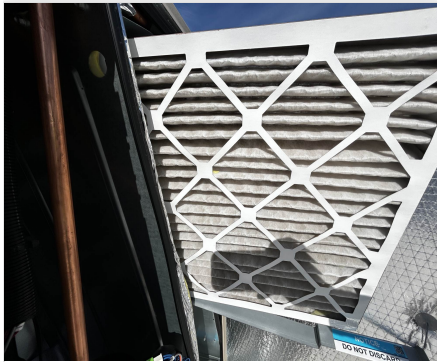
**Issue Name :** RTU 2 Final Filters  
**Description :** The unit's final filters are dirty from construction. Recommend replacing filters before store opening.  
**Created By :** National TAB      **Assigned To :** National TAB - Kristopher Passley  
**Status :** Open  
**Priority :** Medium      **Asset Tag :**  
**Originated Date :** 01/15/2025 - Kristopher Passley - National TAB
