**Report: TAB Report**  
**Function: Test, Adjust, & Balance**  
**Date: 01/22/2025**  
**Completed By: National TAB**

## 01-13-25 WAWA #6301 HINESVILLE, GA

### Client

Wawa  
260 West Baltimore Pike

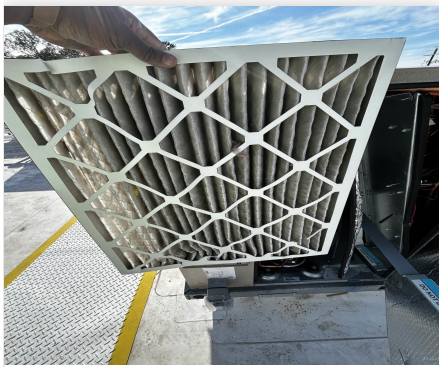
Project Issue File Details

**Issue Name :** RTU Final Filters  
**Description :** RTU final filters are dirty from construction. Recommend replacing filters before store opening.  
**Created By :** National TAB                      **Assigned To :** National TAB - Kristopher Passley  
**Status :** Open  
**Priority :** Medium                                      **Asset Tag :**  
**Originated Date :** 01/15/2025 - Kristopher Passley - National TAB

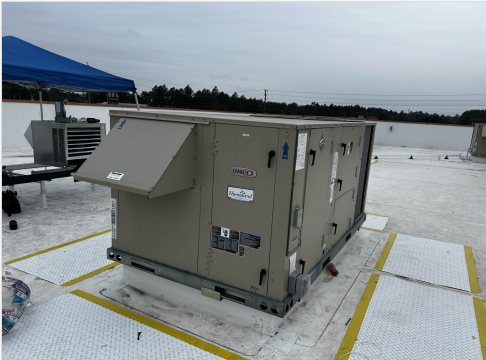
## Unit Data - PHOTO LOG

Unit Data		
	Design	Actual
MFG	LENNOX ENLIGHT	LENNOX ENLIGHT
Serial Num	-	5624F02851
Model Num	LCT102H4E	LCT102H4EG1Y
Type	RTU	RTU
Configuration	VERTICAL	VERTICAL
Num OA Filters 1	-	1
OA Filter Size 1	-	16"X25"
Num Final Filter 1	-	4
Final Filter Size 1	-	20"X25"X2"

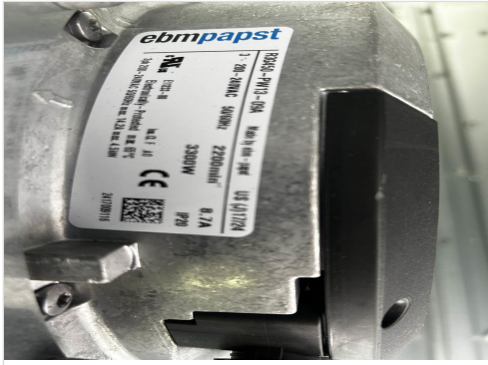
## Motor Data - PHOTO LOG

Motor Data		
	Design	Actual
Motor MFG	-	EBMPAPST
Frame	-	NL
Horsepower	3.75	3.8
Motor Rpm	-	2200
Phase	3	3
Rated Voltage	208	200-240
Rated Amperage	-	8.7
Service Factor	-	NL

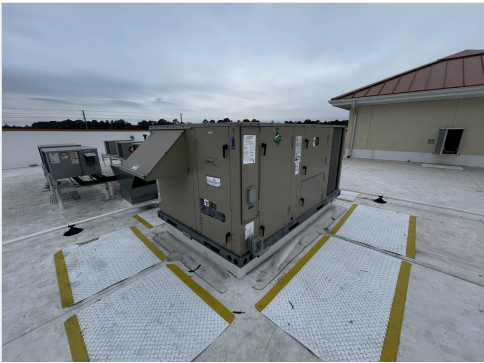
## Unit Data - PHOTO LOG

Unit Data		
	Design	Actual
MFG	LENNOX ENLIGHT	LENNOX ENLIGHT
Serial Num	-	5624F02852
Model Num	LCT150H4E	LCT150H4EN1Y
Type	RTU	RTU
Configuration	VERTICAL	VERTICAL
Num OA Filters 1	-	1
OA Filter Size 1	-	16"X25"
Num Final Filter 1	-	4
Final Filter Size 1	-	20"X25"X2"

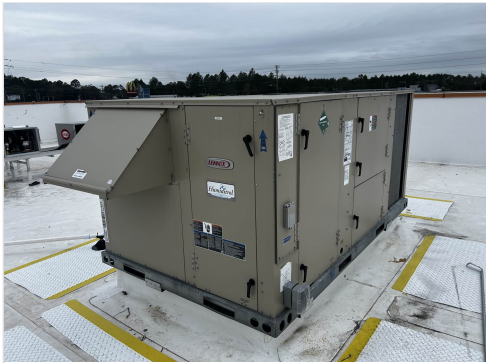
## Unit Data - PHOTO LOG

Unit Data		
	Design	Actual
MFG	LENNOX ENLIGHT	LENNOX ENLIGHT
Serial Num	-	5624F02854
Model Num	LCT092H4E	LCT092H4EG1Y
Type	RTU	RTU
Configuration	VERTICAL	VERTICAL
Num OA Filters 1	-	1
OA Filter Size 1	-	16"X25"
Num Final Filter 1	-	4
Final Filter Size 1	-	20"X25"X2"
