Report: TAB Report
Function: Test, Adjust, & Balance
Date: 01/15/2025
Completed By: National TAB

01-13-25 WAWA #6301 HINESVILLE, GA

721 VETERANS PKWY

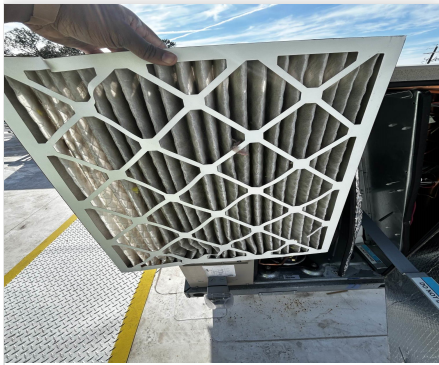
Issue Name : RTU 1 Final Filters
Description : The unit's final filters are dirty from construction. Recommend replacing filters before store opening.
Created By : National TAB **Assigned To :** National TAB - Kristopher Passley
Status : Open
Priority : Medium **Asset Tag :**
Originated Date : 01/15/2025 - Kristopher Passley - National TAB

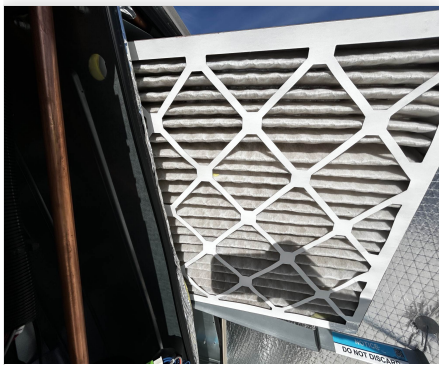
Issue Name : RTU 2 Final Filters
Description : The unit's final filters are dirty from construction. Recommend replacing filters before store opening.
Created By : National TAB **Assigned To :** National TAB - Kristopher Passley
Status : Open
Priority : Medium **Asset Tag :**
Originated Date : 01/15/2025 - Kristopher Passley - National TAB

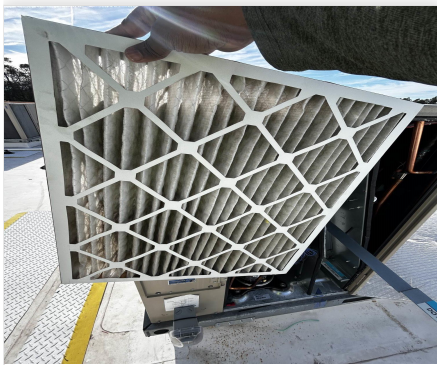
Issue Name : RTU 3 Final Filters
Description : The unit's final filters are dirty from construction. Recommend replacing filters before store opening.
Created By : National TAB **Assigned To :** National TAB - Kristopher Passley
Status : Open
Priority : Medium **Asset Tag :**
Originated Date : 01/15/2025 - Kristopher Passley - National TAB

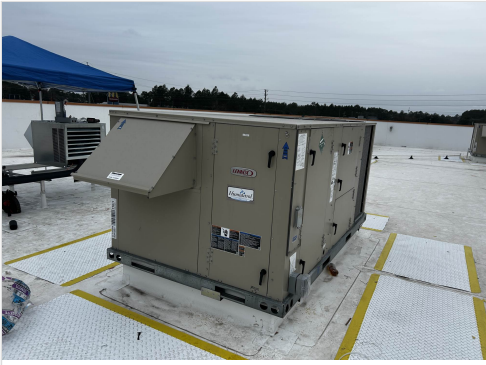
Unit Data - PHOTO LOG

Unit Data		
	Design	Actual
MFG	LENNOX ENLIGHT	LENNOX ENLIGHT
Serial Num	-	5624F02851
Model Num	LCT102H4E	LCT102H4EG1Y
Type	RTU	RTU
Configuration	VERTICAL	VERTICAL
Num OA Filters 1	-	1
OA Filter Size 1	-	16"X25"
Num Final Filter 1	-	4
Final Filter Size 1	-	20"X25"X2"

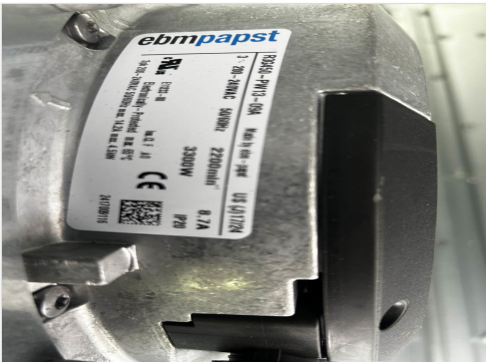
Motor Data - PHOTO LOG

Motor Data		
	Design	Actual
Motor MFG	-	EBMPAPST
Frame	-	NL
Horsepower	3.75	3.8
Motor Rpm	-	2200
Phase	3	3
Rated Voltage	208	200-240
Rated Amperage	-	8.7
Service Factor	-	NL

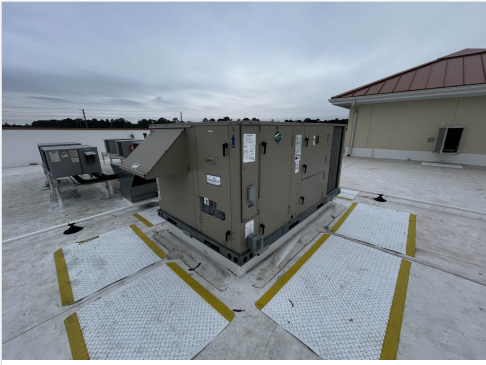
Unit Data - PHOTO LOG

Unit Data		
	Design	Actual
MFG	LENNOX ENLIGHT	LENNOX ENLIGHT
Serial Num	-	5624F02852
Model Num	LCT150H4E	LCT150H4EN1Y
Type	RTU	RTU
Configuration	VERTICAL	VERTICAL
Num OA Filters 1	-	1
OA Filter Size 1	-	16"X25"
Num Final Filter 1	-	4
Final Filter Size 1	-	20"X25"X2"

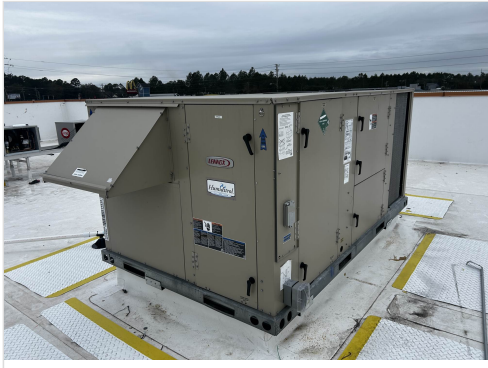
Unit Data - PHOTO LOG

Unit Data		
	Design	Actual
MFG	LENNOX ENLIGHT	LENNOX ENLIGHT
Serial Num	-	5624F02854
Model Num	LCT092H4E	LCT092H4EG1Y
Type	RTU	RTU
Configuration	VERTICAL	VERTICAL
Num OA Filters 1	-	1
OA Filter Size 1	-	16"X25"
Num Final Filter 1	-	4
Final Filter Size 1	-	20"X25"X2"

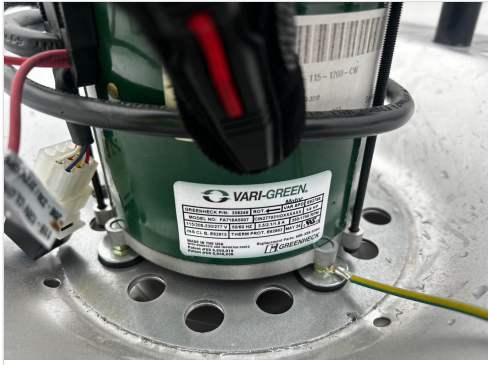
Motor Data - PHOTO LOG

Motor Data		
	Design	Actual
Motor MFG	-	VARI-GREEN
Frame	-	NL
Horsepower	1/4	1/4
Motor Rpm	-	1750
Phase	1	1
Voltage (rated)	120	115/208-230/277
Amperage (rated)	-	3.5/2.1/1.8
Service Factor	-	NL
