Report: Prelim Report
Function: Test, Adjust, & Balance
Date: 01/15/2025
Completed By: National TAB

01-13-25 WAWA #6301 HINESVILLE, GA

Project: 01-13-25 WAWA #6301 HINESVILLE, GA

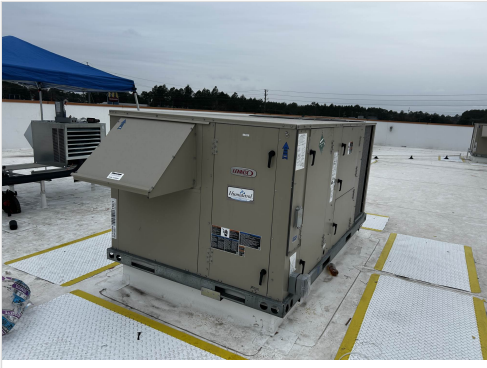
Unit Data - PHOTO LOG

Unit Data		
	Design	Actual
MFG	LENNOX ENLIGHT	LENNOX ENLIGHT
Serial Num	-	5624F02851
Model Num	LCT102H4E	LCT102H4EG1Y
Type	RTU	RTU
Configuration	VERTICAL	VERTICAL
Num OA Filters 1	-	1
OA Filter Size 1	-	16"X25"
Num Final Filter 1	-	4
Final Filter Size 1	-	20"X25"X2"

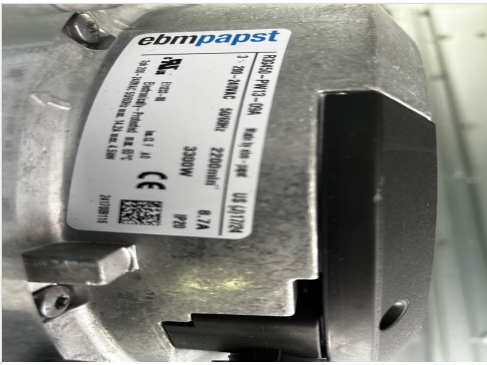
Motor Data - PHOTO LOG

Motor Data		
	Design	Actual
Motor MFG	-	EBMPAPST
Frame	-	NL
Horsepower	3.75	3.8
Motor Rpm	-	2200
Phase	3	3
Rated Voltage	208	200-240
Rated Amperage	-	8.7
Service Factor	-	NL

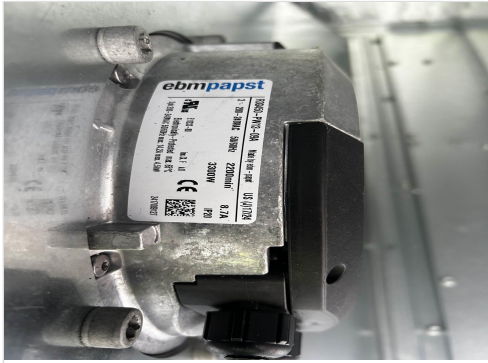
Motor Data - PHOTO LOG

Motor Data		
	Design	Actual
Motor MFG	-	EBMPAPST
Frame	-	NL
Horsepower	3.75	3.8
Motor Rpm	-	2200
Phase	3	3
Rated Voltage	208	200-240
Rated Amperage	-	8.7
Service Factor	-	NL

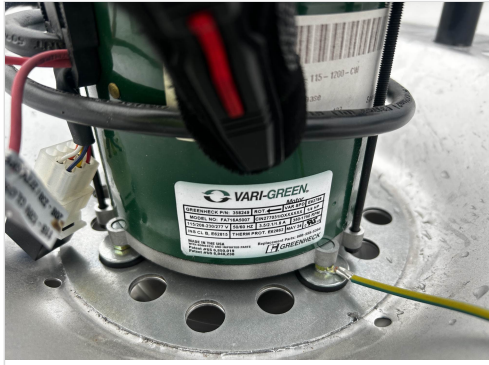
Motor Data - PHOTO LOG

Motor Data		
	Design	Actual
Motor MFG	-	VARI-GREEN
Frame	-	NL
Horsepower	1/4	1/4
Motor Rpm	-	1750
Phase	1	1
Voltage (rated)	120	115/208-230/277
Amperage (rated)	-	3.5/2.1/1.8
Service Factor	-	NL
