Report: TAB Report
Function: Test, Adjust, & Balance
Date: 01/22/2025
Completed By: National TAB

PROJECT
01-13-25 WAWA #6301 HINESVILLE, GA

Project: 01-13-25 WAWA #6301 HINESVILLE, GA

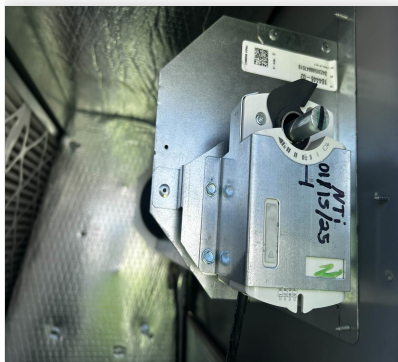
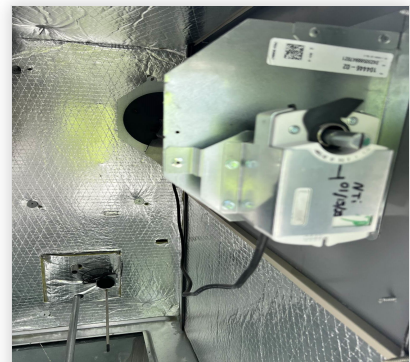
Clean filters installed? Fail

Final outside air damper position is marked with permanent marker?

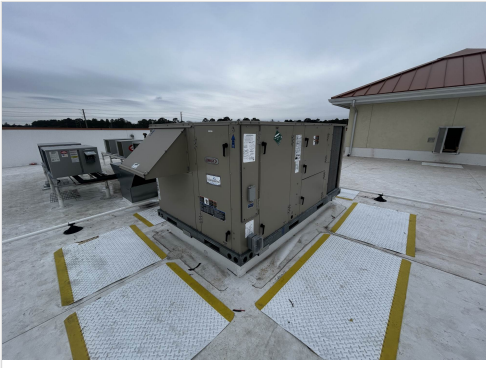
Unit Data - PHOTO LOG

Unit Data		
	Design	Actual
MFG	LENNOX ENLIGHT	LENNOX ENLIGHT
Serial Num	-	5624F02852
Model Num	LCT150H4E	LCT150H4EN1Y
Type	RTU	RTU
Configuration	VERTICAL	VERTICAL
Num OA Filters 1	-	1
OA Filter Size 1	-	16"X25"
Num Final Filter 1	-	4
Final Filter Size 1	-	20"X25"X2"

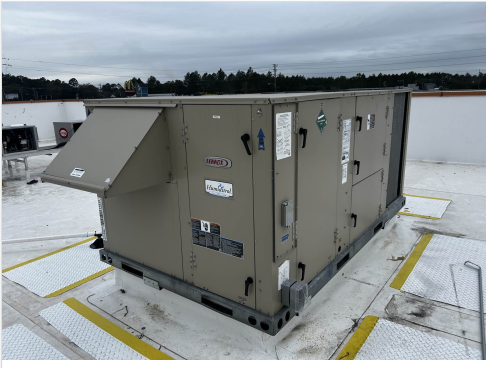
Unit Data - PHOTO LOG

Unit Data		
	Design	Actual
MFG	LENNOX ENLIGHT	LENNOX ENLIGHT
Serial Num	-	5624F02854
Model Num	LCT092H4E	LCT092H4EG1Y
Type	RTU	RTU
Configuration	VERTICAL	VERTICAL
Num OA Filters 1	-	1
OA Filter Size 1	-	16"X25"
Num Final Filter 1	-	4
Final Filter Size 1	-	20"X25"X2"
