Report: TAB Report
Function: Test, Adjust, & Balance
Date: 10/22/2025
Completed By: National TAB

PROJECT
10-13-25 QT # 1093 RICHBURG, SC

Project: 10-13-25 QT # 1093 RICHBURG, SC

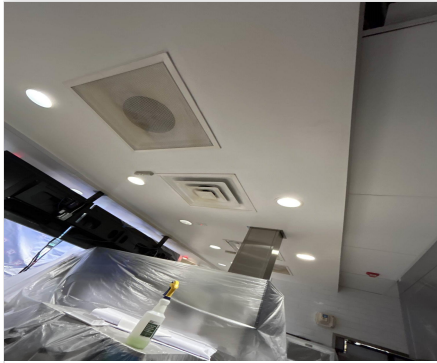
Issue Name : Kitchen diffusers backorder
Description : Per the GC kitchen diffusers are on backorder.
Created By : National TAB **Assigned To :** National TAB - Brianna Biggs
Status : Open
Priority : Low **Asset Tag :** RT-3
Originated Date : 10/16/2025 - Jearod Ferrette - National TAB

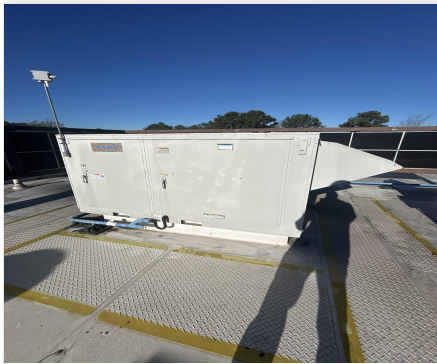
Issue Name : RTU 3 not operational
Description : RTU 3 fan shut off after OA was set. The unit was power cycled with no change. There's a distinct clicking noise after power cycling. Also tried the store PC to force it, but still no change.
Created By : National TAB **Assigned To :** National TAB - Brianna Biggs
Status : Open
Priority : High **Asset Tag :** RT-3
Originated Date : 10/17/2025 - Jearod Ferrette - National TAB

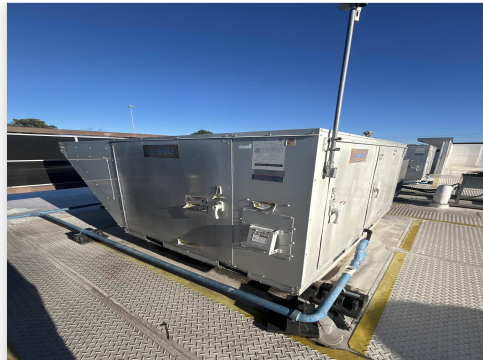
Unit Data - PHOTO LOG

Unit Data		
	Design	Actual
MFG	NA	AAON
Serial Num	-	201710-ANEK16230
Model Num	NA	RN01380EA0A152
Num OA Filters 1	-	1
OA Filter Size 1	-	45.5X22.5

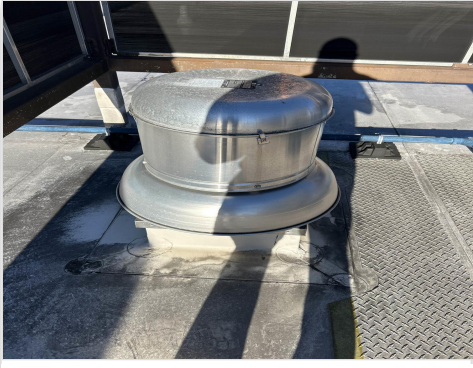
Unit Data - PHOTO LOG

Unit Data		
	Design	Actual
MFG	NA	NA
Model Num	NA	NA
Serial Num	-	410SH16770
Type	-	UPBLAST
Configuration	-	VERTICAL

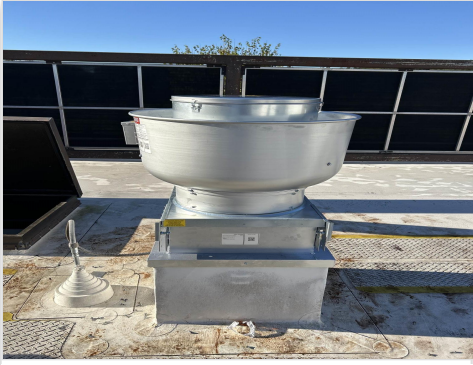
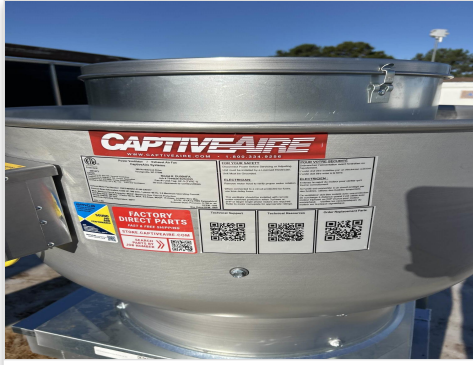
Unit Data - PHOTO LOG

Unit Data		
	Design	Actual
MFG	NA	CAPTIVEAIRE
Model Num	NA	DU50HFA
Serial Num	-	7644828
Type	UPBLAST	UPBLAST
Configuration	VERTICAL	VERTICAL

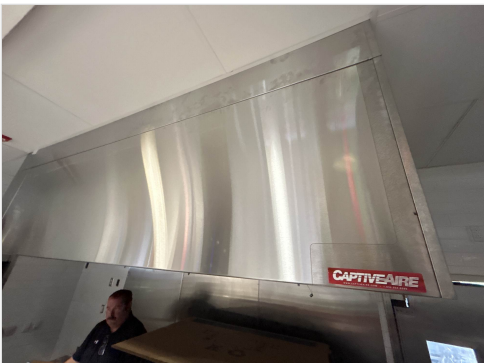
Unit Data - PHOTO LOG

Unit Data		
	Design	Actual
MFG	CAPTIVEAIRE	CAPTIVEAIRE
Model Num	6030ND-2-F	6030ND-2-F
Job / Serial Num	-	7644828
Type	-	TYPE I CANOPY
Hood length	-	121"
Hood Width	-	60"
