**Report: FINAL TAB REPORT  
Function: Test, Adjust, & Balance  
Date: 11/11/2022**

## **11-07 PENN STATION - MINT HILL, NC**

Project: 11-07 PENN STATION - MINT HILL, NC

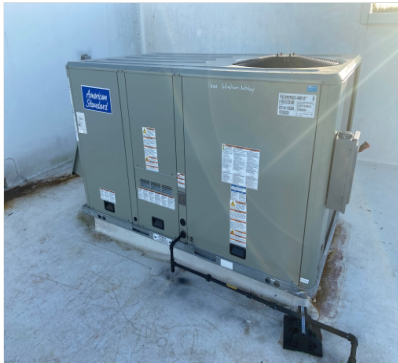
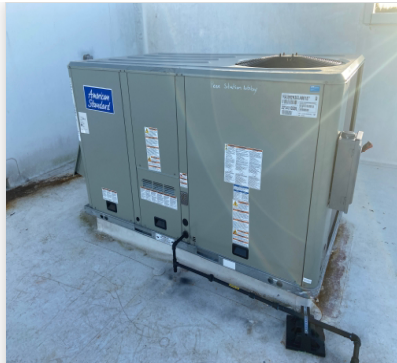
#### RTU-1

Unit Data		
	Design	Actual
MFG	LENNOX	TRANE
Serial Num	-	221411030L
Model Num	LGH090H	YSC092H3ELA26D
Type	RTU	RTU
Configuration	VERTICAL	VERTICAL
Num OA Filters 1	-	1
OA Filter Size 1	-	35X15
Num Final Filter 1	-	4
Final Filter Size 1	-	20X25X2
Num Final Filter 2	-	NA
Final Filter Size 2	-	NA

Test Data		
	Design	Actual
SF CFM	3000	3115
SF RPM	-	675
RA CFM	2250	2372
OA CFM	750	743
RL Voltage	-	208
RL Amperage	-	3.3/3.2/3.1
SF Rotation	-	CCW
RA Damper Position	-	75%
Min OA Damper Position	-	25%
Min OA Damper Type	-	SINGLE BLADE DAMPER

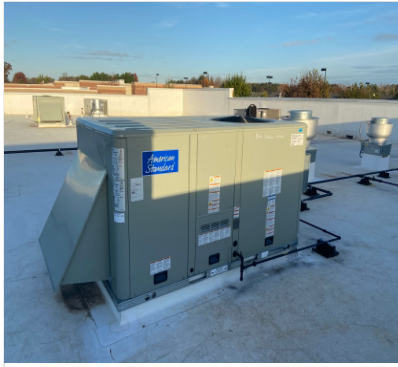
RTU-2

Unit Data		
	Design	Actual
MFG	LENNOX	TRANE
Serial Num	-	221410253L
Model Num	LGH090H	YSC092H3ELA26D
Type	RTU	RTU
Configuration	VERTICAL	VERTICAL
Num OA Filters 1	-	1
OA Filter Size 1	-	35X15
Num Final Filter 1	-	4
Final Filter Size 1	-	20X25X2

Test Data		
	Design	Actual
SF CFM	3000	2967
SF RPM	-	670
RA CFM	2250	2186
OA CFM	750	781
RL Voltage	-	207/208/209
RL Amperage	-	3.1/3.1/3.2
SF Rotation	-	CCW
RA Damper Position	-	80%
Min OA Damper Position	-	25%
Min OA Damper Type	-	SINGLE BLADE

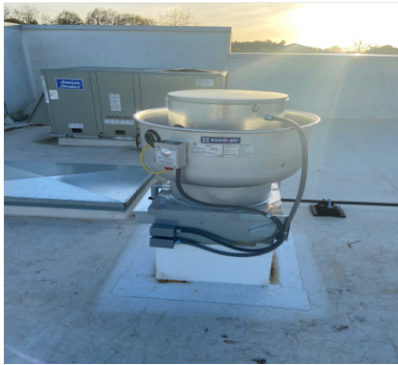
EF-1

Unit Data		
	Design	Actual
MFG	CAPTIVEAIRE	CAPTIVEAIRE
Model Num	DU85HFA	DU85HFA
Serial Num	-	5317880
Type	UPBLAST	UPBLAST
Configuration	VERTICAL	VERTICAL

Test Data		
	Design	Actual
CFM	1120	1121
Fan RPM	1215	DD
Fan Rotation	-	CCW
Motor RPM	-	DD
System SetPt	-	60%
RL Voltage	-	120
RL Amperage	-	5.2
Total ESP	1.150"	0.99"
Fan Inlet SP	-	-0.99
Fan Discharge SP	-	ATM

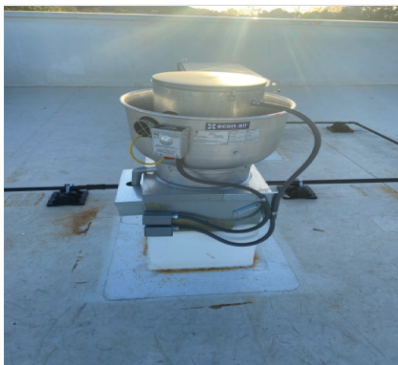
EF-2

Unit Data		
	Design	Actual
MFG	CAPTIVEAIRE	CAPTIVEAIRE
Model Num	DU33HFA	DU33HFA
Serial Num	-	5317880
Type	UPBLAST	UPBLAST
Configuration	VERTICAL	VERTICAL

Test Data		
	Design	Actual
CFM	600	616
Fan RPM	1360	DD
Fan Rotation	-	CCW
Motor RPM	-	DD
System SetPt	-	85%
RL Voltage	-	120
RL Amperage	-	3.7
Total ESP	0.600"	0.56"
Fan Inlet SP	-	-0.56"
Fan Discharge SP	-	ATM

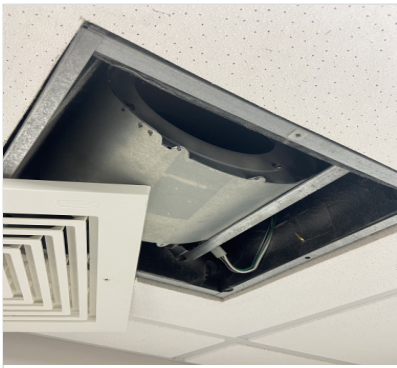
EF-4

Unit Data		
	Design	Actual
<b>MFG</b>	NA	NO ACCESS
<b>Model Num</b>	NA	NO ACCESS

Test Data		
	Design	Actual
<b>CFM</b>	75	77
<b>Fan RPM</b>	-	DD
<b>Fan Rotation</b>	-	CCW
<b>Motor RPM</b>	-	DD
<b>RL Amperage</b>	-	0.53

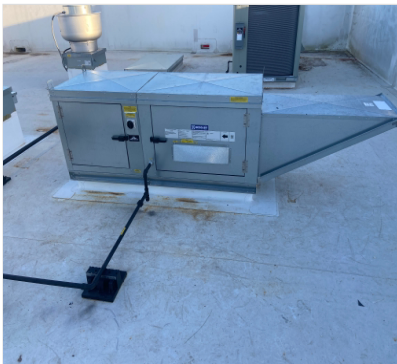
MAU-1

Unit Data		
	Design	Actual
MFG	CAPTIVEAIRE	CAPTIVEAIRE
Model Num	A1-D.250-15D	A1-D.250-15D
Serial Num	-	5317880
Type	MAU	MAU
Configuration	HORIZONTAL	HORIZONTAL

Gas Heat		
	Design	Actual
Heater Operates (y/n)	-	YES
Flame Status (pass/fail)	-	PASS
Inlet Air Temp SetPt	55	55
Discharge Air Temp SetPt	60	60
Air Flow Switch SP Actual	-	0.38

Test Data		
	Design	Actual
CFM	1650	1647
SF RPM	1855	1899
Motor RPM	-	DD
SF System SetPt	-	63.7
RL Voltage	-	208/208/209
RL Amperage	-	3.5/3.6/3.7

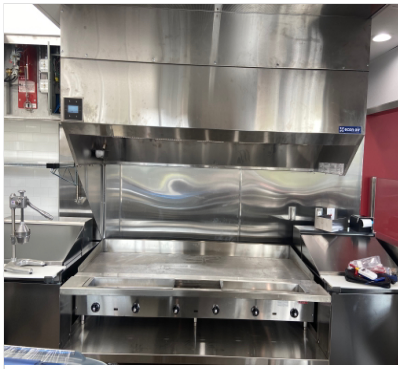
HOOD-1

Unit Data		
	Design	Actual
<b>MFG</b>	CAPTIVEAIRE	CAPTIVEAIRE
<b>Model Num</b>	3650 BD-2 246 ACPSP	3650 BD-2 246 ACPSP
<b>Job / Serial Num</b>	-	5317880
<b>Type</b>	TYPE I LOW PROXIMITY	ACPSP
<b>Hood length</b>	72"	86"
<b>Hood Width</b>	36"	36"
<b>Supply Plenum Type</b>	-	PERF
<b>Supply Plenum Width</b>	14"	14"
<b>Supply Plenum Length</b>	72"	80"

Test Data Supply		
	Design	Actual
<b>Total AK Area</b>	7	7
<b>Kv factor (Vel)</b>	0.89"	0.89
<b>Num of Readings</b>	-	6
<b>Reading1 FPM</b>	-	165
<b>Reading2 FPM</b>	-	177
<b>Reading3 FPM</b>	-	154
<b>Reading4 FPM</b>	-	139
<b>Reading5 FPM</b>	-	149
<b>Reading6 FPM</b>	-	161
<b>Ave FPM(corr)</b>	-	140
<b>CFM</b>	1000	981

Test Data Exhaust		
	Design	Actual
<b>Filter Type</b>	CAPTRATE SOLO	CAPTRATE SOLO
<b>Filter Size 1</b>	16X16	16X16
<b>Filter Qty 1</b>	4	5
<b>Filter AK factor size 1</b>	1.62	1.62
<b>Filter Total AK Area</b>	6.48	8.1
<b>Filter1 FPM</b>	-	145
<b>Filter2 FPM</b>	-	149
<b>Filter3 FPM</b>	-	137
<b>Filter4 FPM</b>	-	128
<b>Filter5 FPM</b>	-	133
<b>Filter Ave FPM(corr)</b>	-	138
<b>CFM</b>	1120	1121

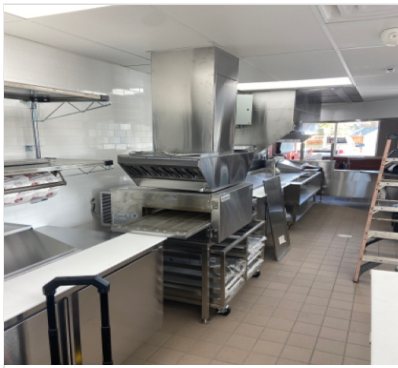
HOOD-2

Design	Actual
MFG	CAPTIVEAIRE	CAPTIVEAIRE
Model Num	4412 PS-OVN	4412 PS-OVN
Job / Serial Num	-	NL
Type	TYPE I LOW PROXIMITY	DROP
Hood length	21.25"	21.25
Hood Width	44"	44"

Design	Actual
Filter Type	BAFFLE	BAFFLE
Filter Size 1	20X10	20X10
Filter Qty 1	2	2
Filter AK factor size 1	-	1.20
Filter Total AK Area	-	2.4
Filter1 FPM	-	249
Filter2 FPM	-	256
Filter3 FPM	-	265
Filter4 FPM	-	255
Filter Ave FPM(corr)	-	256
CFM	600	614

Notes: CEILING DROP HOOD FOR SANDWICH COOKING STATION @ 90%

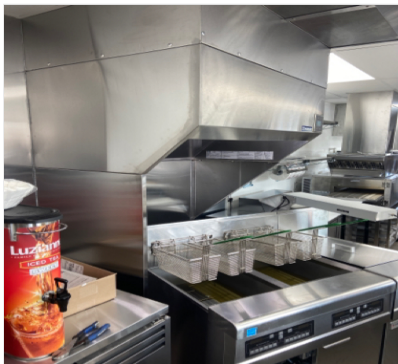
HOOD-3

Unit Data		
	Design	Actual
MFG	CAPTIVEAIRE	CAPTIVEAIRE
Model Num	3650 BD-2 246 ACPSP	3650 BD-2 246 ACPSP
Job / Serial Num	-	5317880
Type	TYPE I LOW PROXIMITY	ACPSP
Hood length	50"	50"
Hood Width	36"	36"
Supply Plenum Type	-	PERF
Supply Plenum Width	14"	14"
Supply Plenum Length	50"	48"

Test Data Supply		
	Design	Actual
Total AK Area	4.86	4.47
Kv factor (Vel)	0.89	0.89
Num of Readings	-	4
Reading1 FPM	-	191
Reading2 FPM	-	152
Reading3 FPM	-	135
Reading4 FPM	-	192
Ave FPM(corr)	-	149
CFM	650	666

Test Data Exhaust		
	Design	Actual
Filter Type	CAPTRATE SOLO	CAPTRATE SOLO
Filter Size 1	16X16	16X16
Filter Qty 1	3	3
Filter AK factor size 1	1.62	1.62
Filter Total AK Area	4.86	4.86
Filter1 FPM	-	173
Filter2 FPM	-	160
Filter3 FPM	-	171
Filter Ave FPM(corr)	-	168
CFM	833	818

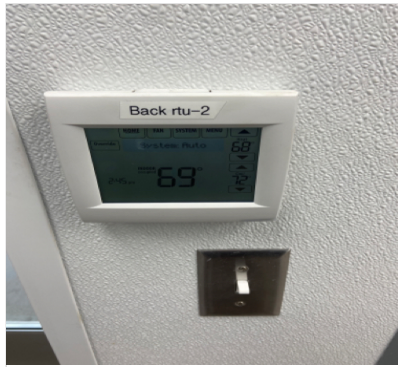
Programed.jpeg

Occupied 7:15AM-10:15PM: 68 Heat/72 Cool (NOTE: 3 degree MAX setback)	YES
---	-----

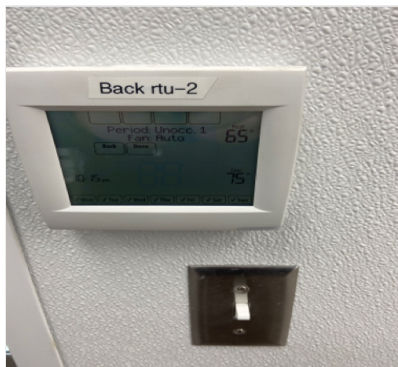
Programed.jpeg

Unoccupied 10:16PM-7:14AM: 65 Heat/75 Cool
