**Report: FINAL TAB REPORT
Function: Test, Adjust, & Balance
Date: 11/11/2022**

11-07 PENN STATION - MINT HILL, NC

Project: 11-07 PENN STATION - MINT HILL, NC

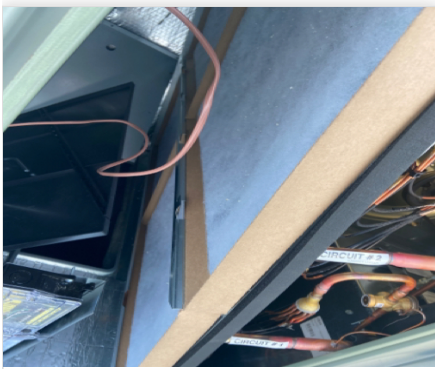
Constructionfilters.j...

Issue Name : CONSTRUCTION FILTER

Description : RTU-2 construction filters(they are clean though)
