**Report: FINAL TAB REPORT
Function: Test, Adjust, & Balance
Date: 11/11/2022**

11-07 PENN STATION - MINT HILL, NC

National TAB

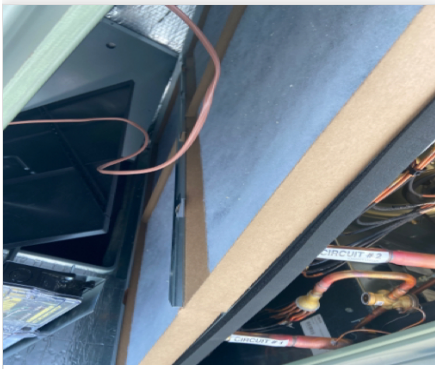
Constructionfilters.j...

Issue Name : RTU-2 CONSTRUCTION FILTERS

Description : RTU-2 has construction filters installed. Recommend installing final pleated filters.

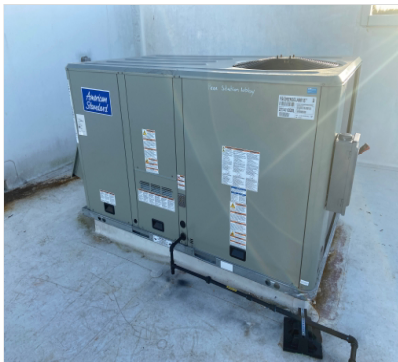
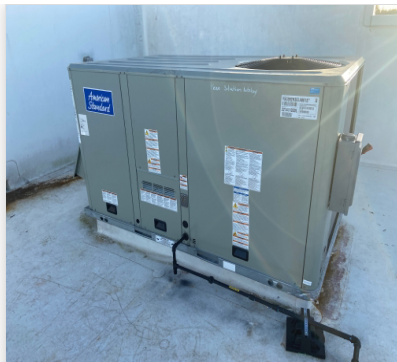
RTU-1

Unit Data		
	Design	Actual
MFG	LENNOX	TRANE
Serial Num	-	221411030L
Model Num	LGH090H	YSC092H3ELA26D
Type	RTU	RTU
Configuration	VERTICAL	VERTICAL
Num OA Filters 1	-	1
OA Filter Size 1	-	35X15
Num Final Filter 1	-	4
Final Filter Size 1	-	20X25X2
Num Final Filter 2	-	NA
Final Filter Size 2	-	NA

Test Data		
	Design	Actual
SF CFM	3000	3115
SF RPM	-	675
RA CFM	2250	2372
OA CFM	750	743
RL Voltage	-	208
RL Amperage	-	3.3/3.2/3.1
SF Rotation	-	CCW
RA Damper Position	-	75%
Min OA Damper Position	-	25%
Min OA Damper Type	-	SINGLE BLADE DAMPER

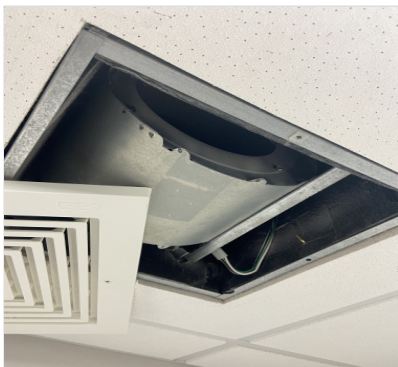
EF-4

Test Data		
	Design	Actual
CFM	75	77
Fan RPM	-	DD
Fan Rotation	-	CCW
Motor RPM	-	DD
RL Amperage	-	0.53

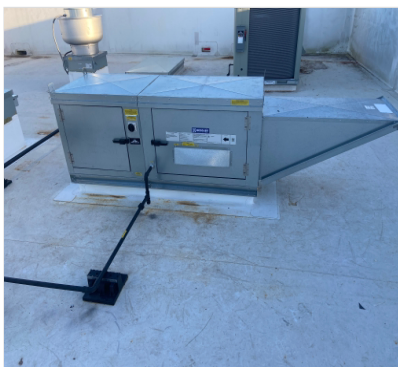
MAU-1

Unit Data		
	Design	Actual
MFG	CAPTIVEAIRE	CAPTIVEAIRE
Model Num	A1-D.250-15D	A1-D.250-15D
Serial Num	-	5317880
Type	MAU	MAU
Configuration	HORIZONTAL	HORIZONTAL

Test Data		
	Design	Actual
CFM	1650	1647
SF RPM	1855	1899
Motor RPM	-	DD
SF System SetPt	-	63.7
RL Voltage	-	208/208/209
RL Amperage	-	3.5/3.6/3.7

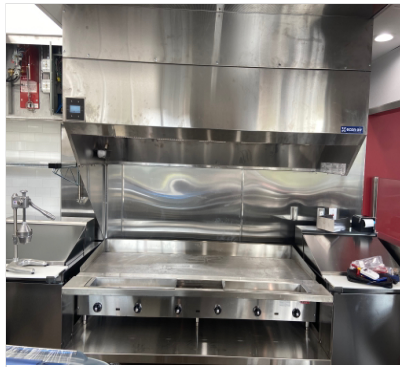
HOOD-1

Unit Data		
	Design	Actual
MFG	CAPTIVEAIRE	CAPTIVEAIRE
Model Num	3650 BD-2 246 ACPSP	3650 BD-2 246 ACPSP
Job / Serial Num	-	5317880
Type	TYPE I LOW PROXIMITY	ACPSP
Hood length	72"	86"
Hood Width	36"	36"
Supply Plenum Type	-	PERF
Supply Plenum Width	14"	14"
Supply Plenum Length	72"	80"

Test Data Supply		
	Design	Actual
Total AK Area	7	7
Kv factor (Vel)	0.89"	0.89
Num of Readings	-	6
Reading1 FPM	-	165
Reading2 FPM	-	177
Reading3 FPM	-	154
Reading4 FPM	-	139
Reading5 FPM	-	149
Reading6 FPM	-	161
Ave FPM(corr)	-	140
CFM	1000	981

Test Data Exhaust		
	Design	Actual
Filter Type	CAPTRATE SOLO	CAPTRATE SOLO
Filter Size 1	16X16	16X16
Filter Qty 1	4	5
Filter AK factor size 1	1.62	1.62
Filter Total AK Area	6.48	8.1
Filter1 FPM	-	145
Filter2 FPM	-	149
Filter3 FPM	-	137
Filter4 FPM	-	128
Filter5 FPM	-	133
Filter Ave FPM(corr)	-	138
CFM	1120	1121

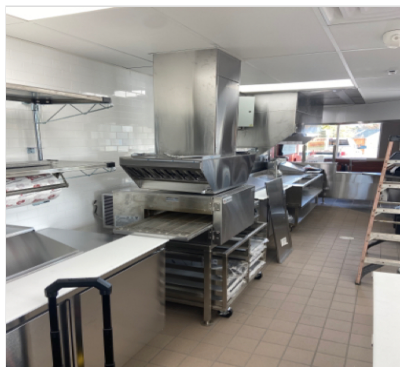
HOOD-2

Unit Data		
	Design	Actual
MFG	CAPTIVEAIRE	CAPTIVEAIRE
Model Num	4412 PS-OVN	4412 PS-OVN
Job / Serial Num	-	NL
Type	TYPE I LOW PROXIMITY	DROP
Hood length	21.25"	21.25
Hood Width	44"	44"

Test Data Exhaust		
	Design	Actual
Filter Type	BAFFLE	BAFFLE
Filter Size 1	20X10	20X10
Filter Qty 1	2	2
Filter AK factor size 1	-	1.20
Filter Total AK Area	-	2.4
Filter1 FPM	-	249
Filter2 FPM	-	256
Filter3 FPM	-	265
Filter4 FPM	-	255
Filter Ave FPM(corr)	-	256
CFM	600	614

Notes: CEILING DROP HOOD FOR SANDWICH COOKING STATION @ 90%

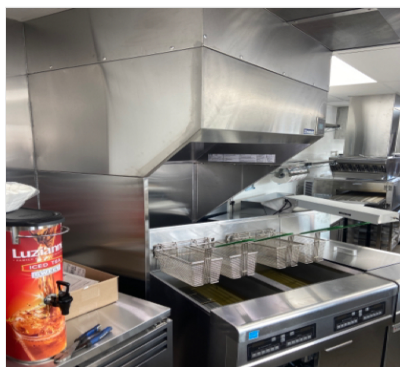
HOOD-3

Unit Data		
	Design	Actual
MFG	CAPTIVEAIRE	CAPTIVEAIRE
Model Num	3650 BD-2 246 ACPSP	3650 BD-2 246 ACPSP
Job / Serial Num	-	5317880
Type	TYPE I LOW PROXIMITY	ACPSP
Hood length	50"	50"
Hood Width	36"	36"
Supply Plenum Type	-	PERF
Supply Plenum Width	14"	14"
Supply Plenum Length	50"	48"

Test Data Supply		
	Design	Actual
Total AK Area	4.86	4.47
Kv factor (Vel)	0.89	0.89
Num of Readings	-	4
Reading1 FPM	-	191
Reading2 FPM	-	152
Reading3 FPM	-	135
Reading4 FPM	-	192
Ave FPM(corr)	-	149
CFM	650	666

Test Data Exhaust		
	Design	Actual
Filter Type	CAPTRATE SOLO	CAPTRATE SOLO
Filter Size 1	16X16	16X16
Filter Qty 1	3	3
Filter AK factor size 1	1.62	1.62
Filter Total AK Area	4.86	4.86
Filter1 FPM	-	173
Filter2 FPM	-	160
Filter3 FPM	-	171
Filter Ave FPM(corr)	-	168
CFM	833	818

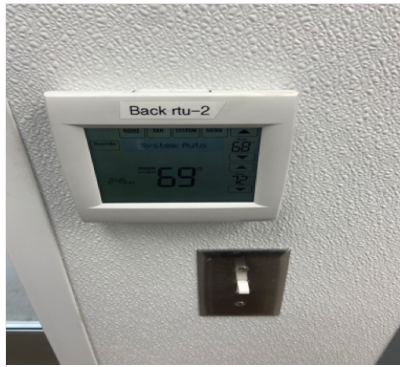
Programed.jpeg

Occupied 7:15AM-10:15PM: 68 Heat/72 Cool (NOTE: 3 degree MAX setback)	YES
---	-----

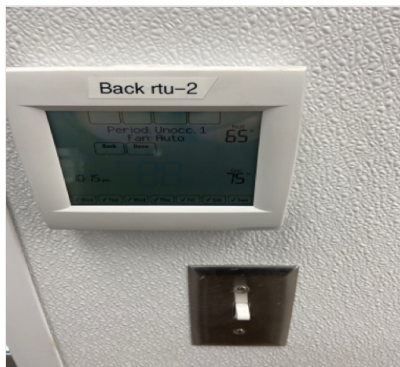
Programed.jpeg

Unoccupied 10:16PM-7:14AM: 65 Heat/75 Cool
