PlanGrid Task Report - Mar 31, 2025

L05378_Hanover Towne Center FSU (NJ)

799 New Jersey 10, Hanover, New Jersey

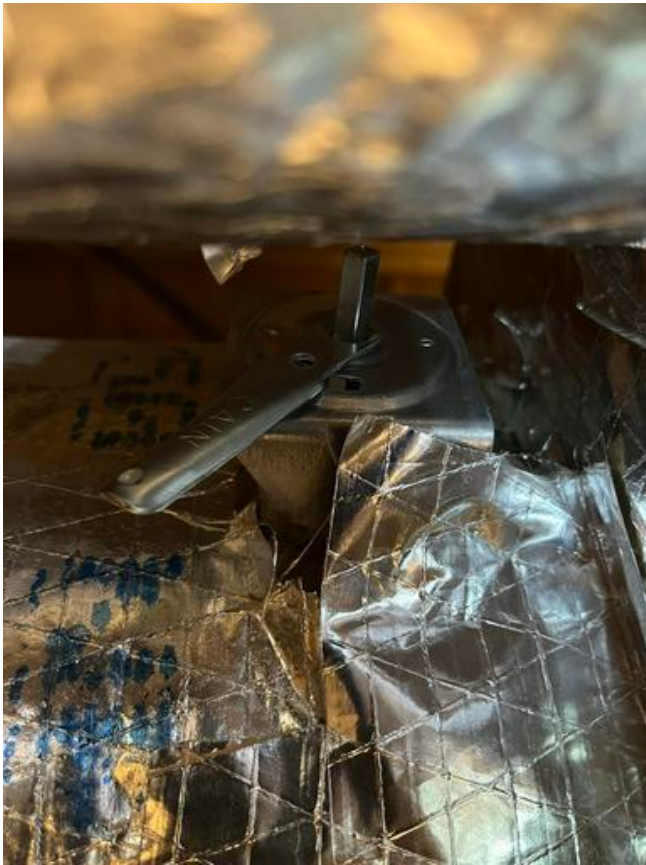
IMG_7407

#25 [DUCT 010] [NEW] CRITICAL – Damper(s) missing hardware.

AC1 SGRD5 is missing wingnut.
AC4 SGRD5 is missing wingnut and screw.

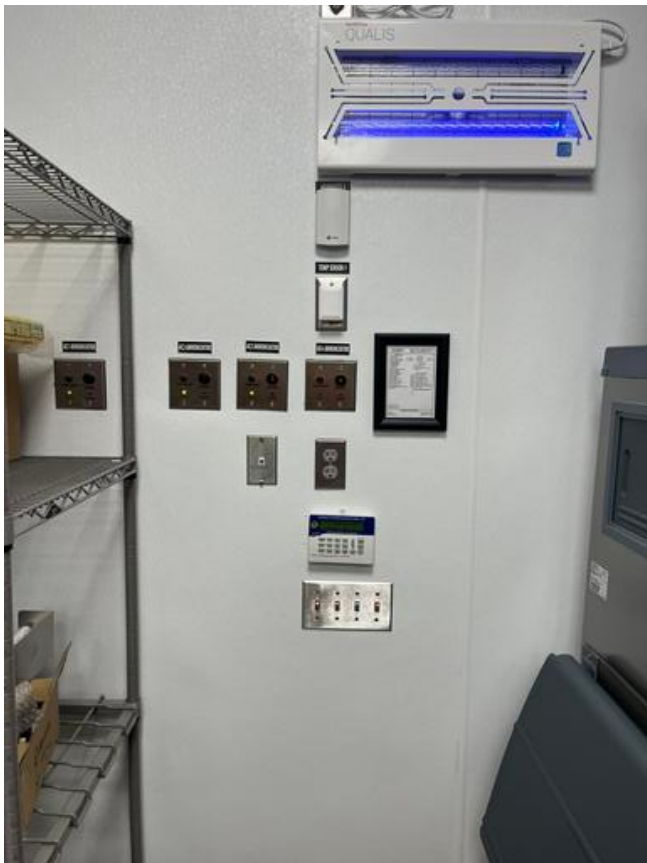
IMG_7371

#24 [CNTL 505] [NEW] Devices not located per plans.

AC1 temp. & humidity sensor are not installed where shown on plans.

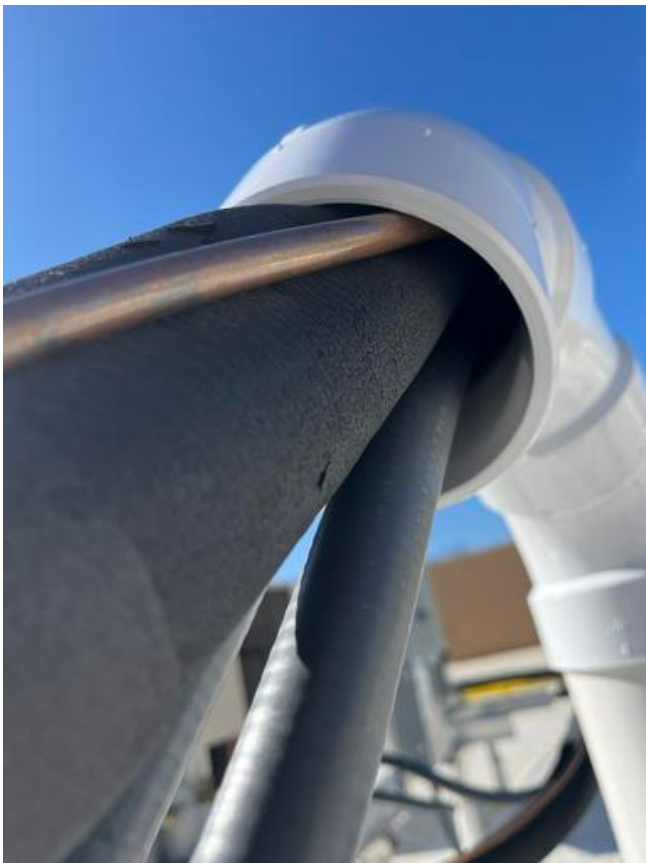
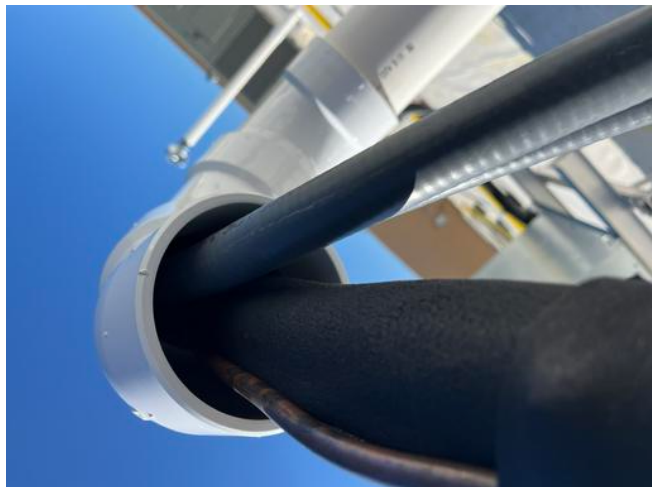
#23 [REFG 511] [NEW] PVC pipe chase (gooseneck) installation.

WIF & WIC need to be sealed with spray foam and caulking.

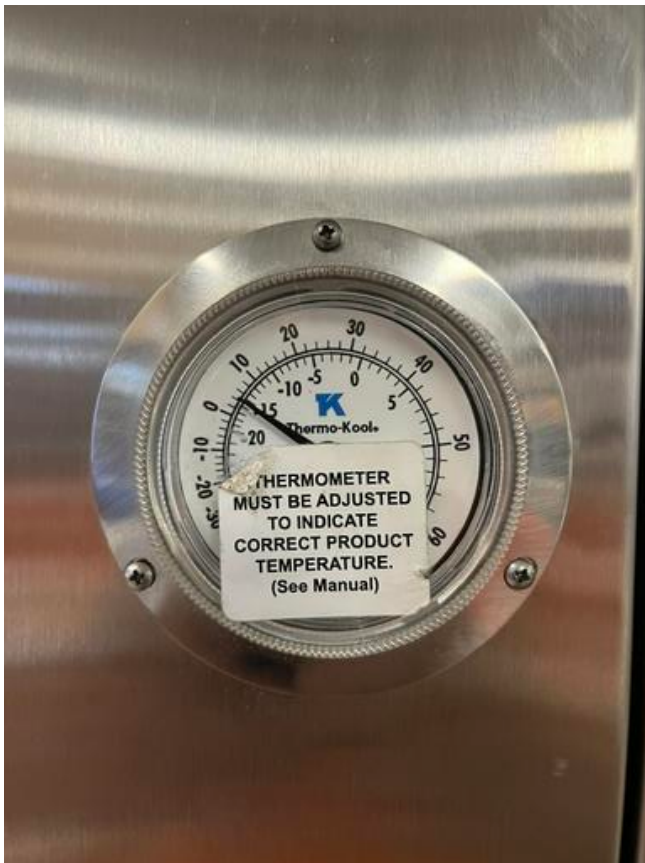
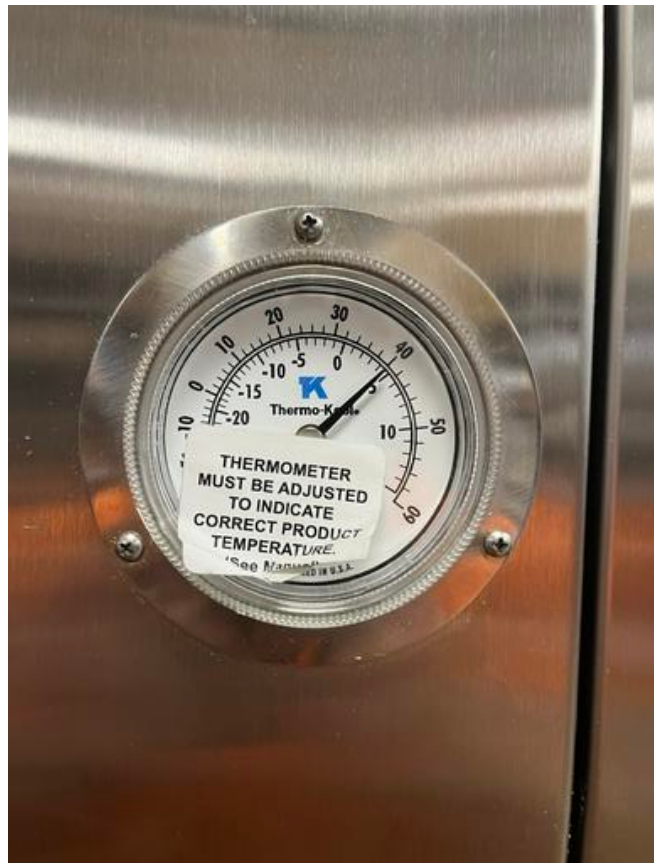
#22 [REFG 999] [NEW] (MISC) [dials need calibrated]

WIF & WIC dials need to be calibrated to match actual temp. inside box.

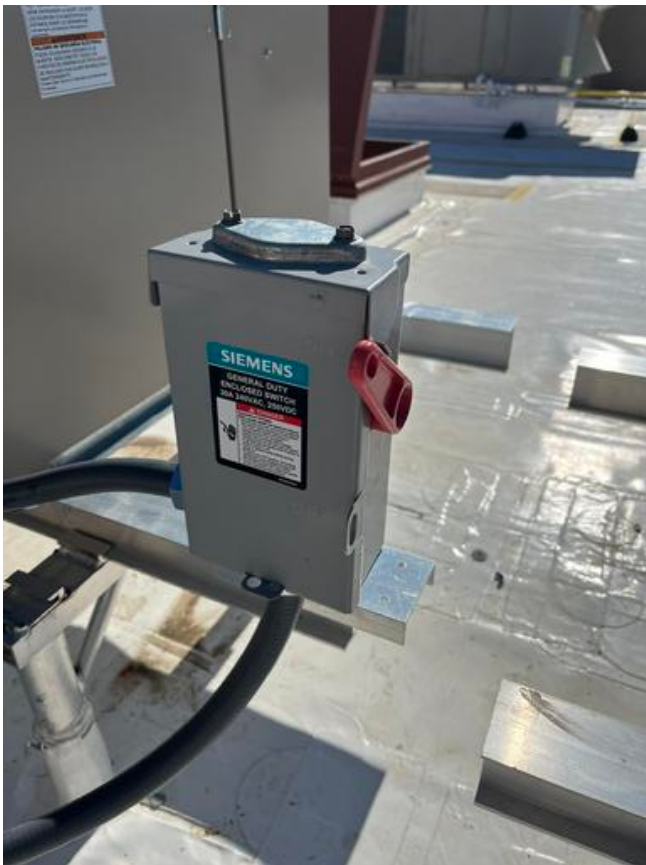
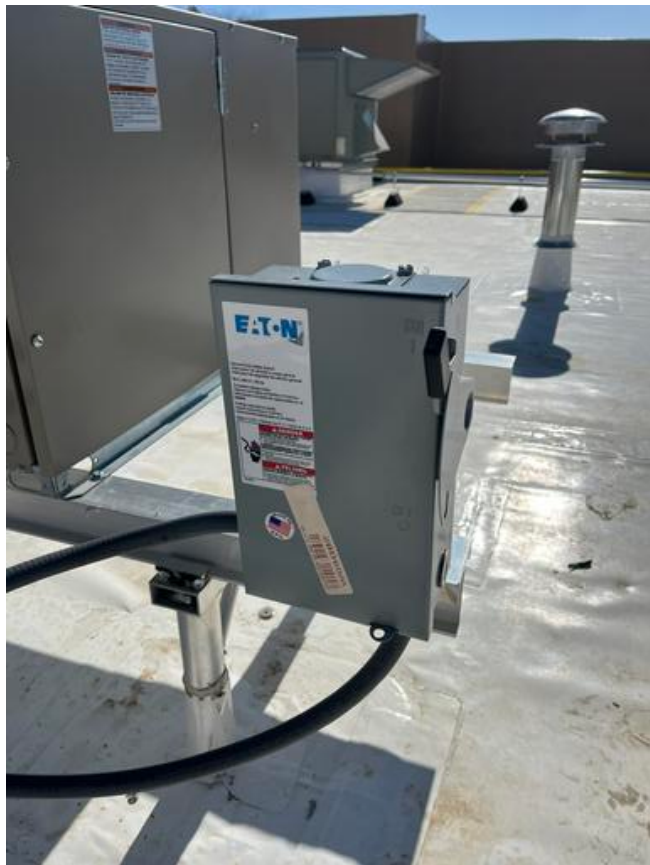
#21 [REFG 516] [NEW] Condenser electrical disconnects.

WIF & WIC breakers need labeled.

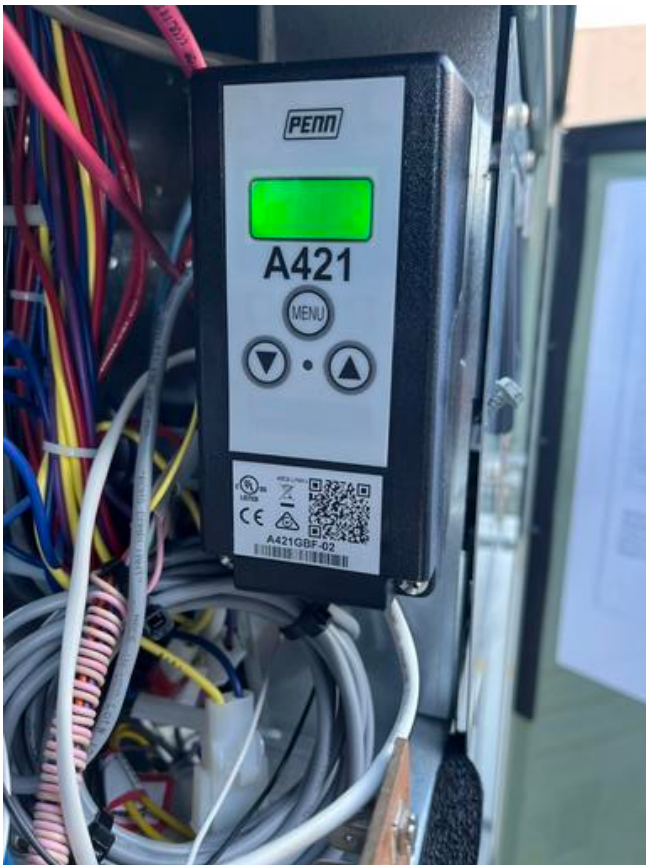
IMG_7417

#20 [UNIT 504] [NEW] Equipment Fresh Air Tempering.

AC4 Penn controller will not allow you to scroll through controller options to set parameters for fresh air tempering.

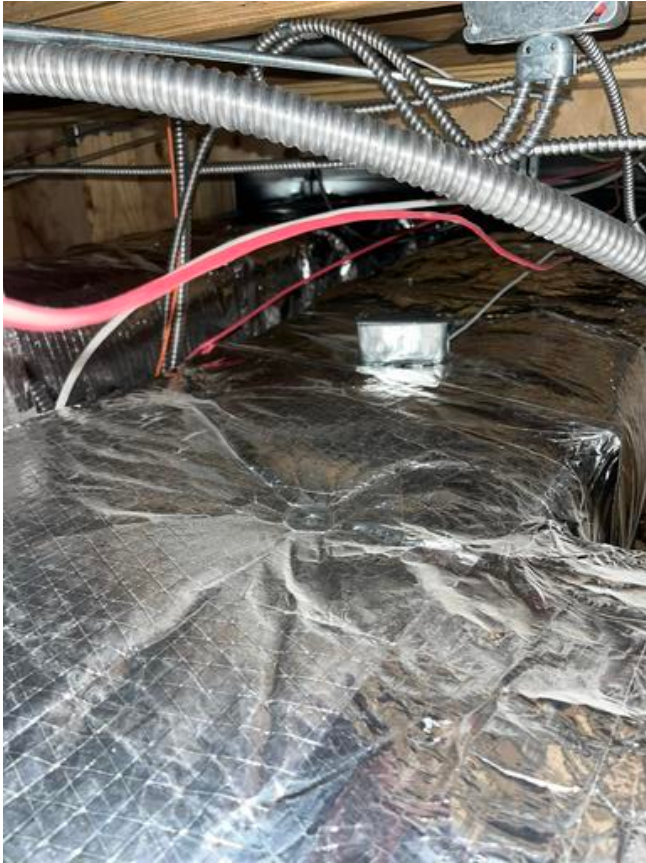
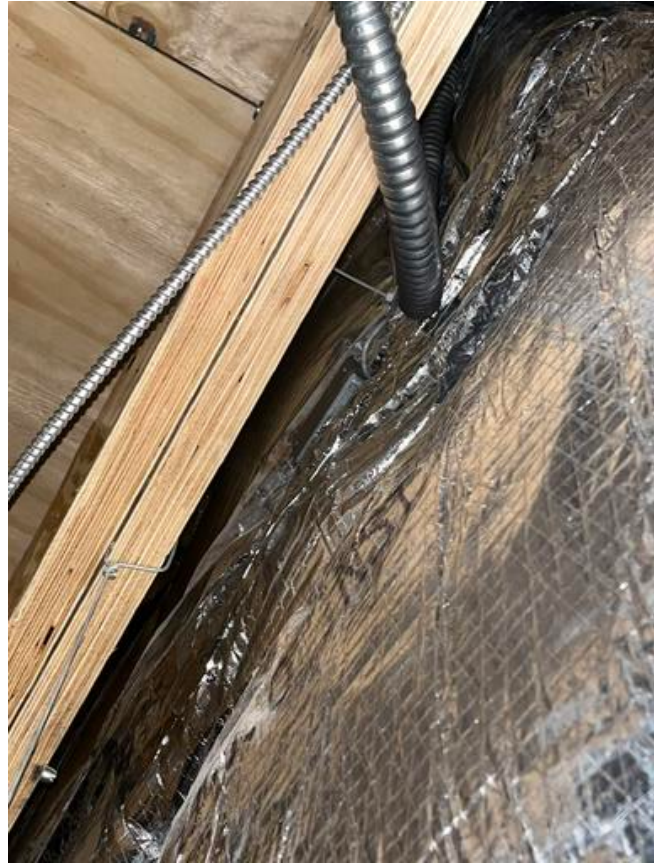
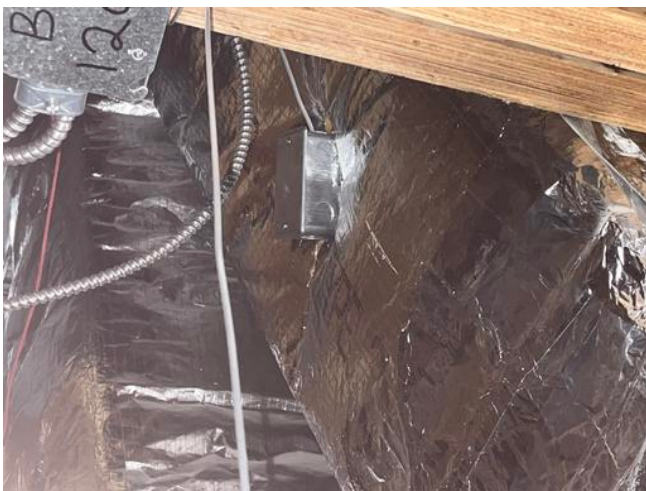
#19 [UNIT 504] [NEW] Equipment Fresh Air Tempering.

AC2, AC3, AC4 fresh air tempering sensor are not installed in the supply duct after the first 90 degree elbow. Recommend sensor be relocated to the correct location.

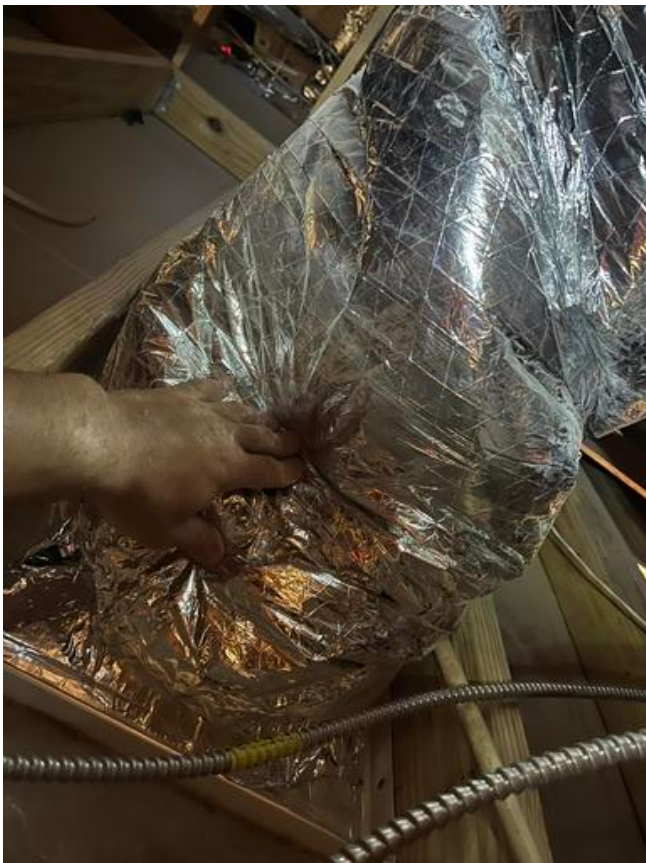
IMG_7406

#18 [DUCT 007] [NEW] CRITICAL – Diffuser rigid 90's.

AC3 SGRD17 & SGRD5 flex should not be connected to diffuser collar. diffuser should have hard pipe installed for flex to be secured to.

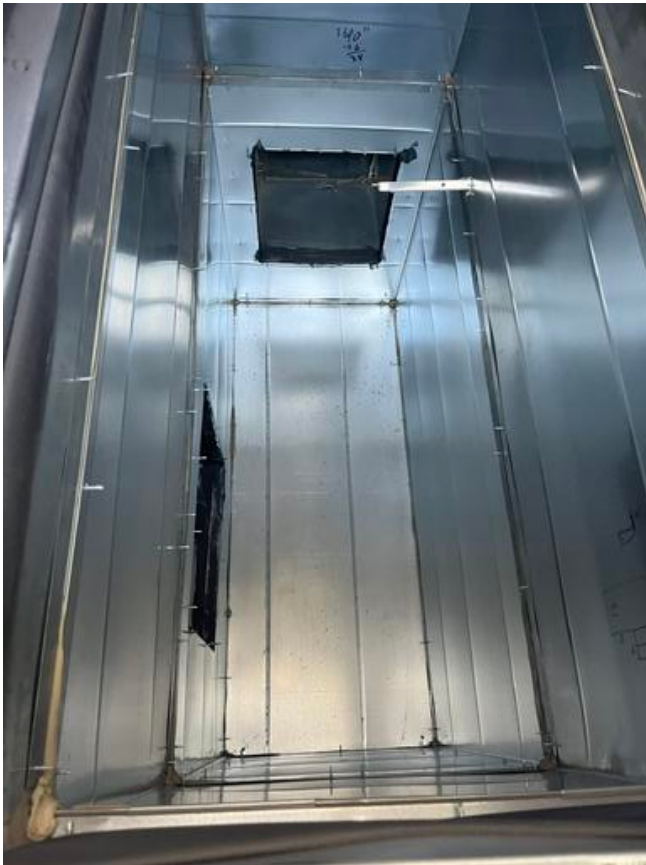
IMG_7391

#17 [DUCT 499] [NEW] CRITICAL (Turning Vanes Not Installed)

AC3 turning vanes are not installed on supply ductwork.

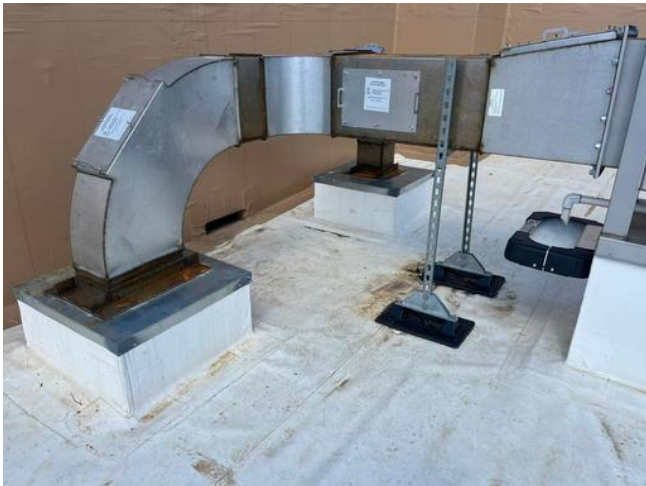
IMG_7383

#16 [EXHA 510] [NEW] Grease exhaust duct is not supported.

EF1 grease duct drops are not supported. Support legs should be added for grease duct drops.

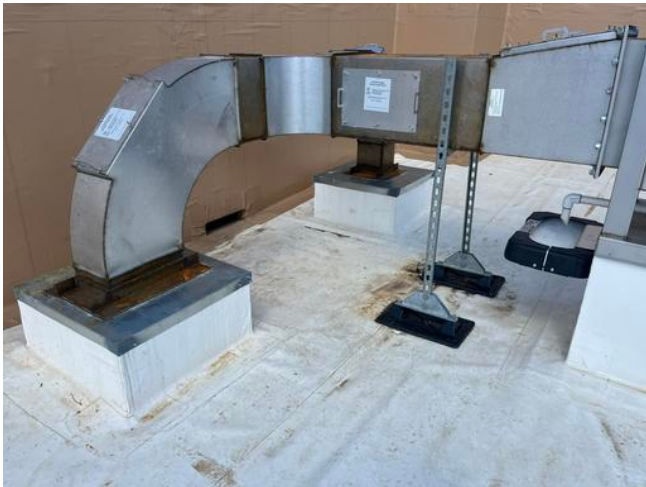
IMG_7383

#15 [EXHA 509] [NEW] Grease exhaust duct is not painted.

EF1 grease duct needs painted.

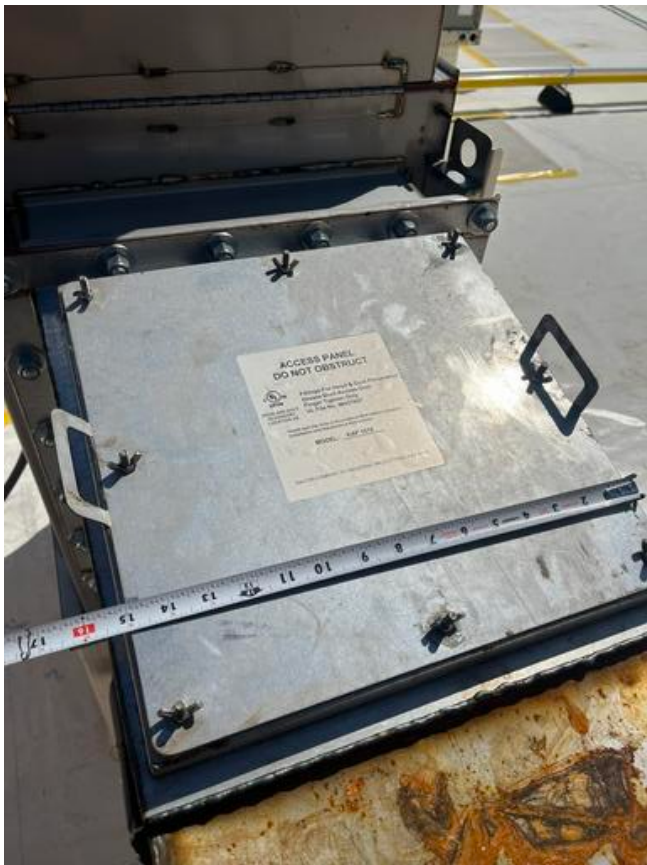
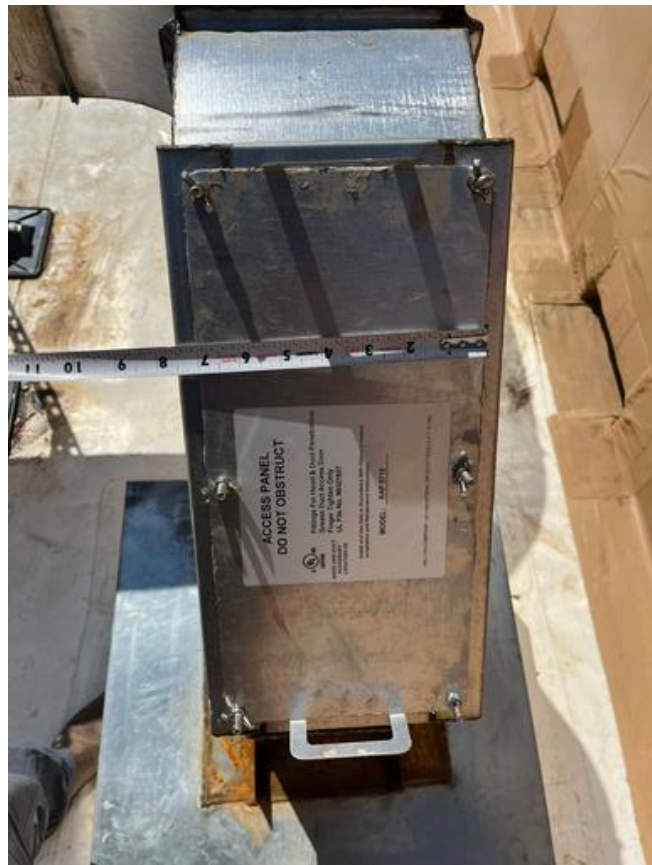
#14 [EXHA 001] [NEW] CRITICAL – Grease duct access doors.

EF1 has three grease cleanout doors installed that are a different size than listed in prints. This is a Halton issue.

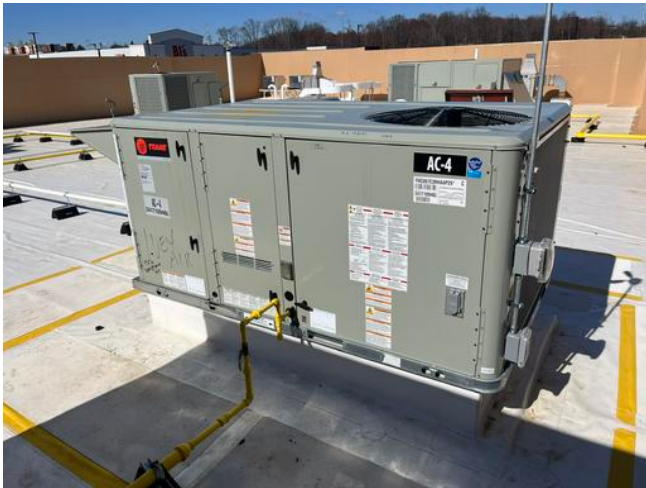
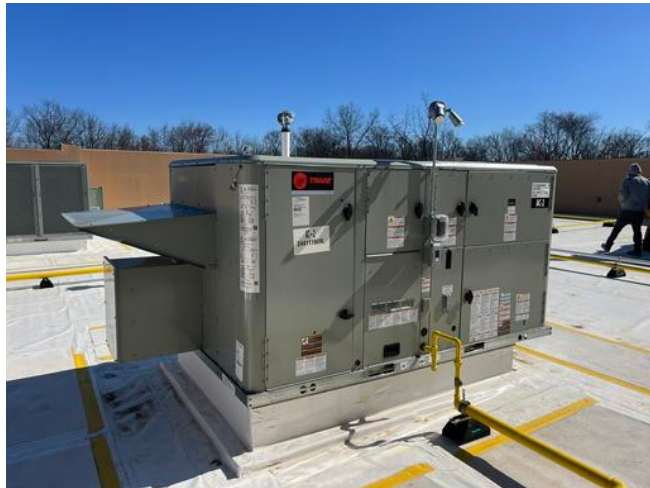
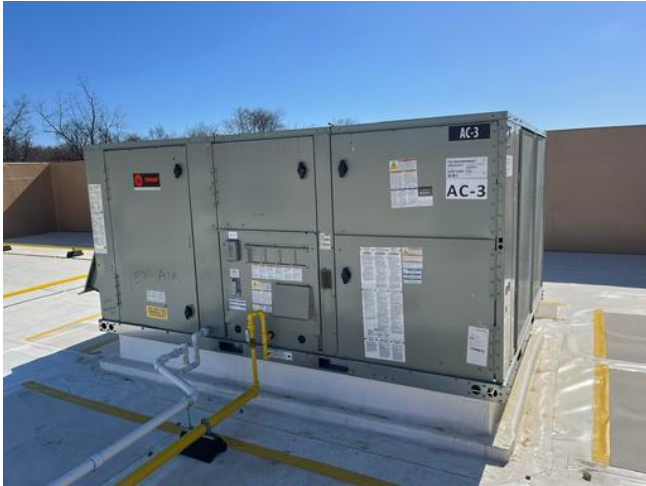
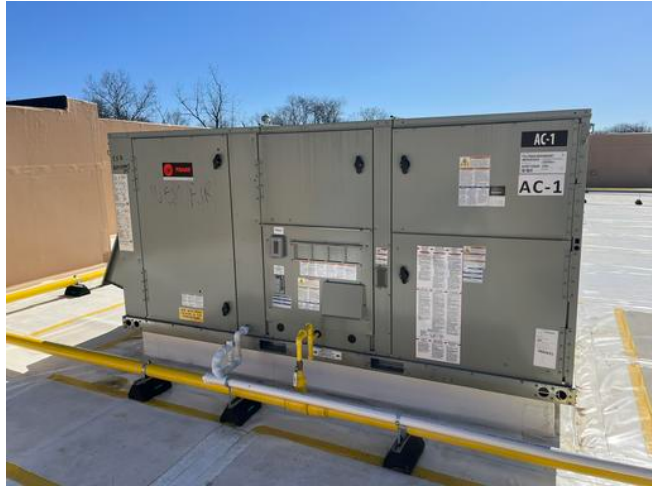
#13 [UNIT 501] [NEW] Equipment low voltage diagrams

AC1, AC2, AC3, AC4 need a laminated copy of controls detail low voltage wiring diagram.

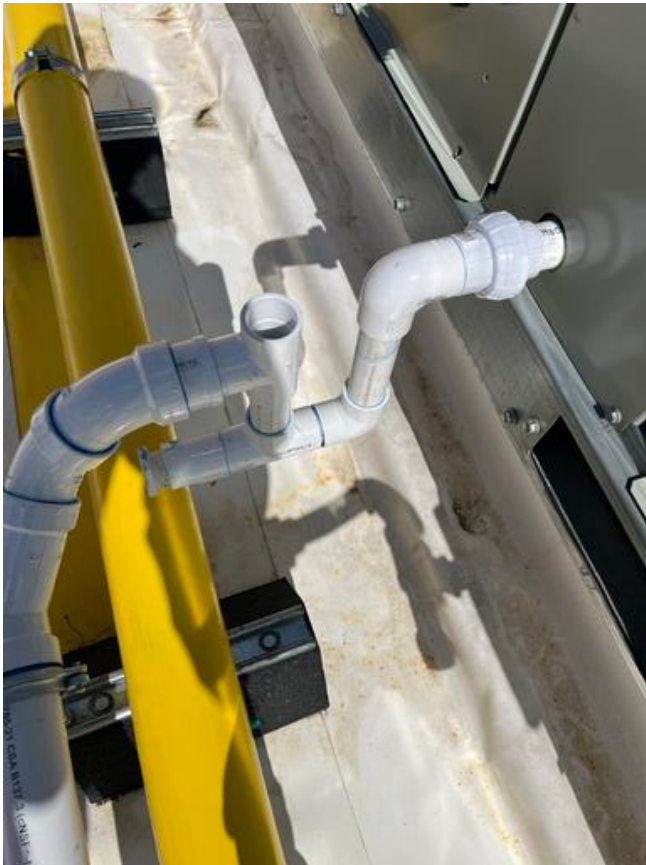
IMG_7393

#12 [UNIT 517] [NEW] Condensate piping construction.

AC1 p-trap is missing one union.

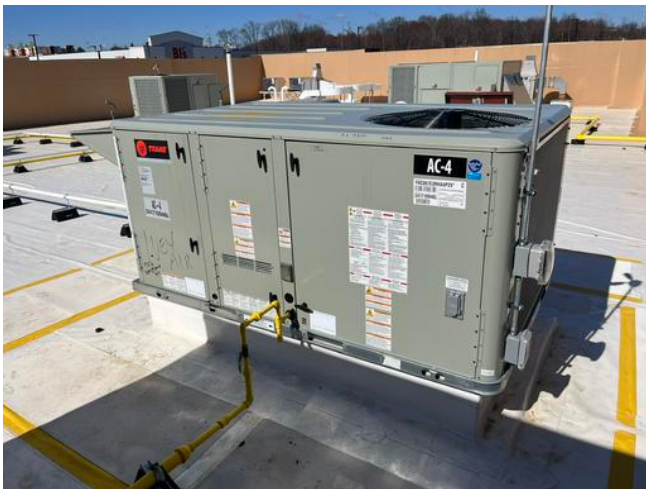
IMG_7433

#11 [UNIT 524] [NEW] Equipment economizers.

AC4 outside air damper is not communicating with controller. All wires appear to be landed, and no error code is present on controller. Outside air damper had to be set manually.

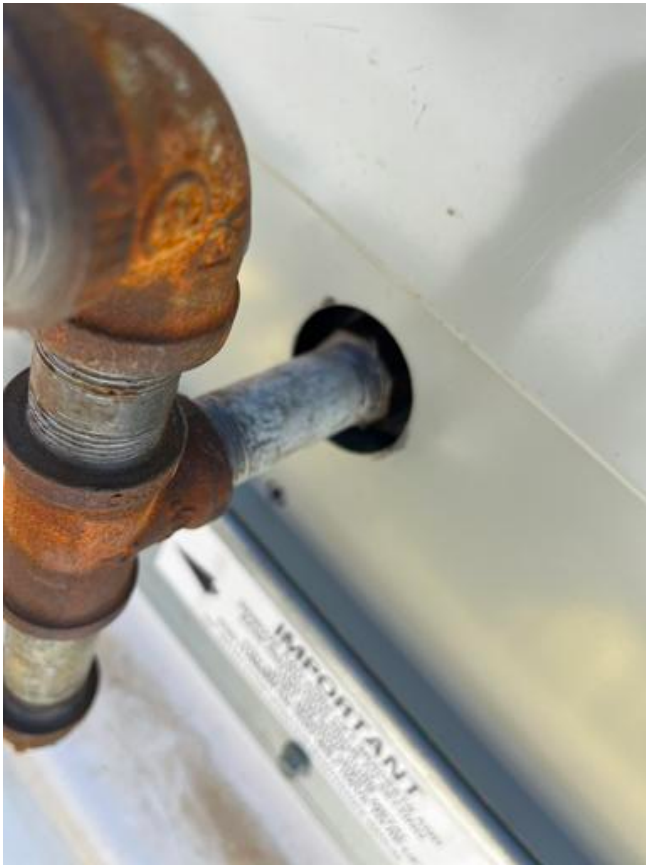
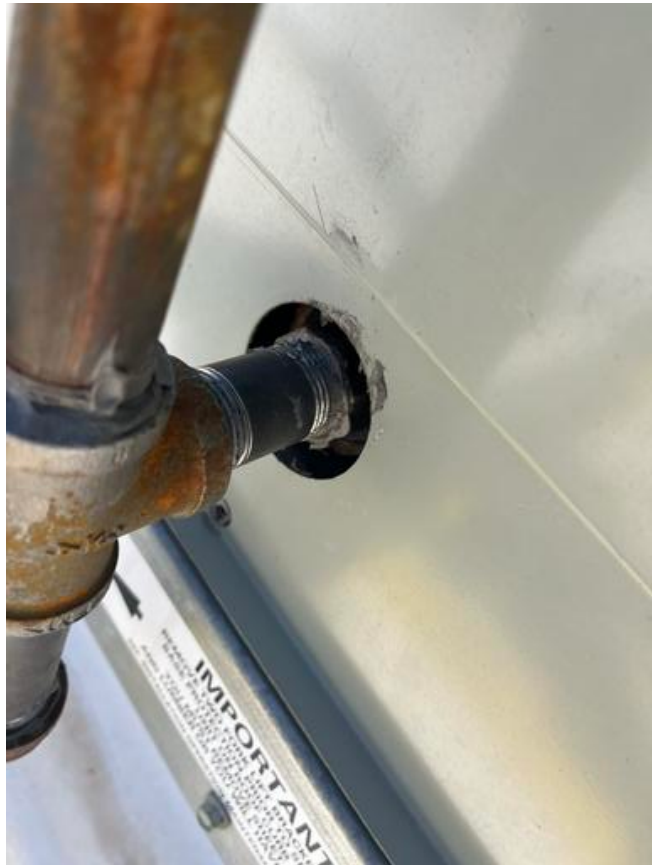
#10 [UNIT 514] [NEW] Equipment gas piping.

AC1 & AC3 are missing gas piping grommet.

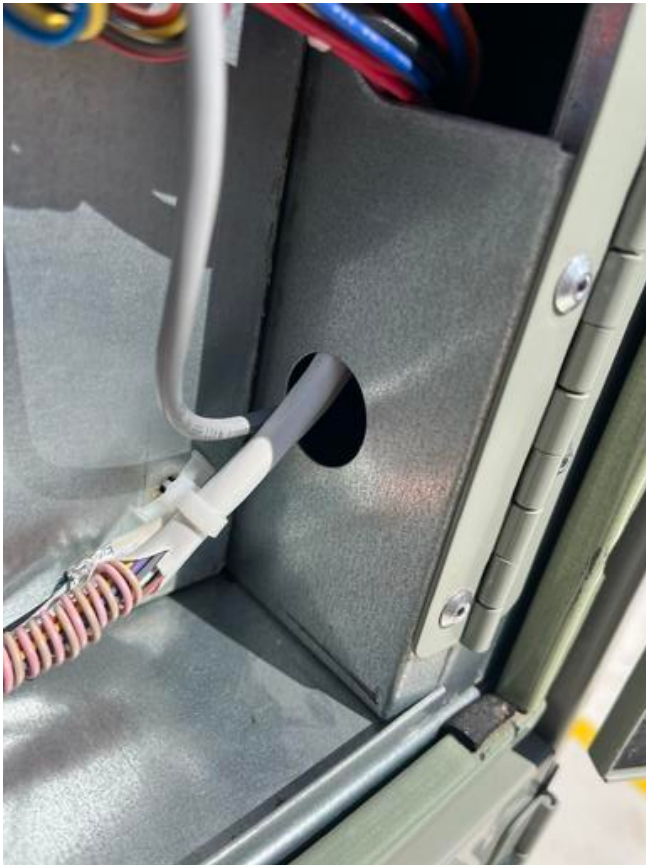
IMG_7386

#9 [UNIT 505] [NEW] Equipment wiring portals.

AC2 is missing a low voltage
wiring grommet

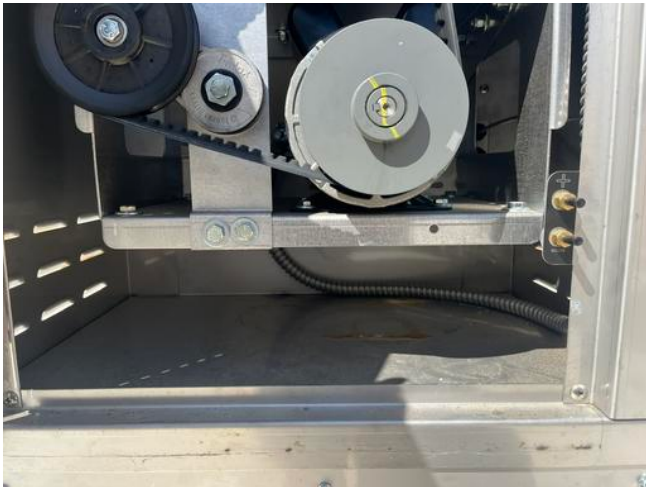
IMG_7375

#8 [EXHA 503] [NEW] Exhaust fan spare belt.

EF1 does not have a spare belt.

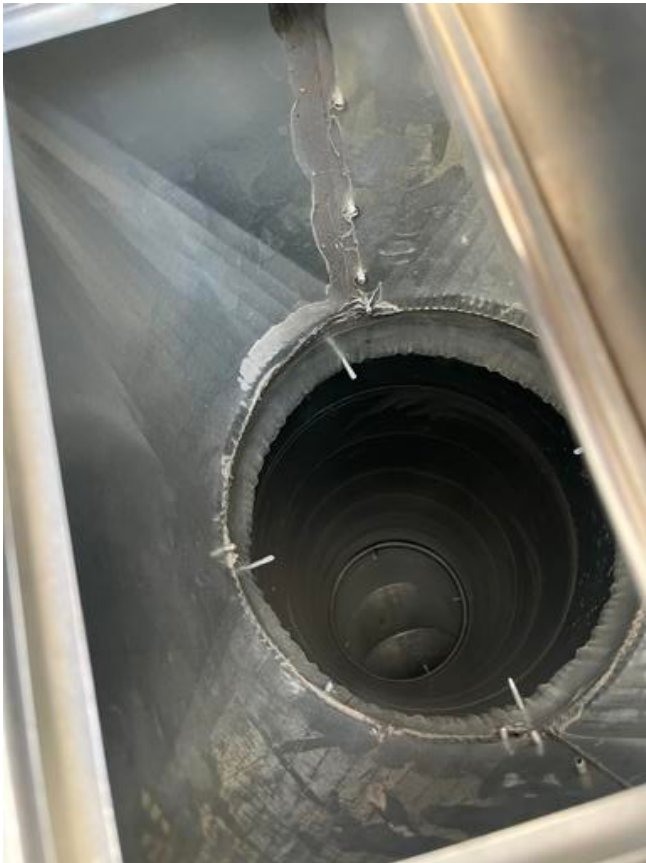
IMG_7378

#7 [EXHA 500] [NEW] Restroom rectangular duct riser.

EF3 plans call for a rectangular duct with liner to be installed. Mechanical installed spiral duct.
