**National TAB
1329 E. KEMPER ROAD
SUITE 4210
CINCINNATI, OH 45246**

**Report: Final TAB Report
Function: Test, Adjust, & Balance
Date: 11/09/2022**

PROJECT
11-07 FAMILY DOLLAR - CHARLESTON, MO
351 EAST MARSHALL ST
CHARLESTON, MO 63834

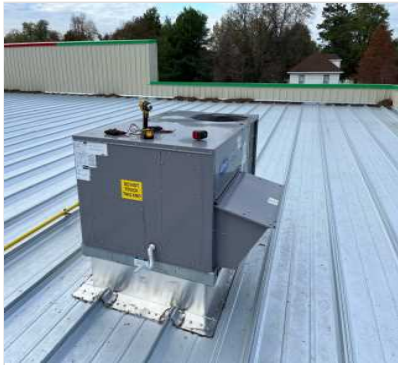
RTU-1

Asset: RTU1

AREA:STORAGE

Test Data		
	Design	Actual
SF CFM	1400	1412
SF RPM	-	1447
RA CFM	1250	1251
OA CFM	150	161
RL Voltage	-	213
RL Amperage	-	6.6
SF Rotation	-	CW, CORRECT
Min OA Damper Position	-	0.5"
Min OA Damper Type	-	ECONOMIZER

Performance Data		
	Design	Actual
MA Plenum SP	-	-0.20"
Fan Suction SP	-	-0.38"
Fan Discharge SP	-	0.22"
Total ESP	1.0"	0.42"
Fan Total SP	-	0.60"

General		
	Design	Actual
Fan Rotation Correct	-	YES
Unit Filters Clean	-	YES
Condensate Drain Installed	-	YES

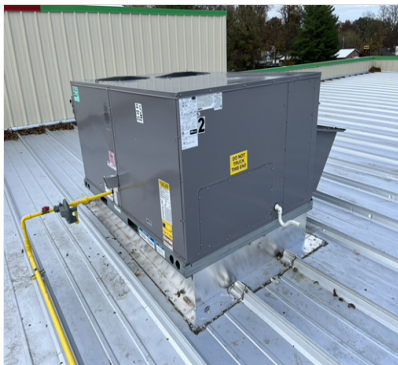
RTU-2

Asset: RTU2

AREA:WEST SALES

Test Data		
	Design	Actual
SF CFM	2800	2761
SF RPM	-	771
RA CFM	2150	2105
OA CFM	650	656
RL Voltage	-	213/212/212
RL Amperage	-	4.8/4.8/4.8
SF Rotation	-	CCW, CORRECT
Min OA Damper Position	-	0.375"
Min OA Damper Type	-	ECONOMIZER

Performance Data		
	Design	Actual
MA Plenum SP	-	-0.49"
Fan Suction SP	-	-0.71"
Fan Discharge SP	-	0.18"
Total ESP	1.0"	0.67"
Fan Total SP	-	0.89"

General		
	Design	Actual
Fan Rotation Correct	-	YES
Unit Filters Clean	-	YES
Condensate Drain Installed	-	YES

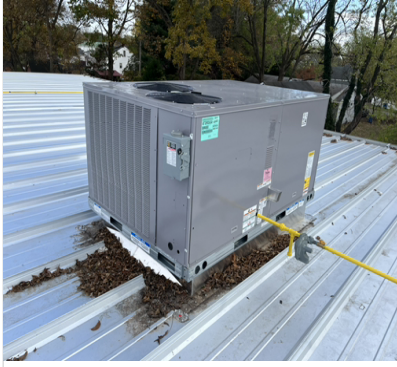
RTU-3

Asset: RTU3

AREA:EAST SALES

Test Data		
	Design	Actual
SF CFM	2800	2721
SF RPM	-	779
RA CFM	2150	2106
OA CFM	650	615
RL Voltage	-	212/212/213
RL Amperage	-	5.2/5.2/5.2
SF Rotation	-	CCW, CORRECT
Min OA Damper Position	-	0.375"
Min OA Damper Type	-	ECONOMIZER

Performance Data		
	Design	Actual
MA Plenum SP	-	-0.45"
Fan Suction SP	-	-0.67"
Fan Discharge SP	-	0.28"
Total ESP	1.0"	0.73"
Fan Total SP	-	0.95"

General		
	Design	Actual
Fan Rotation Correct	-	YES
Unit Filters Clean	-	YES
Condensate Drain Installed	-	YES

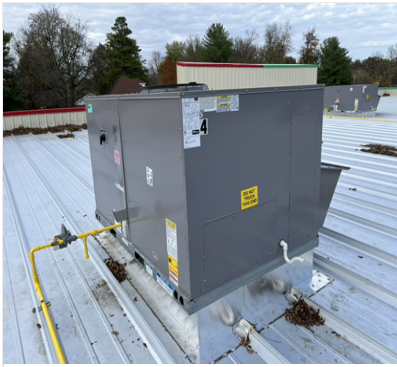
RTU-4

Asset: RTU4

AREA:SOUTH SALES

Test Data		
	Design	Actual
SF CFM	3500	3544
SF RPM	-	875
RA CFM	2725	2756
OA CFM	775	788
RL Voltage	-	212/212/212
RL Amperage	-	5.9/5.9/5.9
SF Rotation	-	CCW, CORRECT
Min OA Damper Position	-	0.75" HI / 1.25" LOW
Min OA Damper Type	-	ECONOMIZER

Performance Data		
	Design	Actual
MA Plenum SP	-	-0.74"
Fan Suction SP	-	-1.01"
Fan Discharge SP	-	0.31"
Total ESP	1.0"	1.05"
Fan Total SP	-	1.32"

General		
	Design	Actual
Fan Rotation Correct	-	YES
Unit Filters Clean	-	YES
Condensate Drain Installed	-	YES

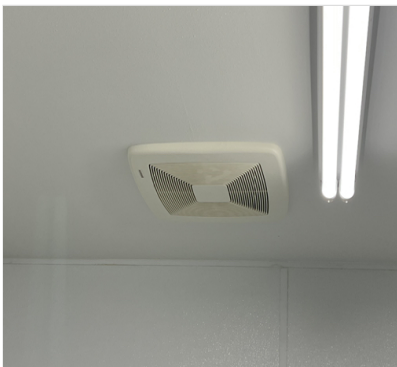
EF-1

Asset: EF1

AREA:RESTROOM

Design	Actual
CFM	75	101
Fan RPM	-	DD
Fan Rotation	-	CCW, CORRECT
Motor RPM	-	DD
System SetPt	-	SINGLE SPEED
RL Voltage	-	122
RL Amperage	-	0.17
Total ESP	0.25"	[1]
Fan Inlet SP	-	ATM
Fan Discharge SP	-	[1]

Notes:[1] Ductwork located above hard ceiling, unable to take static pressure.

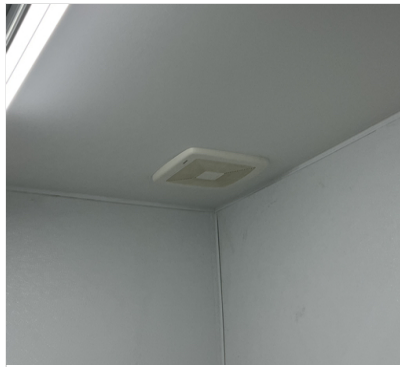
EF-2

Asset: EF2

AREA:RESTROOM

Test Data		
	Design	Actual
CFM	75	99
Fan RPM	-	DD
Fan Rotation	-	CCW, CORRECT
Motor RPM	-	DD
System SetPt	-	SINGLE SPEED
RL Voltage	-	122
RL Amperage	-	0.18
Total ESP	0.25"	[1]
Fan Inlet SP	-	ATM
Fan Discharge SP	-	[1]

Notes:[1] Ductwork located above hard ceiling, unable to take static pressure.
