**Report: TAB**

**Function: Test, Adjust, & Balance**

**Date: 09/05/2024**

**09-02-24 CHIPOTLE #04-4316 OAKHURST  
(OAKHURST, CA)**

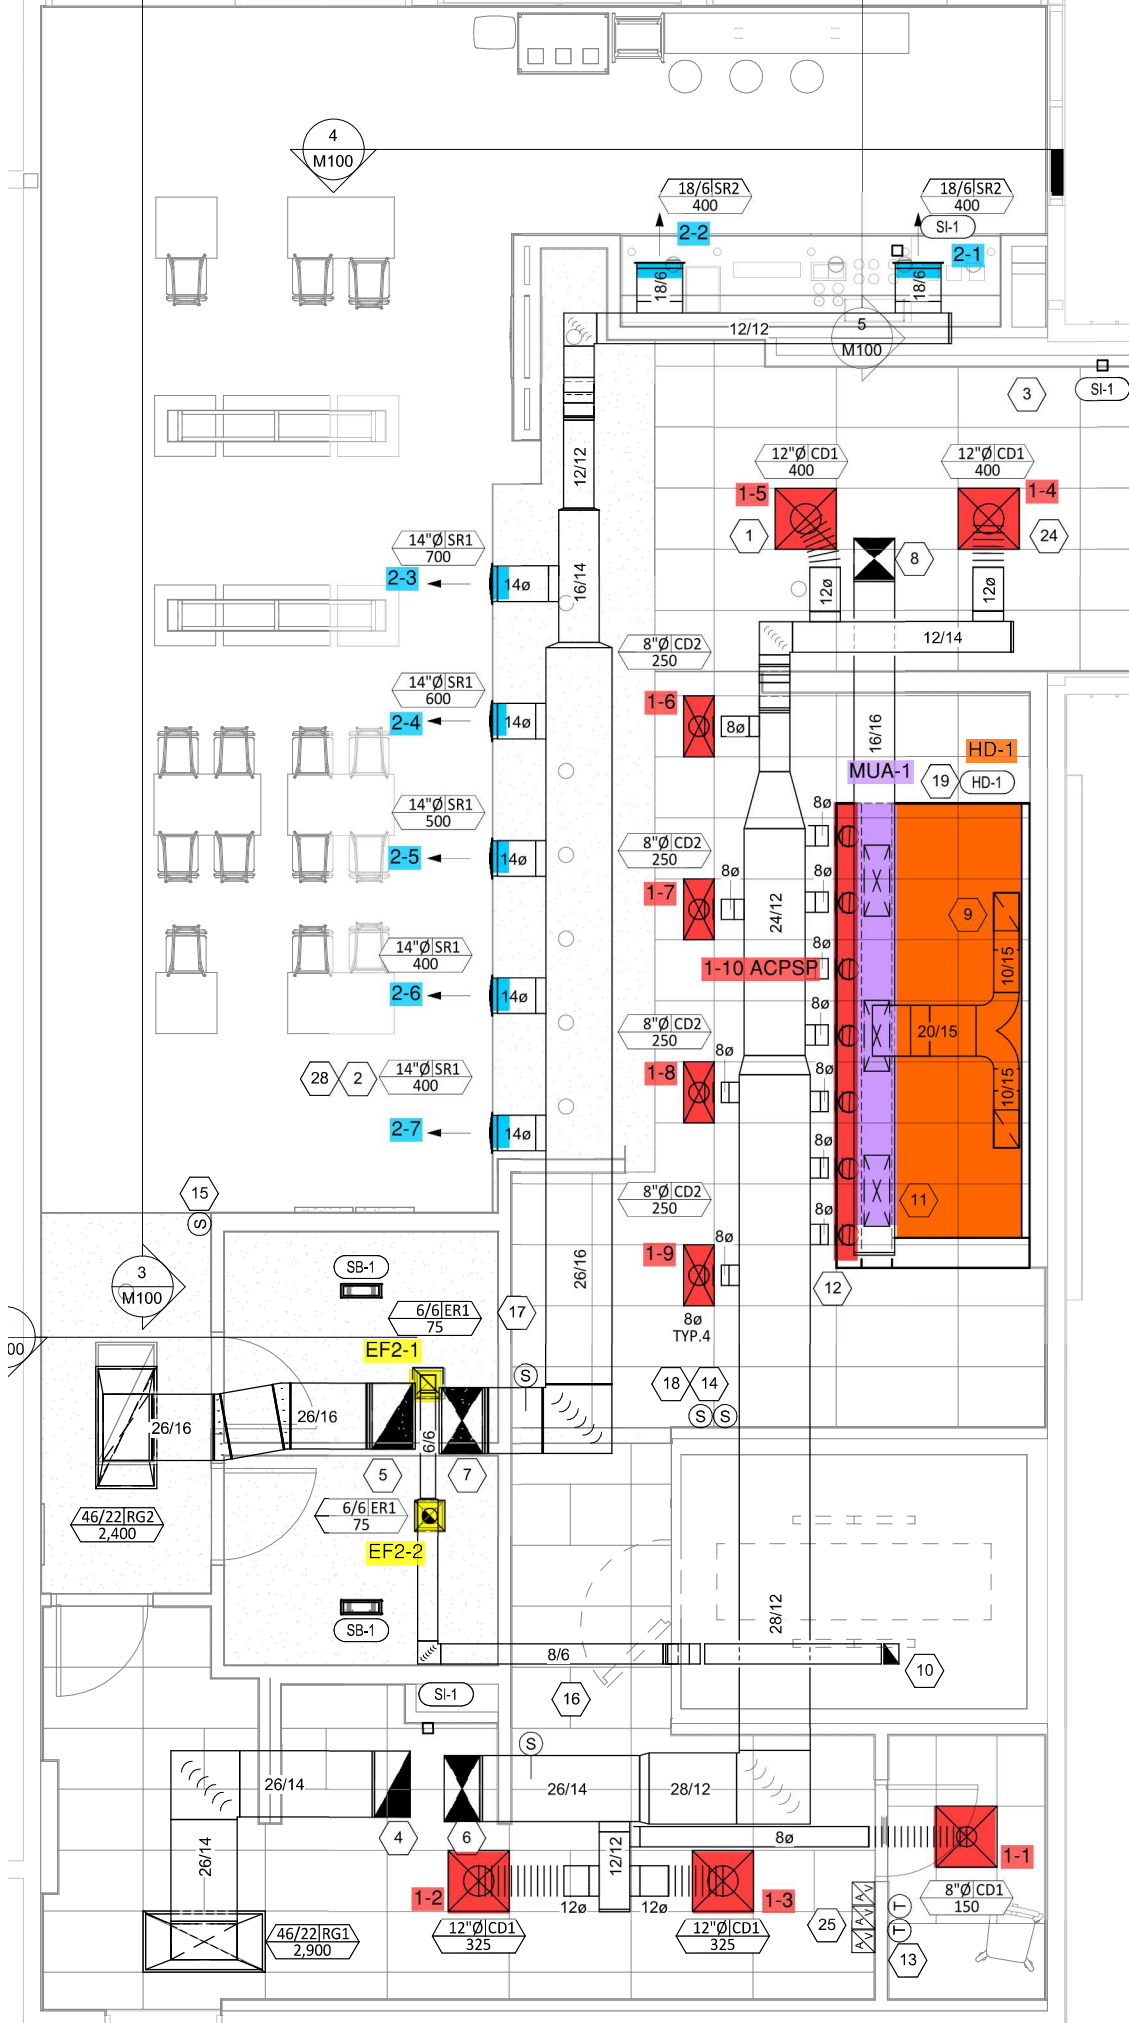
Test Data Supply		
	Design	Actual
Total AK Area	15.25	15.25
Kv factor (Vel)	0.87	0.87
Num of Readings	-	12
Reading1 FPM	-	168
Reading2 FPM	-	120
Reading3 FPM	-	129
Reading4 FPM	-	143
Reading5 FPM	-	162
Reading6 FPM	-	122
Reading7 FPM	-	126
Reading8 FPM	-	153
Reading9 FPM	-	151
Reading10 FPM	-	133
Reading11 FPM	-	124
Reading12 FPM	-	185
Ave FPM(corr)	-	143
CFM	1950	1897
