**Report: Test and Balance**

**Date: 6/5/2018**

## FREDDY'S - 135TH STREET OP, KS (FULL BALANCE) [OPEN STORE]

Project: FREDDY'S - 135TH STREET OP, KS (FULL BALANCE) [OPEN STORE]

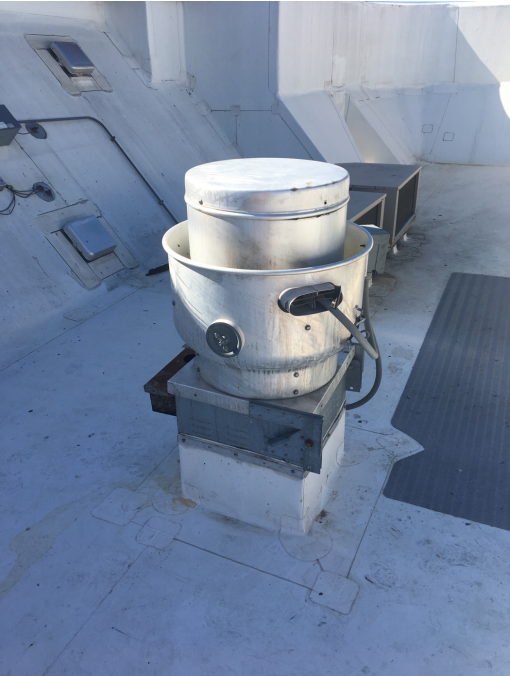
KEF-1

Test Data		
	Design	Actual
CFM	1083	923
Fan RPM	1290	1376
Fan Rotation	-	CW
Motor RPM	-	1740
RL Voltage	-	118
RL Amperage	-	3.6
Suction ESP	-	-0.56
Discharge ESP	-	ATM
Total ESP	0.67"	0.56
Brake Horse Power	-	0.20

Notes: [1]MOTOR PULLEY MAXIMIZED

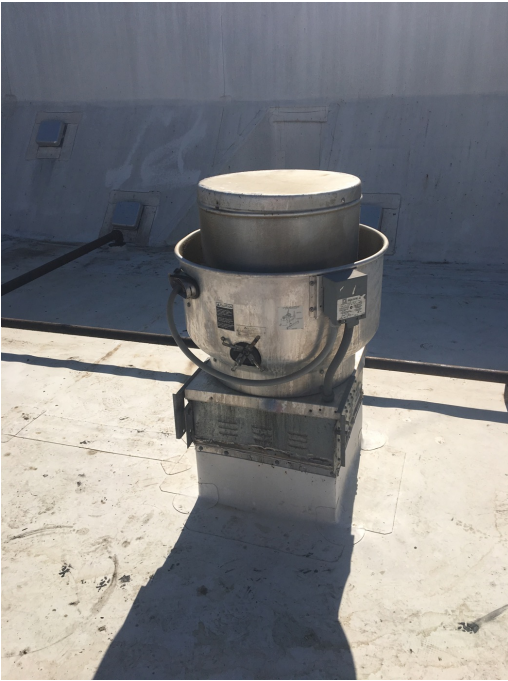
KEF-2

Test Data		
	Design	Actual
<b>CFM</b>	2200	2403
<b>Fan RPM</b>	1417	1400
<b>Fan Rotation</b>	-	CW
<b>Motor RPM</b>	-	1740
<b>RL Voltage</b>	-	118
<b>RL Amperage</b>	-	7.1
<b>Suction ESP</b>	-	-0.34
<b>Discharge ESP</b>	-	ATM
<b>Total ESP</b>	0.54"	0.34
<b>Brake Horse Power</b>	-	0.53

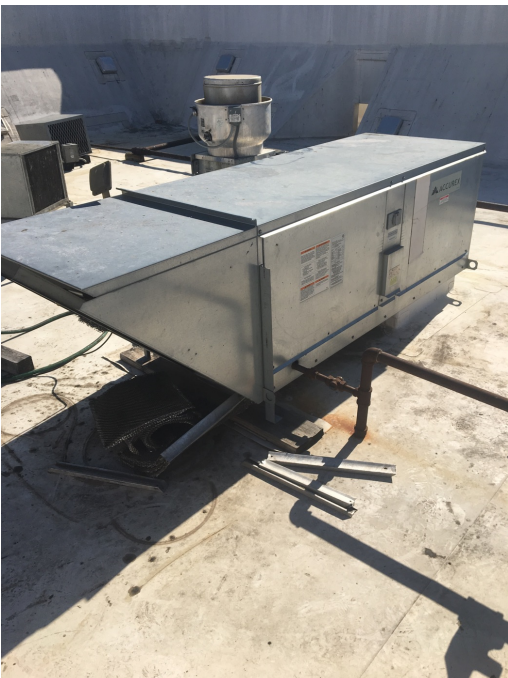
MAU-1

Test Data		
	Design	Actual
<b>CFM</b>	2340	1845
<b>SF RPM</b>	1359	1412
<b>Motor RPM</b>	-	1760
<b>RL Voltage</b>	-	200/201/200
<b>RL Amperage</b>	-	2.3/2.0/2.0
<b>Total ESP</b>	1.177"	[2]
<b>Fan Discharge SP</b>	-	[2]

Notes: [1] NOT ABLE TO GET TOTAL ESP DUE TO THE STORE BEING OPEN  
15.5X20  
initial cfm 1665

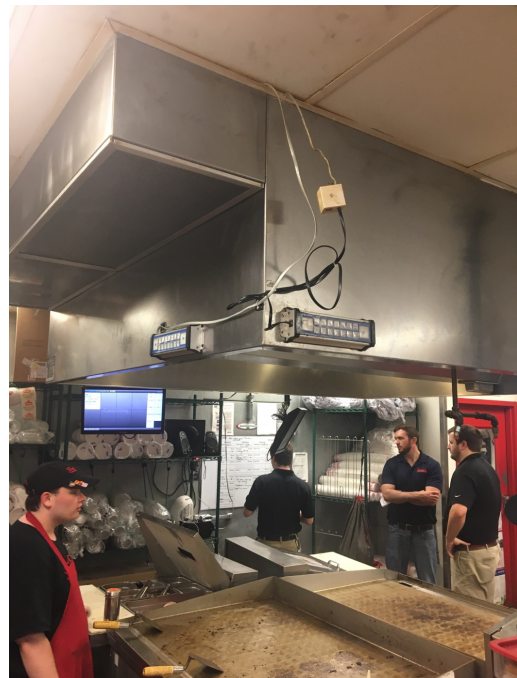
HD-2

Notes: PHYSICALLY UNABLE TO DROP PSP  
[1] LABEL IS WORN OFF  
[2] NOT ABLE TO DO THE SMOKE TEST DUE TO THE STORE BEING OPEN  
[3] NOT ABLE TO TAKE TEMPERATURE AT THE HOOD

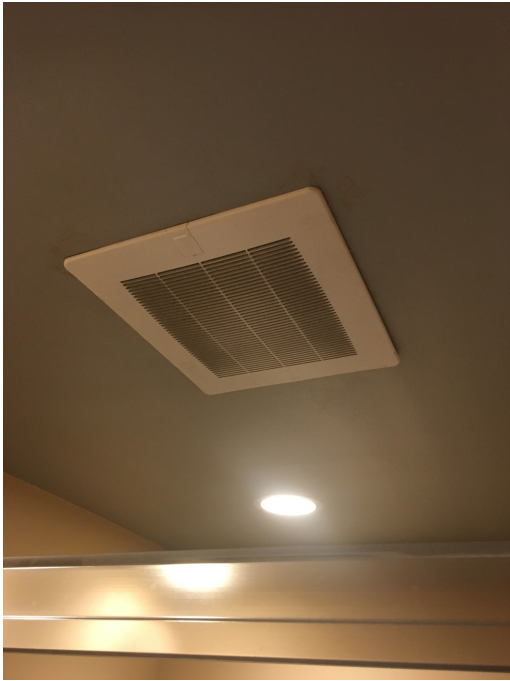
EF-1,2

EF1 and EF2 were measured by reading each air device with a flow hood. The total airflow for each fan is equivalent to the sum of these readings. Fan speed could not be adjusted without speed controllers to get within +/-10% of design.

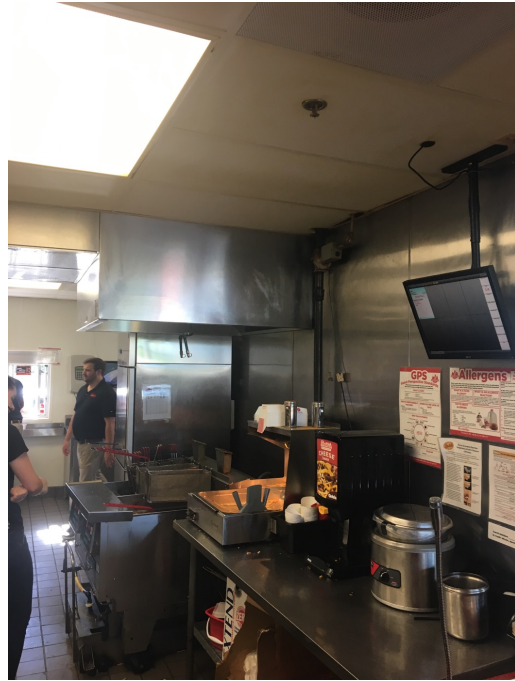
HD-1

Notes: UNABLE TO INCREASE CFM WITHOUT PULLEY CHANGE

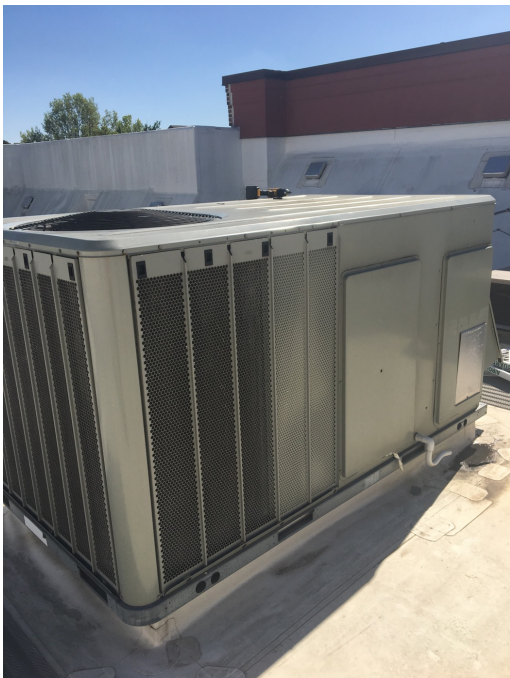
- Notes: [1] OA IS SET TO 25% AS PER REQUEST.  
 [2] OA FILTER IS DIRTY AND IS RESTRICTING OUTSIDE AIR.  
 [3] AIR FLOW TESTING WAS DONE WITHOUT FINAL FILTES

Info Only	Final Filters on RTUs are dirty. They will be replaced during a Renew Visit.
Info Only	RTU-2 (Dining) Outside air filter was clogged. It was later cleaned in the Renew program.
Info Only	RTU-2 (Dining) is 89% of design. It is slightly low on airflow. With a clean evaporator coil will bring the airflow in design. It will take a few cleanings to get to this point.
Info Only	RTU 2 & 3 evaporator coil were found dirty and later cleaned in the Renew program.
Info Only	MAU filters are damaged, and one is missing. The Renew program will order and replace filters.
Info Only	KEF-1 (Fryer) is at 85% design airflow. This is not impacting hood performance, so no further action is required.

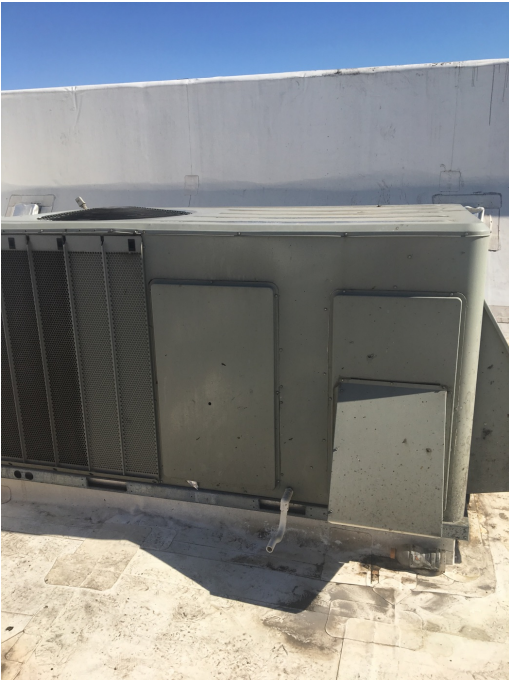
PRIORITY (HIGH/LOW/INFO ONLY)	
HIGH	RTU-3 (Kitchen) is 45% of design (1364 CFM out of design of 3000 CFM). Significant build up of grime noted on the blower. First step is to have a mechanical clean the blower fan (NTAB is coordinating). Then National TAB will re-measure airflow. The next step would be, if target airflow is not meet by the cleaning, adding an additional return diffuser to the return duct to increase airflow. There are only (2) 12" flex duct returns with sharp transition out of bottom of unit which is causing restriction.
LOW	RTU-3 Barometric relief is not installed properly and is introducing outside air. Sheet metal will be installed over opening at time of next Renew.
LOW (Operations to monitor)	RTU- 1 & 2 (Dining) creates drafting in the space due the distance between the dining tables and the diffusers. The ceiling is lower than the typical Freddy's. Spoke to manager and if customer complaints arise we recommend installing side wall diffusers on to the main duct relieve this drafting. Adding these diffusers will lower the airflow at the rround diffusers that is causing the drafting in the dining area.

- Notes:
- [1] SECOND OA DAMPER 13X11 (122 CFM)
  - [2] THE RETURN DUCTING IS NOT OF SAFFICIENT SIZE WHICH AFFECTS THE AIR FLOW TO THE RTU AND BUILDING.
  - [3] AIR FLOW TESTING WAS DONE WITHOUT FINAL FILTERS
  - [4] CD-6 WAS NOT INSTALLED
  - [5] OA IS SET TO (25%) AS PER REQUEST.
  - [6] OA ECONOMIZER NOT FUNCTIONAL

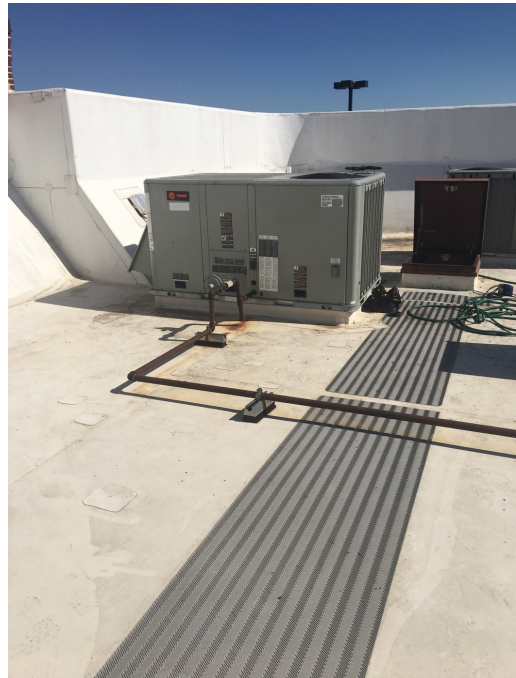
RTU-1

- Notes: [1] SECOND OA DAMPER 13X11 (150 CFM)  
[2] OA IS SET TO 25% AS PER REQUEST  
[3] AIR FLOW TESTING WAS DONE WITHOUT FINAL FILTES

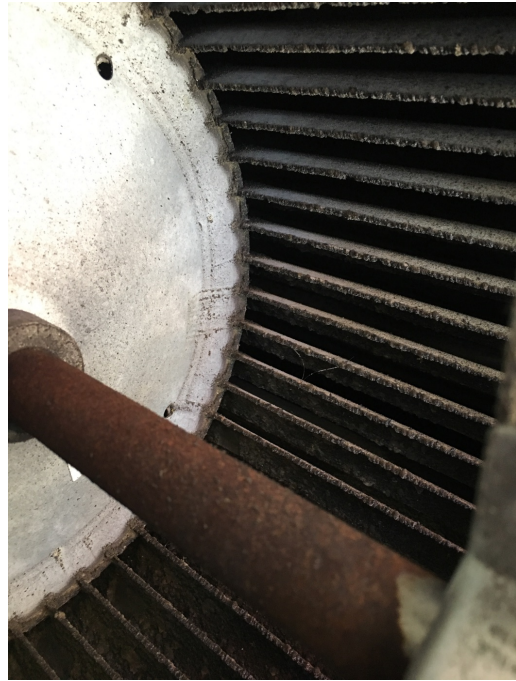
RTU-3 FAN IS MAKING NOISE AND IT COULD BE THE BEARINGS ON THE FAN.
