PlanGrid Task Report - Mar 6, 2025

L05434_Westerville FSU (OH)

680 Polaris Parkway, Westerville, Ohio

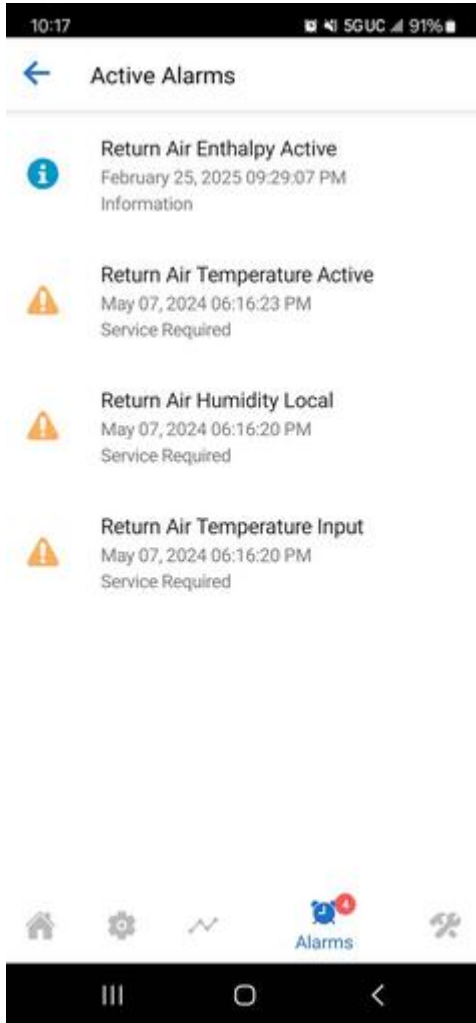
Screenshot_20250306_101719_Symbio

#164 [CNTL 016] [NEW] CRITICAL – Sensor communication.

(Averaging) Sensors not communicating properly, check for correct terminations, correct dip switch / jumper settings, and shorts to ground on AC#3. Currently AC#3 is using return duct temperature sensor to control unit.

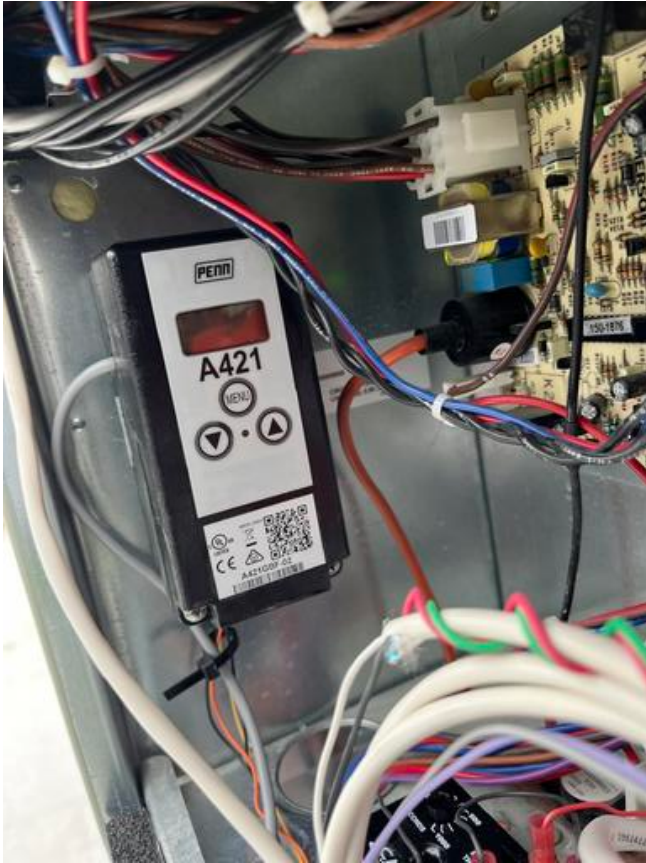
IMG_9601

#163 [UNIT 504] [NEW] Equipment Fresh Air Tempering.

Fresh air tempering Penn controller is not powered on AC#4. Off should be set to 67 degrees, On should be set to 62 degrees, with SF turned to 0 for when the Penn controller gets power.

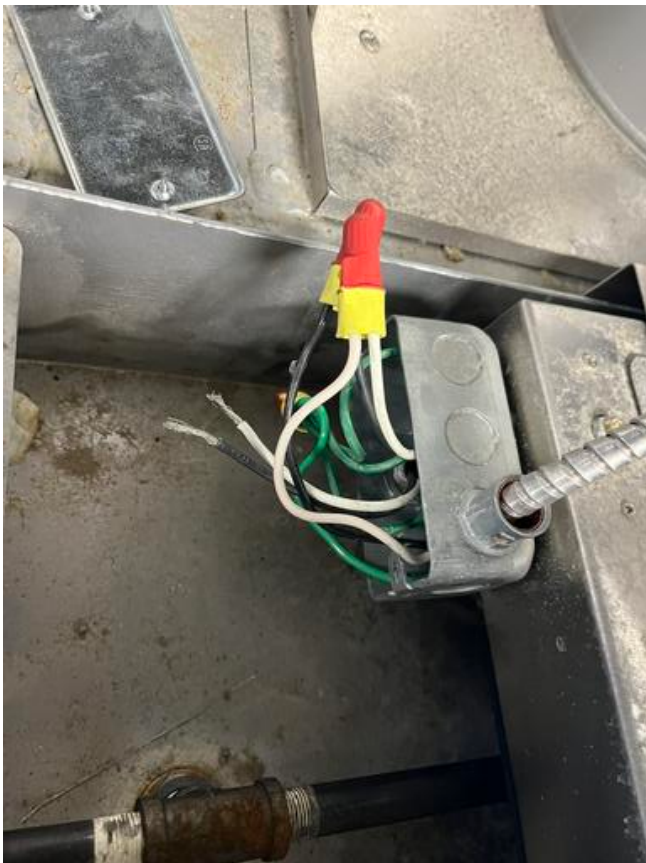
IMG_9551

#161 [HOOD 004] [NEW] CRITICAL - CaptureJet speed controller.

CaptureJet or Side
CaptureJet speed controller
not wired.

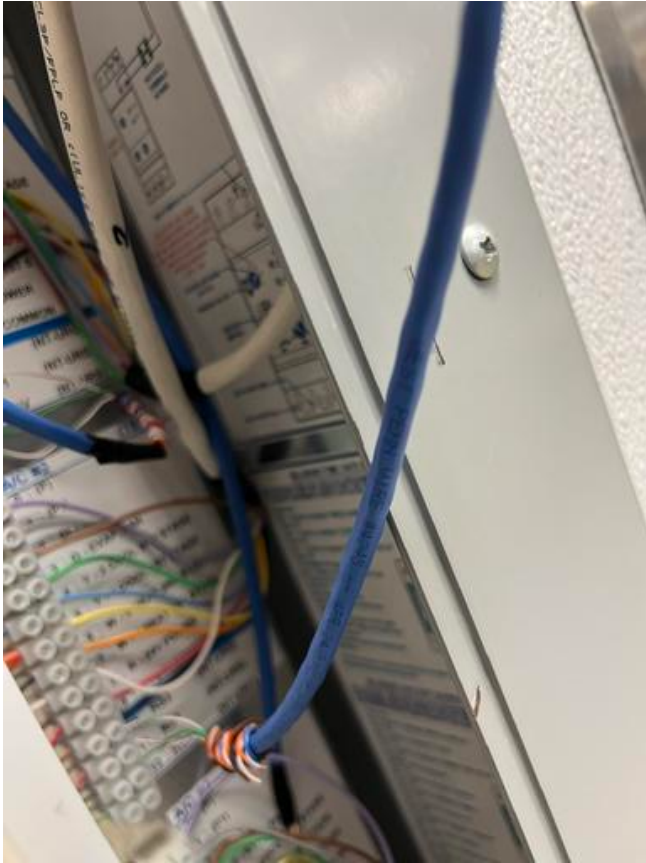
IMG_9539

#159 [CNTL 003] [NEW] CRITICAL – Wiring specifications.

Thermostat cabling is not
18awg 12 conductor
ConnectAir W1812C-2148
and / or sensor cable is not
ConnectAir W221P-2003NT
cable. Full spec and ordering
at: NetworkThermostat.com/
CFA

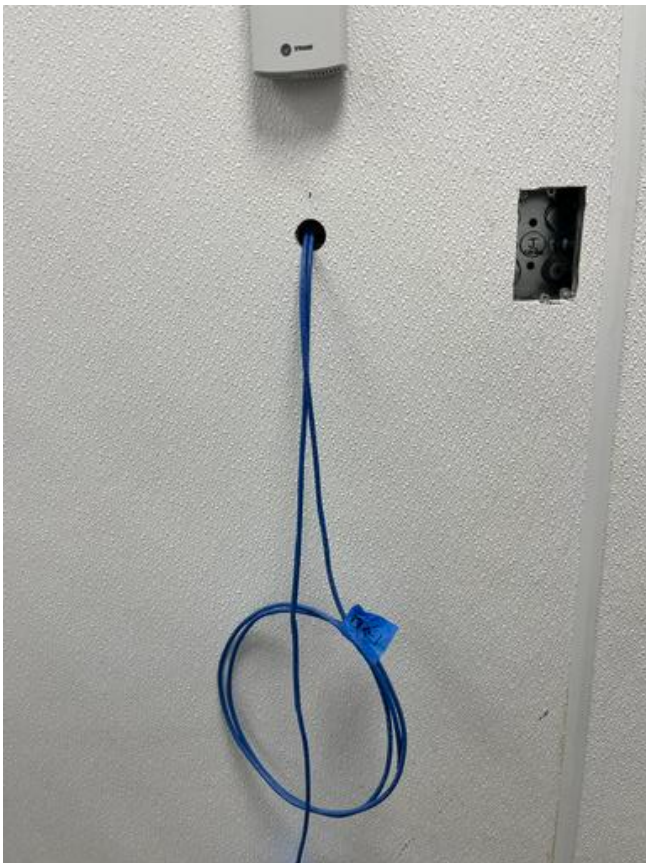
IMG_9541

#158 [CNTL 499] [NEW] CRITICAL (MISC) – Thermostat sensor not installed

Thermostat sensor not installed outside office on AC#4.

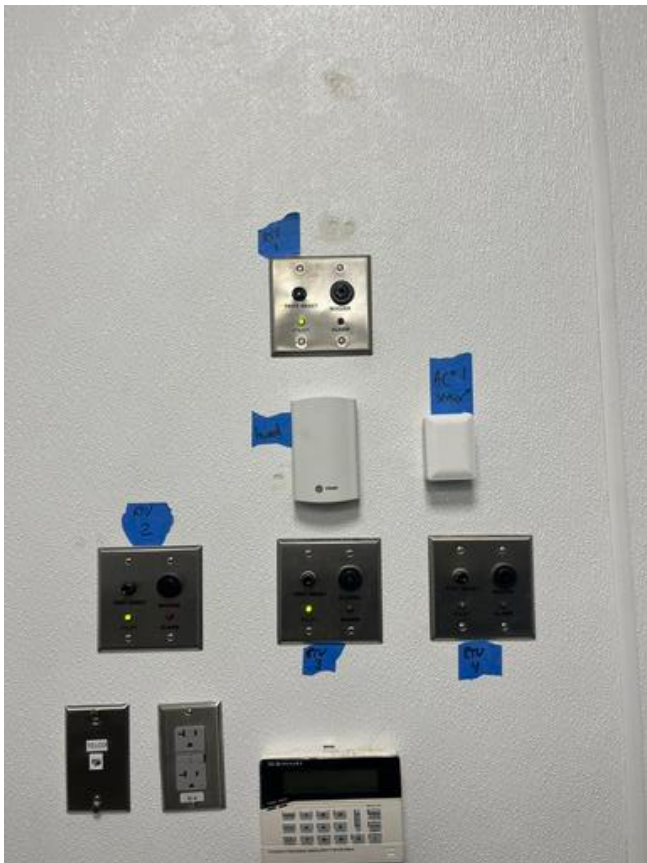
IMG_9531

#156 [CNTL 508] [NEW] Controls labeling.

Label all sensors,
humidistats, thermostats,
and smoke annunciators.

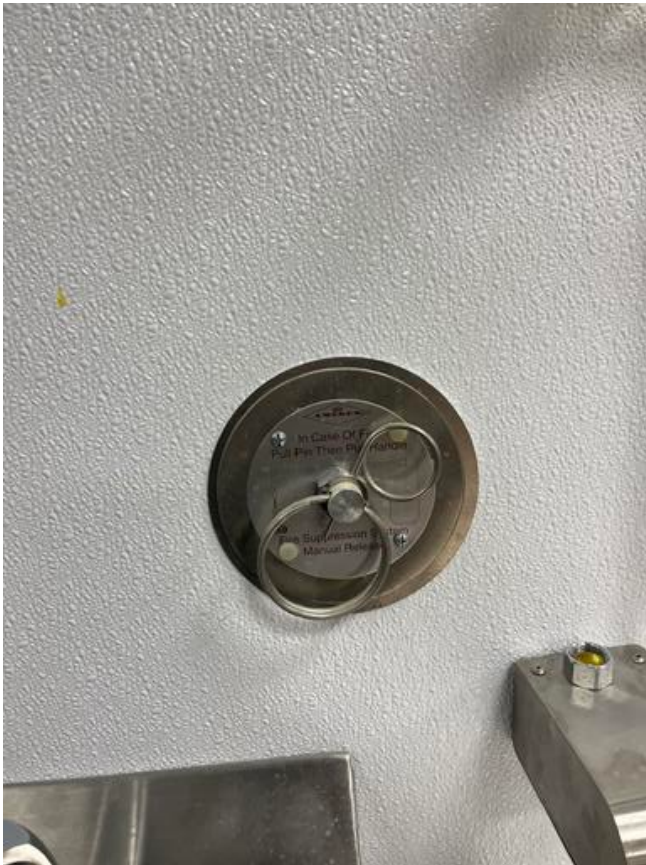
IMG_9552

#155 [CNTL 509] [NEW] Ansul pull labeling.

Label all ansul pull stations
for which hoods they serve.

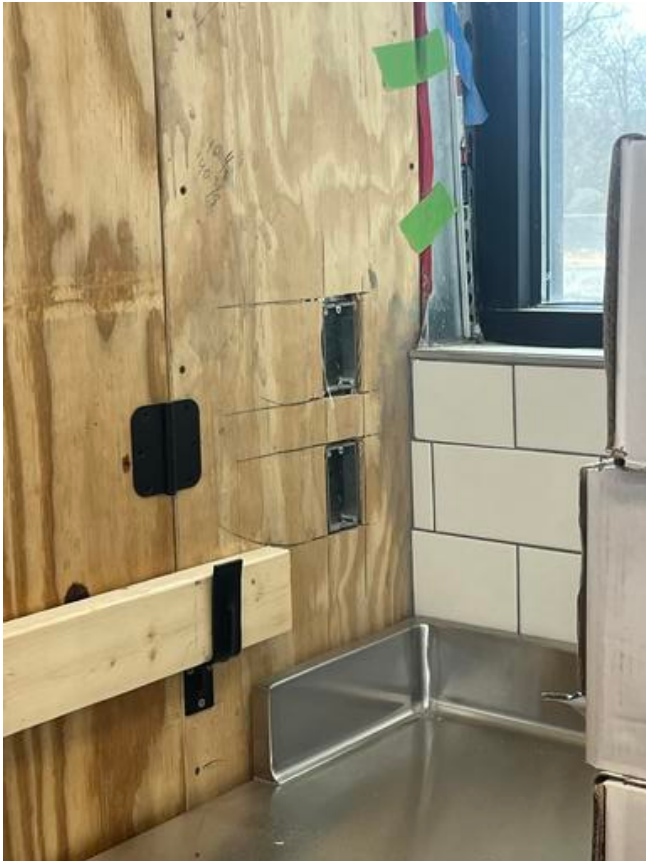
IMG_9530

#150 [CURT 503] [NEW] Air curtain door switches.

Air curtain magnetic door switches are not installed correctly or not properly controlling mode activation in Auto at time of TAB inspection.

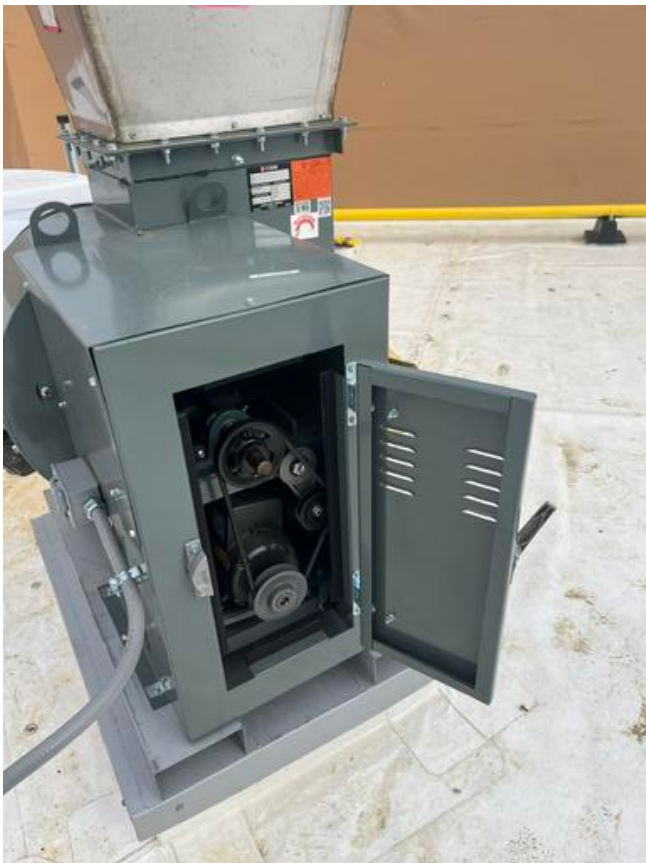
IMG_9583

#149 [EXHA 503] [NEW] Exhaust fan spare belt.

Exhaust fan #1 does not have factory provided spare belt.

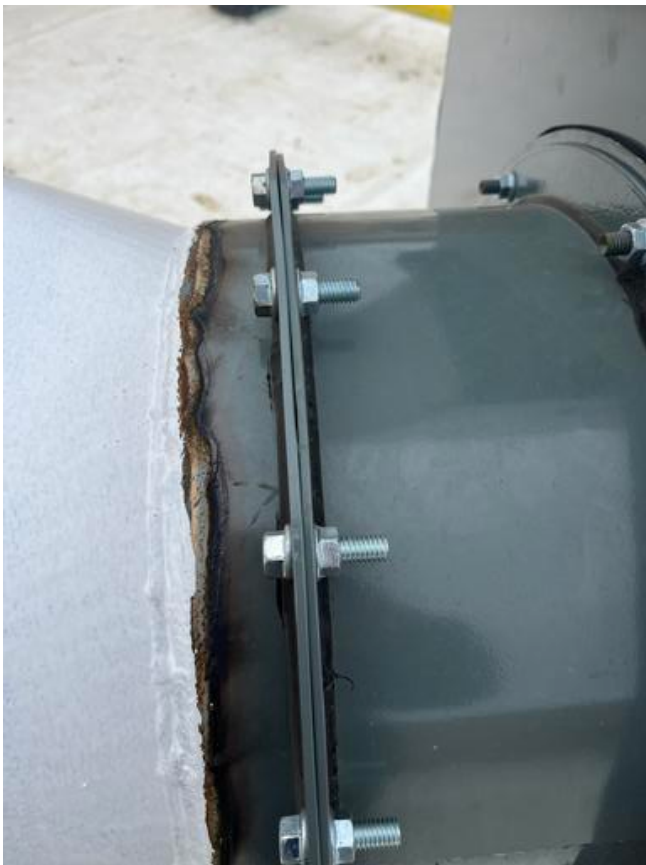
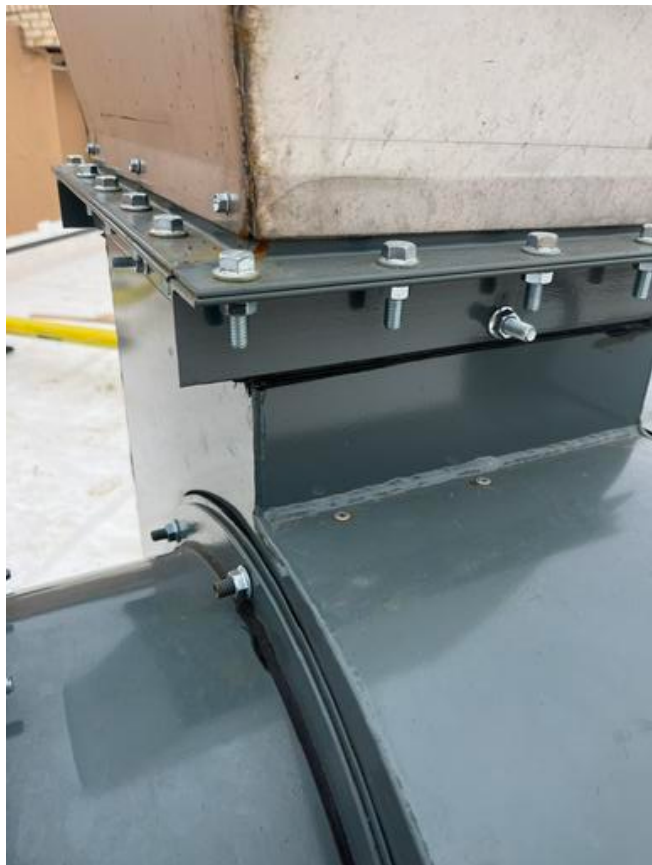
#148 [EXHA 505] [NEW] Exhaust fan 1500F gasketing.

Exhaust fan is missing
1500°F rated field provided/
installed gasketing at intake
and/or discharge companion
flange connections.

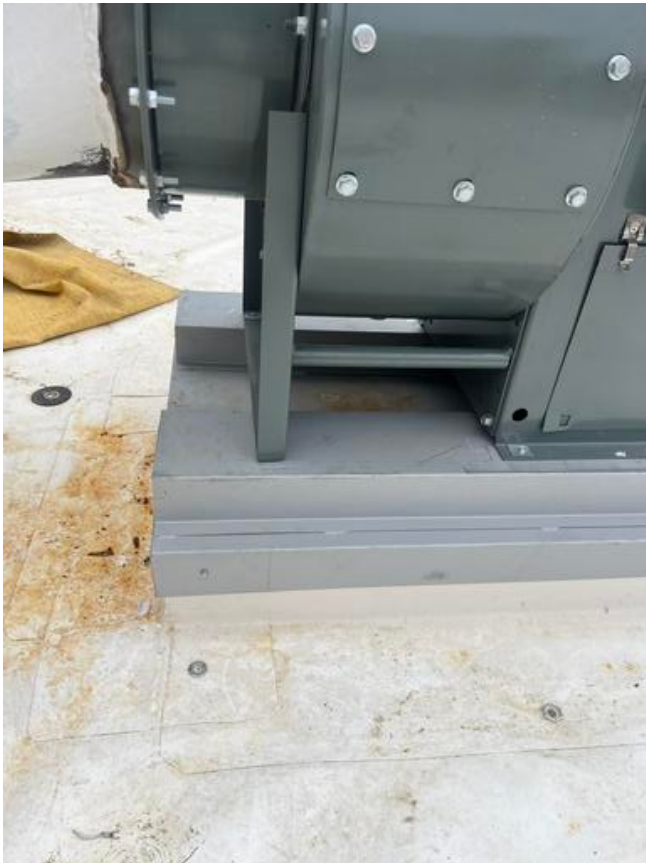
IMG_9566

#147 [EXHA 507] [NEW] Exhaust fan drain line.

Exhaust fan drain is not installed, pitched, or routed to center of drip guard per detail.

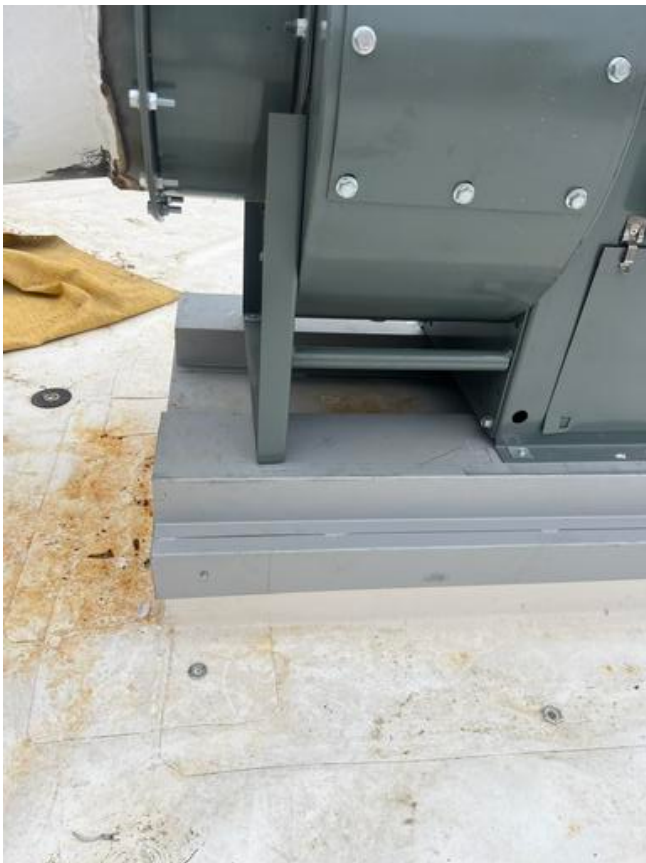
IMG_9566

#146 [EXHA 508] [NEW] Exhaust fan G2 Drip Guard.

Exhaust fan G2 Drip Guard is not installed correctly or is missing.

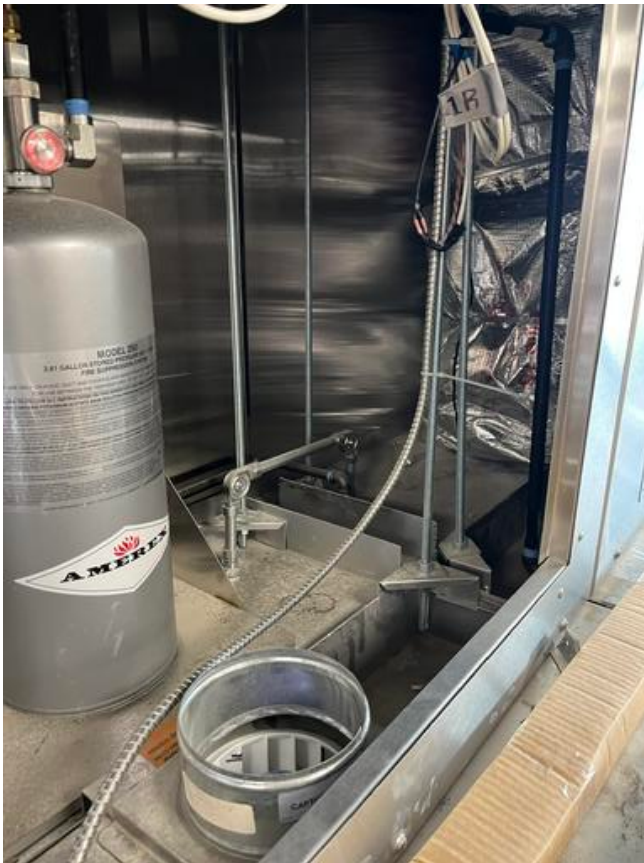
IMG_9550

#144 [HOOD 507] [NEW] CaptureJet piping.

CaptureJet duct is to be hard piped and sealed at seams up to intake grilles. Intake grilles are to remain unobstructed and removable by Operator for cleaning.

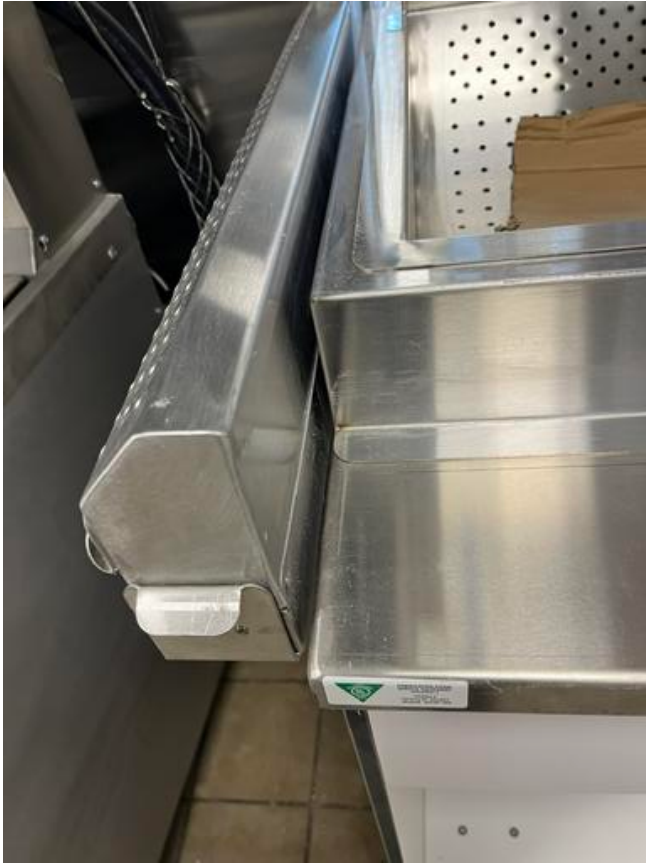
IMG_9545

#143 [HOOD 508] [NEW] Sidejet arm angle bracket.

The Halton supplied angle bracket that connects the integral sidejet arm to the counter is missing or not installed correctly. Secure bracket to arm and bracket to counter underneath removeable fry dump via stainless steel rivets.

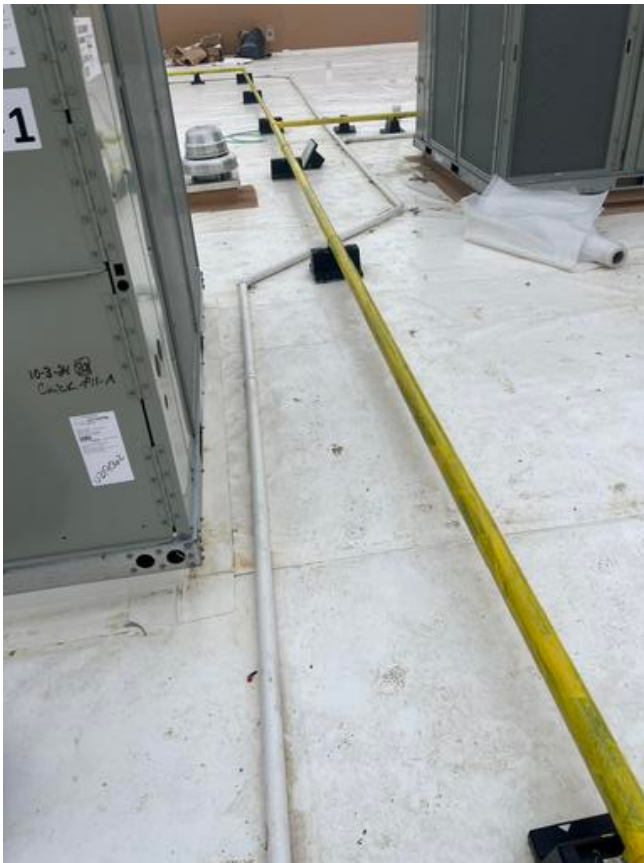
IMG_9565

#141 [UNIT 516] [NEW] Condensate piping pitch.

Equipment condensate piping pitch is not sloped correctly downward away from the unit. No stands installed for condensate piping.

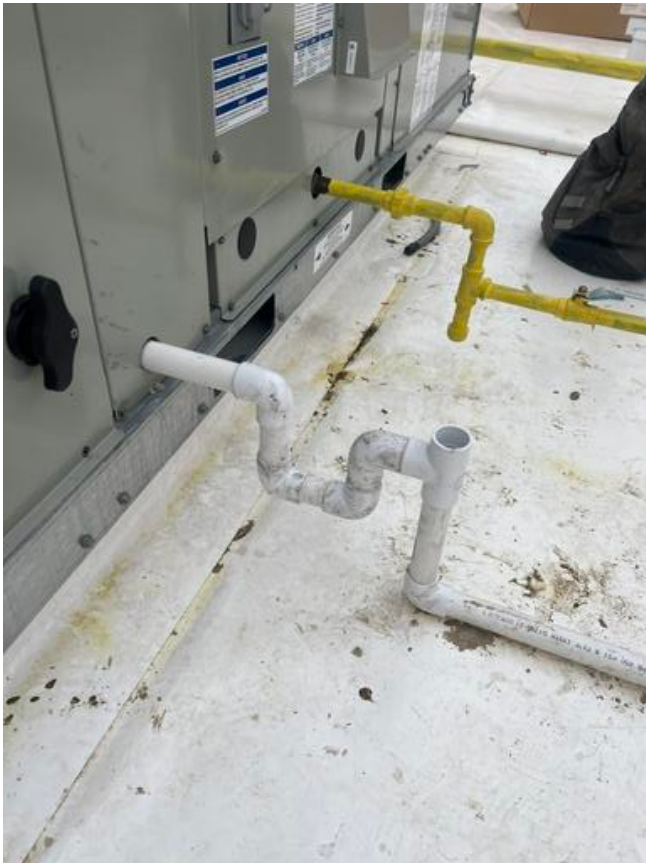
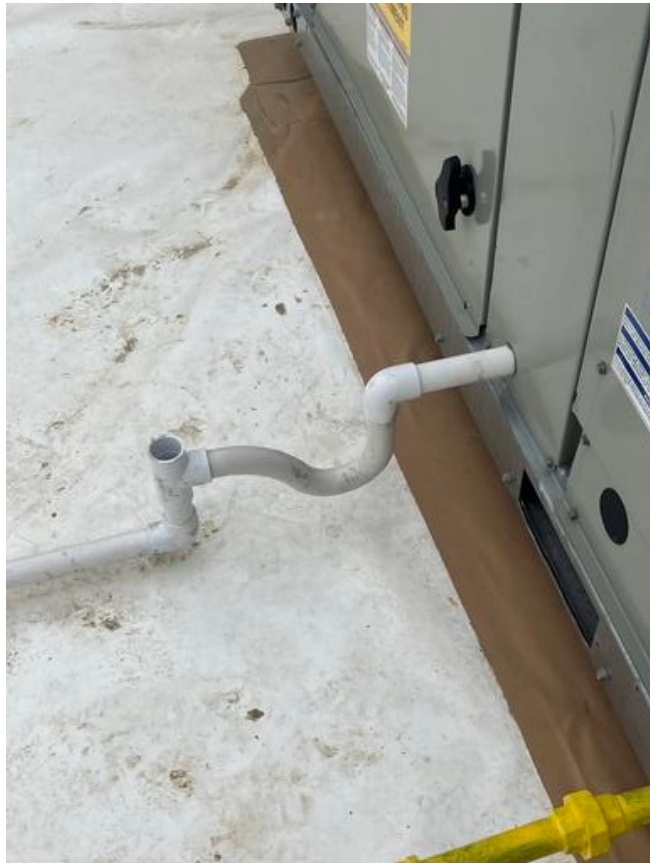
#140 [UNIT 517] [NEW] Condensate piping construction.

Equipment condensate piping or p-trap is not constructed per normal CFA specifications.

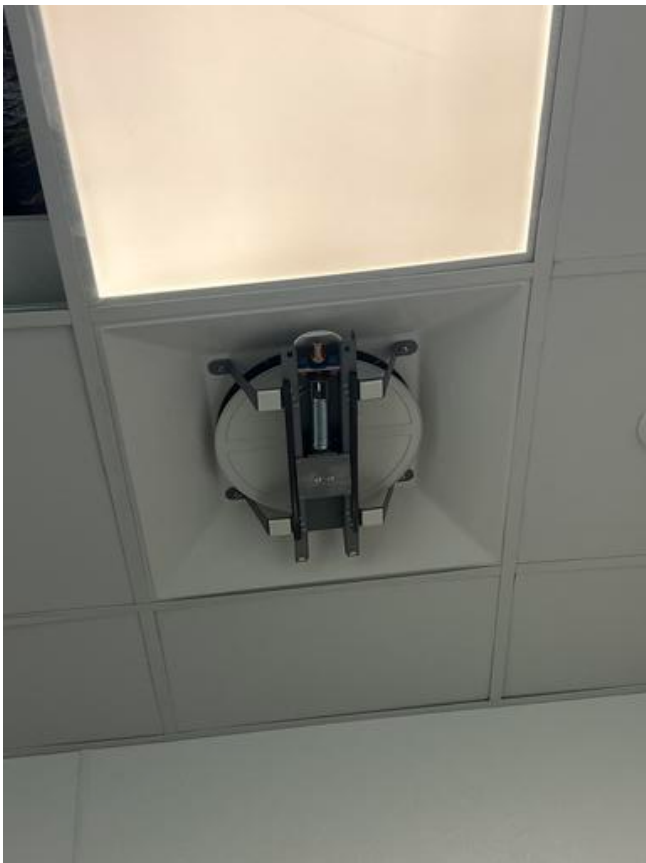
IMG_9540

#139 [DUCT 500] [NEW] Air pattern deflections.

Air pattern deflections are missing on Diffuser 4-4 in office.

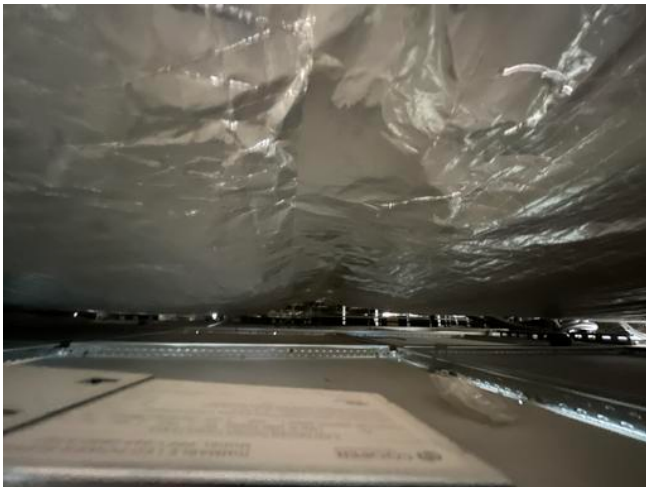
IMG_9553

#138 [DUCT 501] [NEW] Insulation stick pins.

External insulation on bottom of ducts 24" or wider is to be supported by stick pins 18" on center. Cut pins and apply tape or mastic over stick pin washers.
