**Report: TAB REPORT**  
**Function: Test, Adjust, & Balance**  
**Date: 12/09/2024**  
**Completed By: National TAB**

**PROJECT**  
**12-02-24 FREDDY'S SUMMERVILLE, SC**

Charleston Custard, LLC

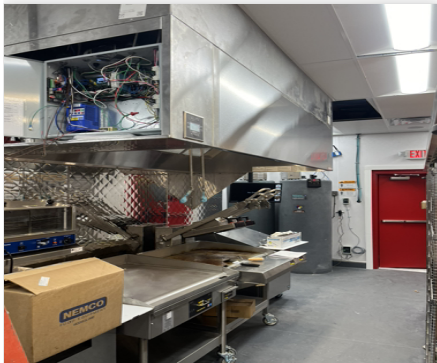
**Issue Name :** HOOD1 / Alarm: Temp Sensor  
**Description :** Hood1 has a alarm flashing on the screen for missing temp. sensor.  
**Created By :** National TAB                      **Assigned To :** National TAB - Dale Wheeler  
**Status :** Open  
**Priority :** Medium                                      **Asset Tag :**  
**Originated Date :** 12/06/2024 - Dale Wheeler - National TAB

MISSING TEMP. SENSOR ALARM

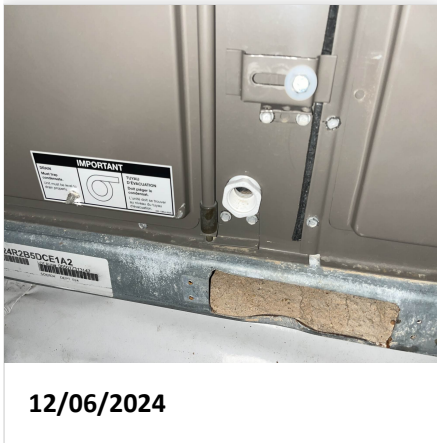
**Issue Name :** RTU1 / Condensate Line  
**Description :** RTU1 condensate line is not installed.  
**Created By :** National TAB                      **Assigned To :** National TAB - Dale Wheeler  
**Status :** Open  
**Priority :** Medium                                      **Asset Tag :**  
**Originated Date :** 12/06/2024 - Dale Wheeler - National TAB

General	
	Actual
Fan Rotation Correct	YES
Unit Filters Clean	YES
Condensate Drain Installed	NO

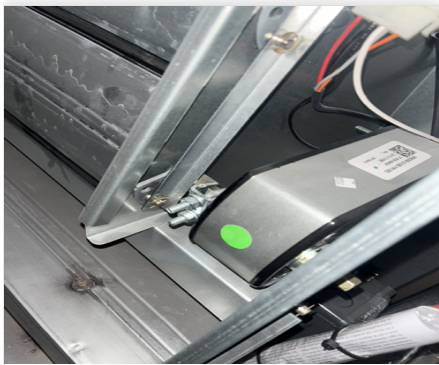
**Issue Name :** RTU1 / Economizer Controller  
**Description :** RTU1 economizer is not responding to controller, econ was set manually due to this issue.  
**Created By :** National TAB                      **Assigned To :** National TAB - Dale Wheeler  
**Status :** Open  
**Priority :** High                                      **Asset Tag :**  
**Originated Date :** 12/06/2024 - Dale Wheeler - National TAB

RTU1 / ECON IS ASSEMBLED BUT IS NOT OPERATIONAL WITH CONTROL BOARD, OUTSIDE AIR DAMPER HAD TO BE SET MANUALLY YES / DOAS UNIT
