Report: TAB Report
Function: Test, Adjust, & Balance
Date: 10/27/2023

10-23-23 WALGREENS #11134 - SMYRNA, DE

Project: 10-23-23 WALGREENS #11134 - SMYRNA, DE

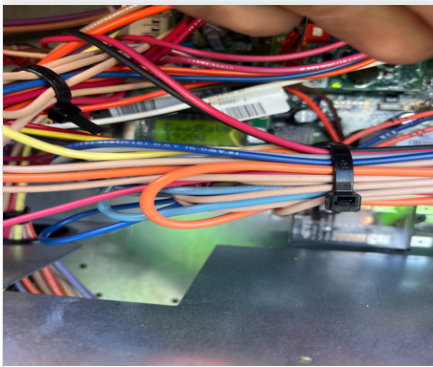
Baudrate
10/25/2023

Issue Name : CONTROLLER: Baud rate setting
Description : Baudrate setting not set to auto. All units set to 19200
Created By : National TAB **Assigned To :** National TAB - Tyler Youells
Status : Open
Originated Date : 10/25/2023 - Tyler Youells - National TAB

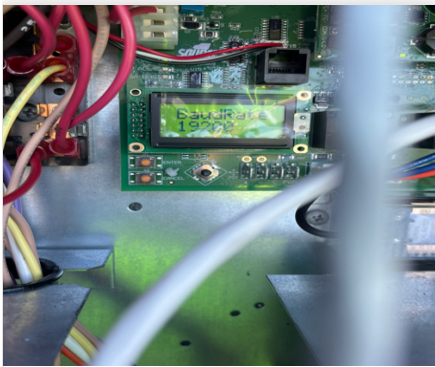
Baudrate
10/25/2023

Issue Name : CONTROLS: Baudrate
Description : Rtu Baudrate a have not been changed to auto, they are all set to 19200
Created By : National TAB **Assigned To :** National TAB - Tyler Youells
Status : Open
Originated Date : 10/25/2023 - Tyler Youells - National TAB

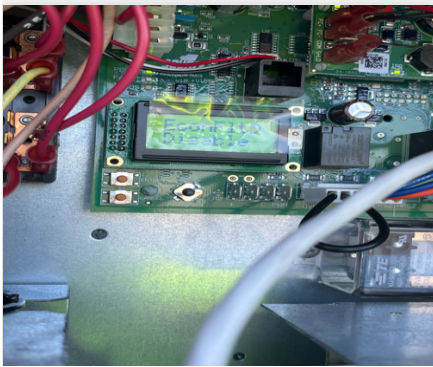
**Econfitdetect
10/25/2023**

Issue Name : CONTROLS: EconFitDetectEn
Description : Econ fit detect En is set to disabled when it should be enabled.
Created By : National TAB **Assigned To :** National TAB - Tyler Youells
Status : Open
Originated Date : 10/25/2023 - Tyler Youells - National TAB

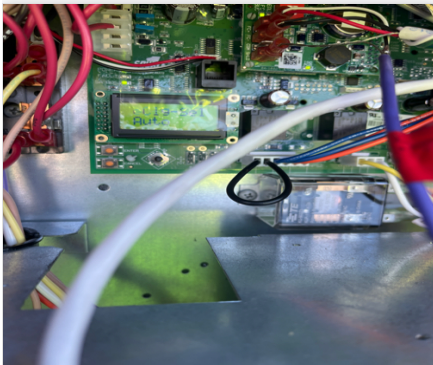
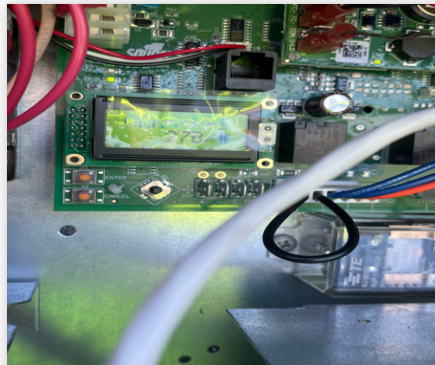
Selection auto
10/25/2023

Issue Name : CONTROLS: Enthalpy reference
Description : Under Econ free cooling selection it is set to auto for all units when it should be set to single enthalpy. All enthalpy engage setpoints are 27B/# when they should be 24B/#
Created By : National TAB **Assigned To :** National TAB - Tyler Youells
Status : Open
Originated Date : 10/25/2023 - Tyler Youells - National TAB

Enthalpy engage setpoint..
10/25/2023

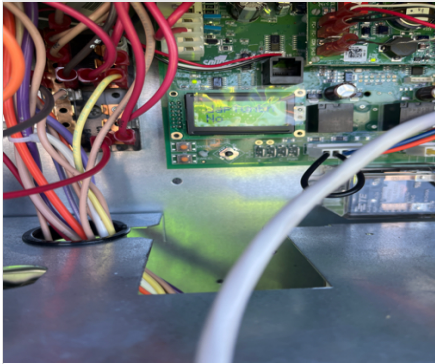
**Htgadaptunen
10/25/2023**

Issue Name : CONTROLS: HtgAdapTunEn
Description : Heating adap Tun En has not been set to yes for all units
Created By : National TAB **Assigned To :** National TAB - Tyler Youells
Status : Open
Originated Date : 10/25/2023 - Tyler Youells - National TAB

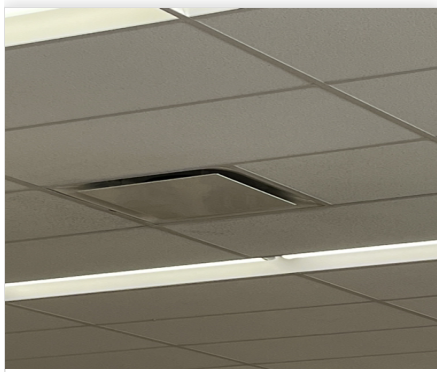
Diff1rtu1neck
10/26/2023

Issue Name : DIFFUSER 1-1 Neck size
Description : Diffuser 1-1 has a smaller neck size compared to other diffusers on RTU-1 700 CFM is not obtainable through current neck size
Created By : National TAB **Assigned To :** National TAB - Tyler Youells
Status : Open
Originated Date : 10/26/2023 - Tyler Youells - National TAB

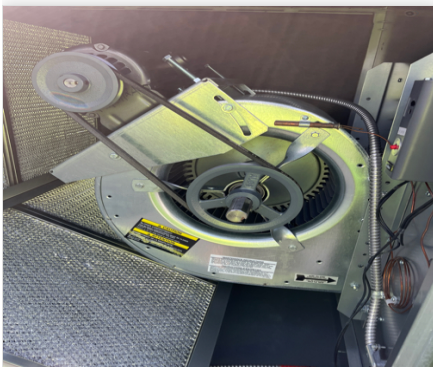
**Blowerwontstayon
10/26/2023**

Issue Name : EH-1 Not running correctly
Description : Found flow was extremely low and blower rotation incorrect. Flipped phases and confirmed correct rotation now blower will kick on for two seconds then shut off, back on then off. Unable to balance unit
Created By : National TAB **Assigned To :** National TAB - Tyler Youells
Status : Open
Originated Date : 10/26/2023 - Tyler Youells - National TAB

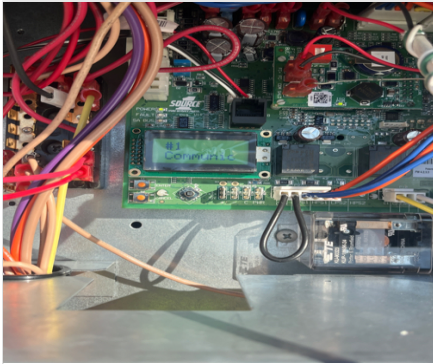
**Communicationerror.jp..
10/25/2023**

Issue Name : RTU's 2, 4, 5: COMMUNICATION ERROR
Description : Rtu-2, 4, &5 have a stage 4 communication error alarm.
Created By : National TAB **Assigned To :** National TAB - Tyler Youells
Status : Open
Originated Date : 10/25/2023 - Tyler Youells - National TAB

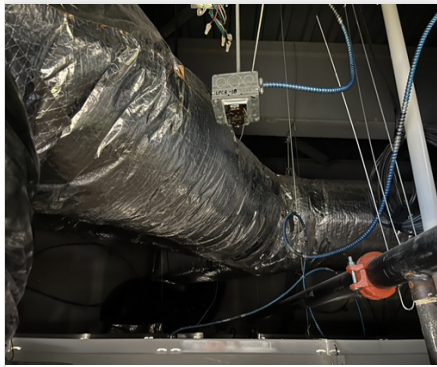
Nodamper(1)
10/26/2023

Issue Name : RTU-1 Diffuser 3 No damper
Description : Diffusers is attached to the termination of the main trunkline and there is no visible damper. Flow is high above prescribed 700CFM (851/700cfm). Diffuser is located in front of vestibule, so higher airflow may be preferred. Walgreens/Sevan to advise.

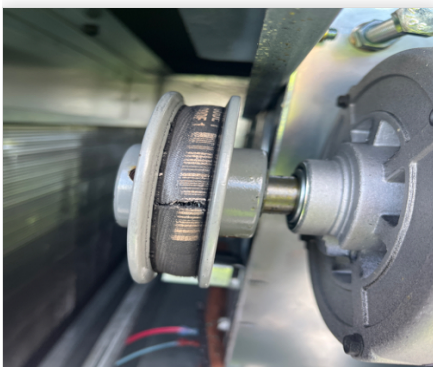
Rtu6belt
10/25/2023

Issue Name : RTU-6 Belt condition
Description : Rtu-6 belt is in bad condition. Recommend replacing. It has multiple cracks along the length of the belt
Created By : National TAB **Assigned To :** National TAB - Tyler Youells
Status : Open
Originated Date : 10/25/2023 - Tyler Youells - National TAB

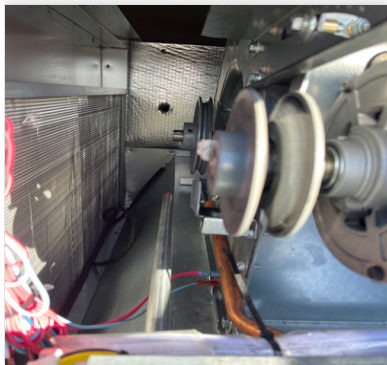
Rtu6beltsnapped
10/26/2023

- **10/26/2023 National TAB - Tyler Youells**
 - Belt snapped prior to end of TAB, unable to finish balance on unit. Turned unit off. Unable to source belt nearby
