**Report: TAB Report**  
**Function: Test, Adjust, & Balance**  
**Date: 10/27/2023**

## 10-23-23 WALGREENS #11134 - SMYRNA, DE

Walgreens

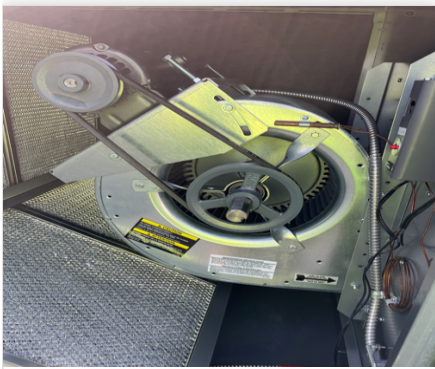
**Blowerwontstayon  
10/26/2023**

**Issue Name :** EH-1 Not running correctly  
**Description :** Found flow was extremely low and blower rotation incorrect. Flipped phases and confirmed correct rotation now blower will kick on for two seconds then shut off, back on then off. Unable to balance unit  
**Created By :** National TAB                      **Assigned To :** National TAB - Tyler Youells  
**Status :** Open  
**Priority :**    **Asset Tag :**  
**Originated Date :** 10/26/2023 - Tyler Youells - National TAB

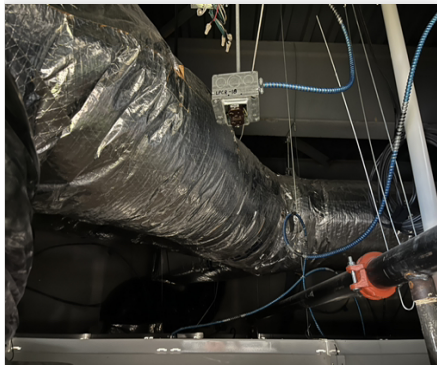
**Nodamper(1)**  
**10/26/2023**

**Issue Name :** RTU-1 Diffuser 3 No damper  
**Description :** Diffusers is attached to the termination of the main trunkline and there is no visible damper. Flow is high above prescribed 700CFM (851/700cfm). Diffuser is located in front of vestibule, so higher airflow may be preferred. Walgreens/Sevan to advise.

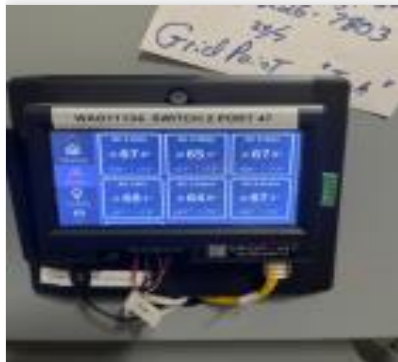
**Tempsetpoints  
01/02/2024**

Temperature setpoints must be set using provided charts are based on state and space that each RTU serves. Confirm with controls company that these are set correctly

**Issue Name :** Temperature Setpoints  
**Description :** Temperature setpoints do not match provided ashrae chart. GRIDPOINT does not authorize me to change them. Recommend authorized personnel to adjust the temperature setpoints. Note most setpoints are only off by 1 Degree  
**Created By :** National TAB                      **Assigned To :** National TAB - Tyler Youells  
**Status :** Open  
**Priority :**    **Asset Tag :**  
**Originated Date :** 01/02/2024 - Tyler Youells - National TAB
