**Report: Renew  
Date: 2/24/2022**

**PROJECT  
FREDDY'S - BRIDGETON, MO - RENEW 4FB (4)**

Project: FREDDY'S - BRIDGETON, MO - RENEW 4FB (4)

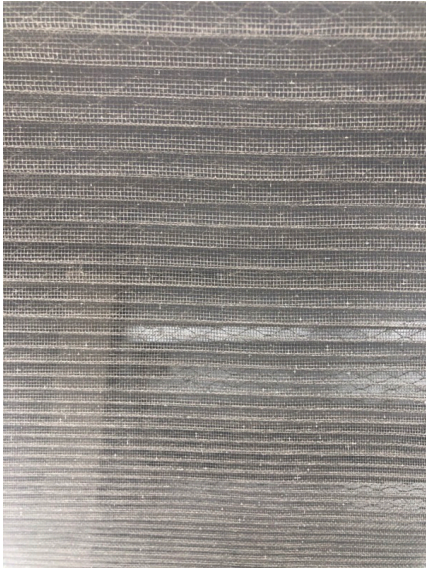
RTU-1  
Dirty outside air filters

Notes: [1] UNABLE TO CLEAN FILTERS/COIL DUE TO BELOW FREEZING TEMPERATURES.

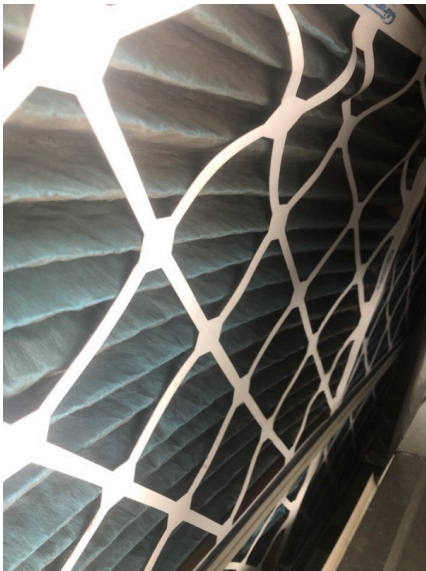
RTU-1  
Dirty evaporator filters

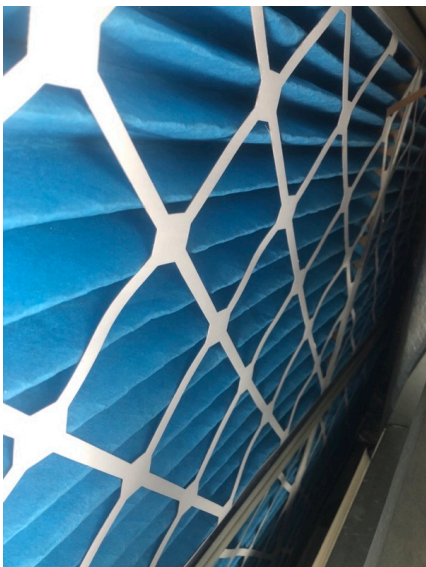
RTU-1  
Clean evaporator filters

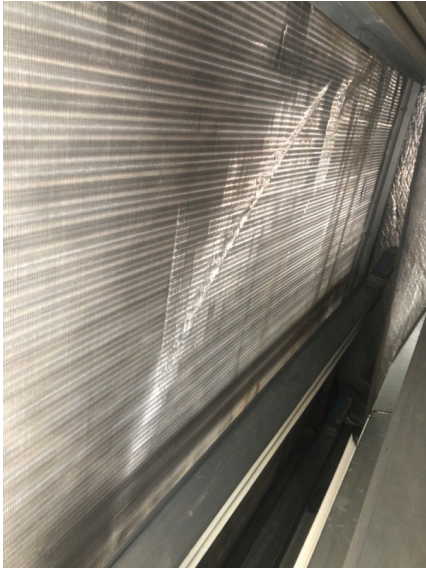
RTU-1  
Dirty evaporator coil

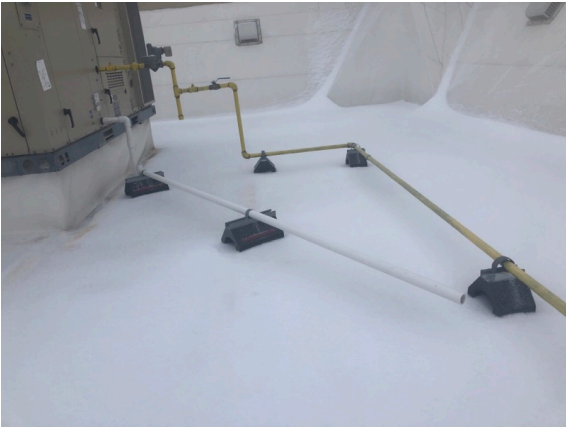
RTU-1  
Condensate drain

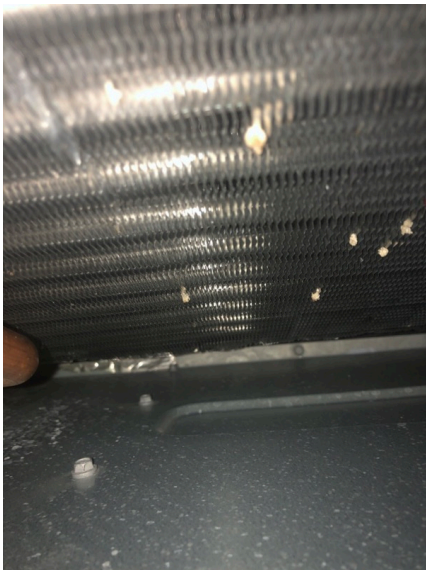
RTU-1  
Drain pan

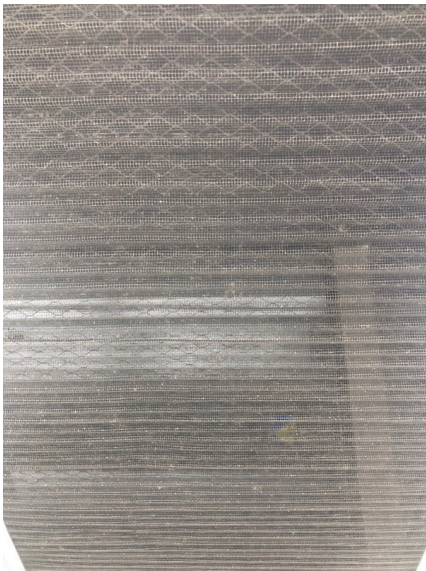
RTU-2  
Dirty outside air filters

Notes: [1] UNABLE TO CLEAN FILTERS/COILS DUE TO BELOW FREEZING TEMPERATURE.

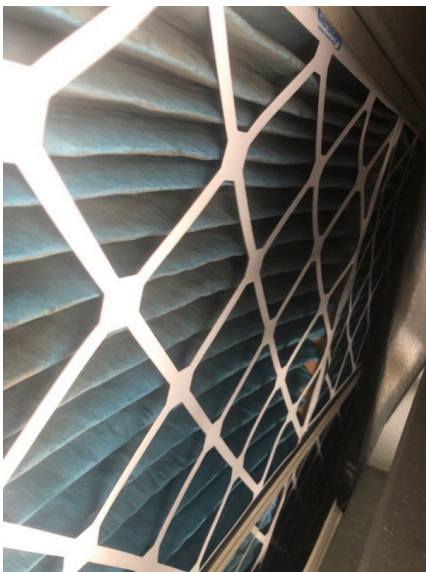
RTU-2  
Dirty evaporator filters

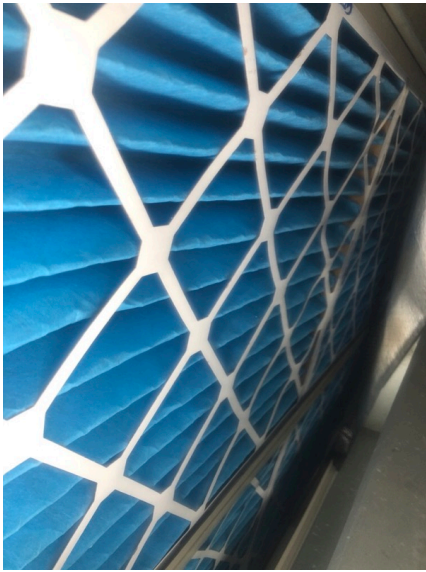
RTU-2  
Clean evaporator filters

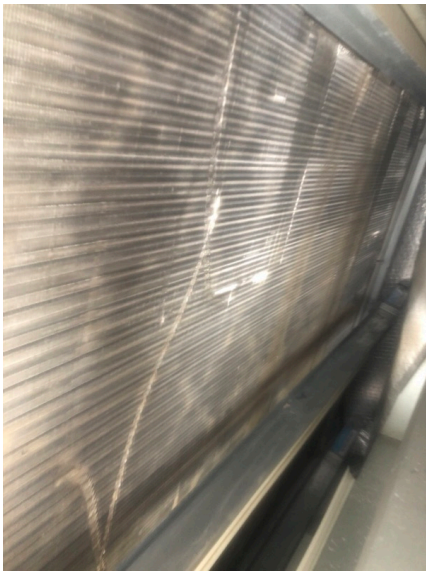
RTU-2  
Dirty evaporator coil

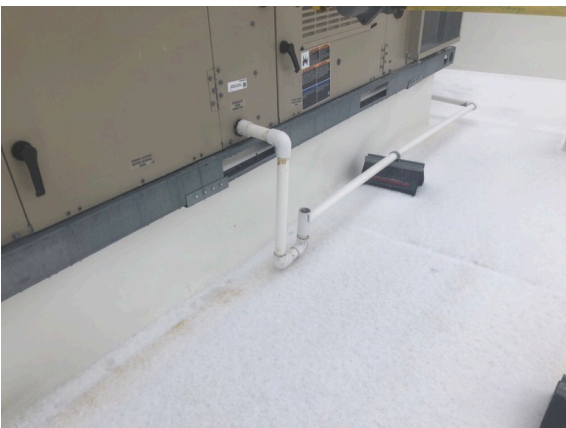
RTU-2  
Condensate drain

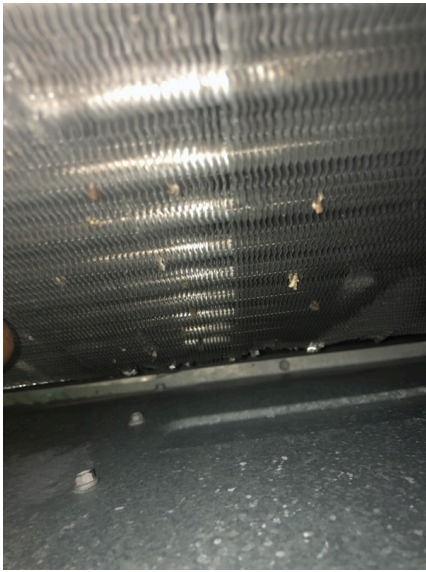
RTU-2  
Drain pan

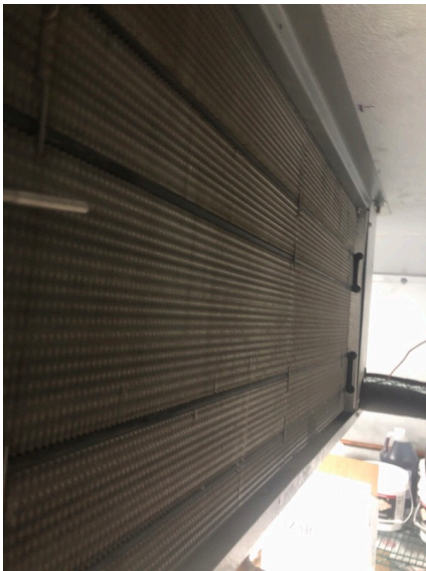
Walk-in Cooler  
Dirty evaporator

Food equipment condensers were cleaned. The Walk-In evaporator were cleaned. All equipment is in good health unless stated in the Recommendation List.

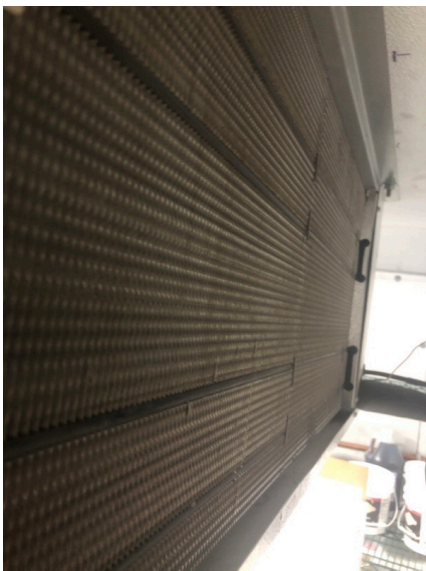
Walk-in Cooler  
Clean evaporator

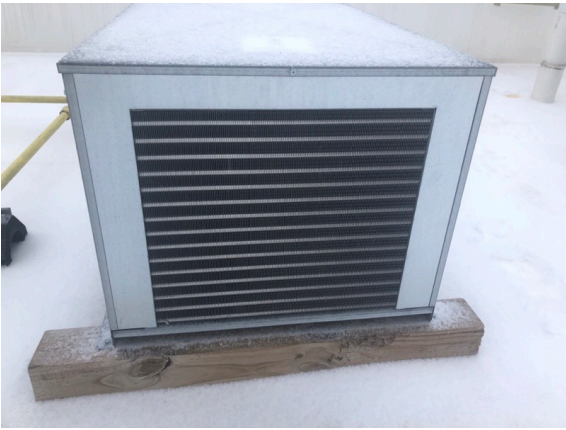
Walk-in Cooler  
Dirty condenser

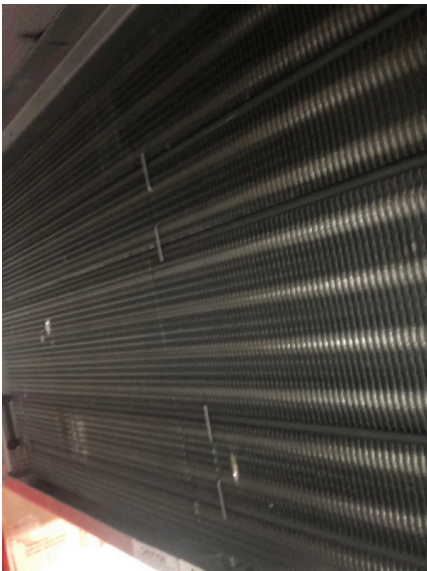
Walk-in Freezer  
Dirty evaporator

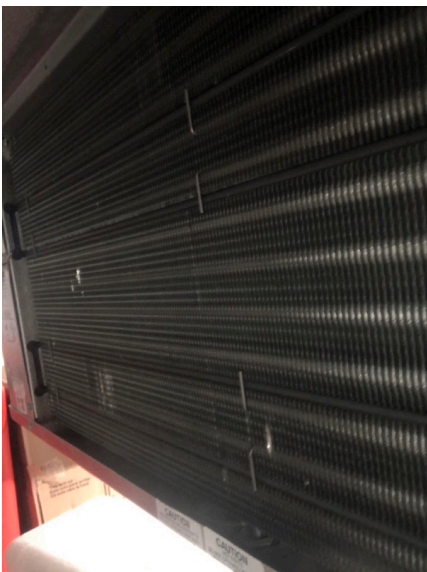
Walk-in Freezer  
Clean evaporator

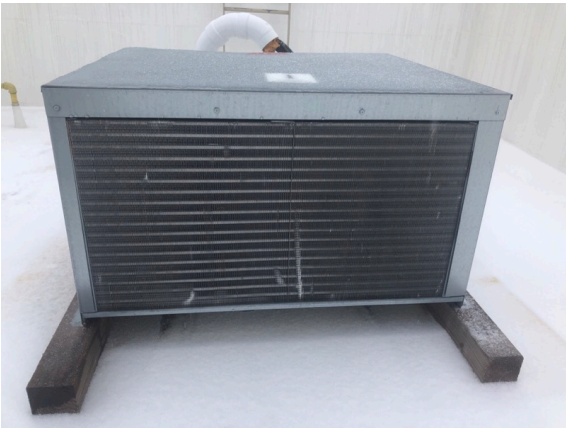
Walk-in Freezer  
Dirty condenser

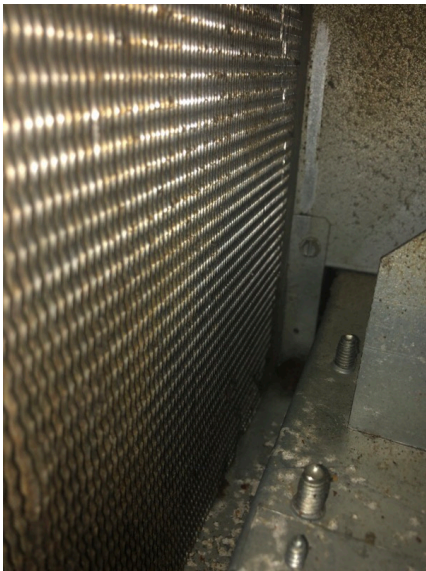
Meat Cooler 1  
Dirty condenser

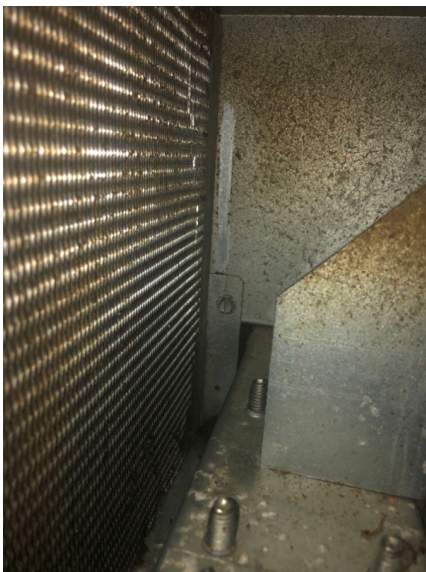
Meat Cooler 1  
Clean condenser

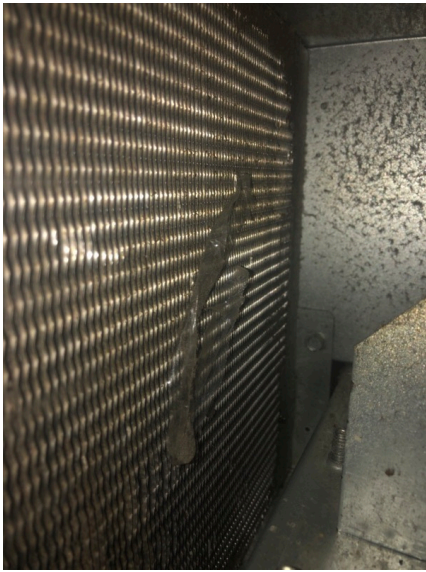
Meat Cooler 2  
Dirty condenser

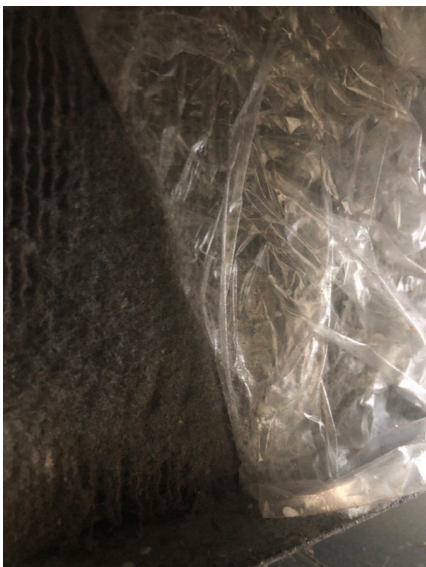
Prep Table 1  
Dirty condenser

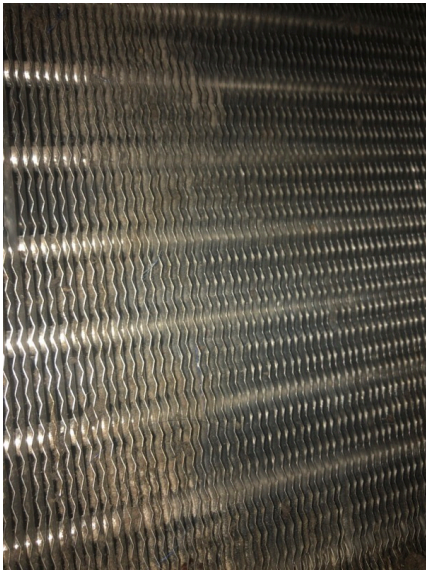
Prep Table 1  
Clean condenser

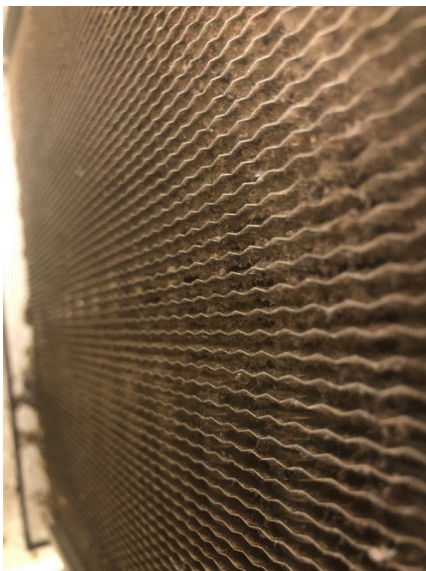
Fryer Freezer  
Clean condenser

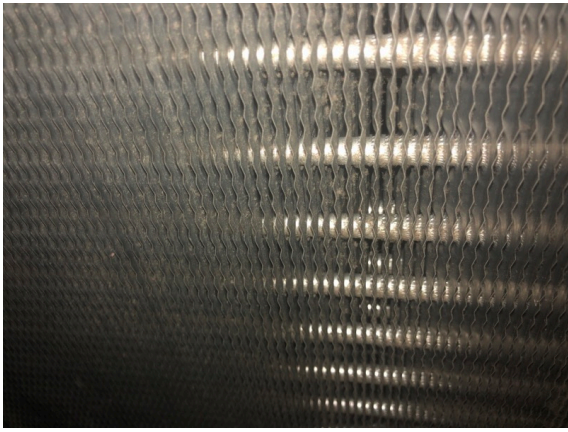
Sundae Prep  
Dirty condenser

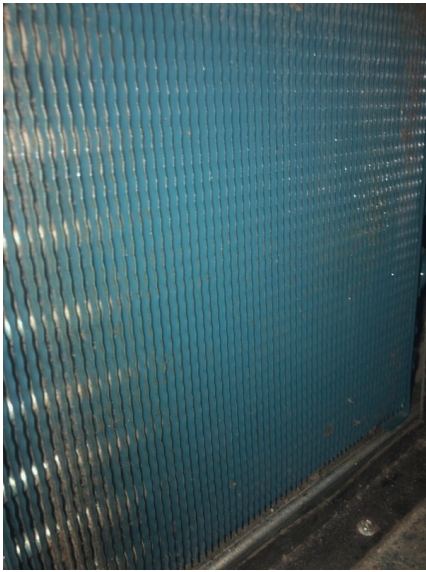
Toppings  
Clean condenser

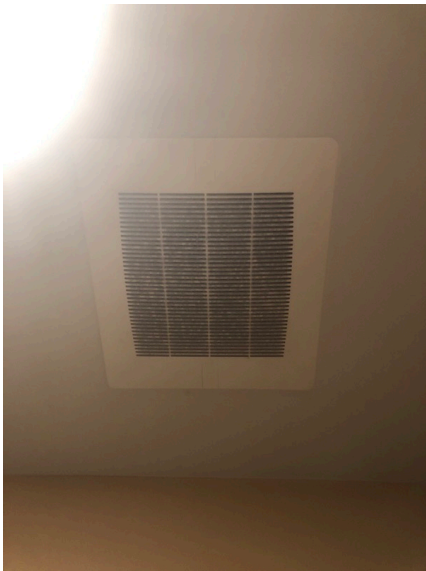
EF-1  
Dirty

All exhaust fans were cleaned out on the roof. The vents to the motor were cleaned so they can vent properly.

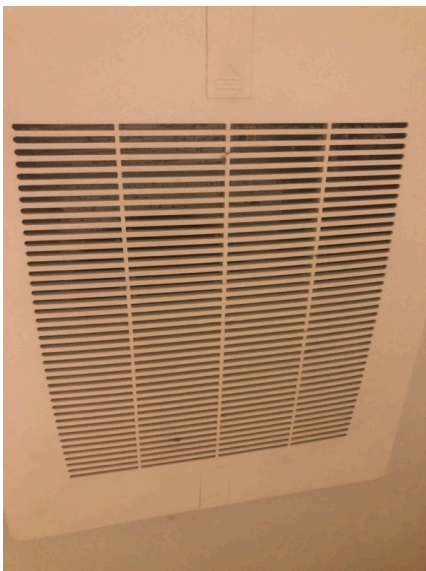
EF-1  
Clean

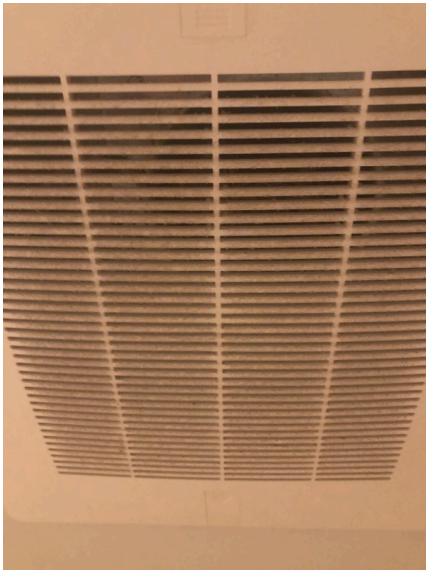
EF-2  
Dirty

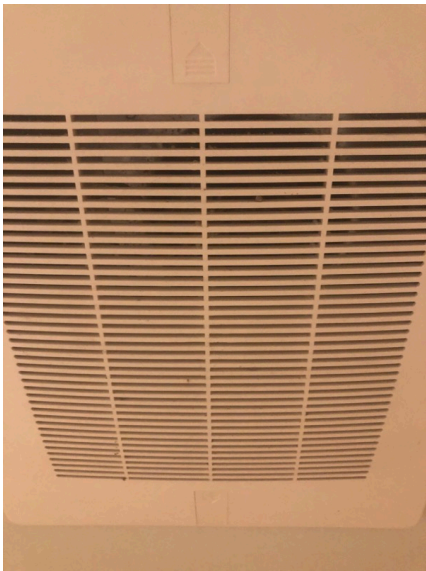
EF-2  
Clean
