**Report: TAB REPORT**  
**Function: Test, Adjust, & Balance**  
**Date: 12/02/2022**

**11-28 WALGREENS #3802 - RICHARDSON,  
TX**

# National TAB

## Project Summary

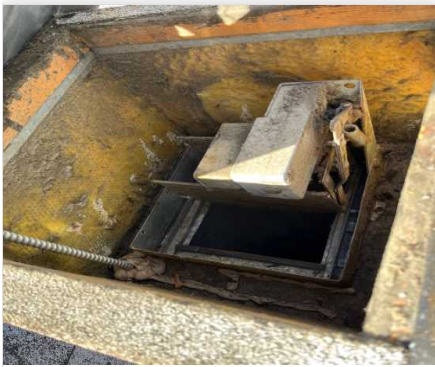
tmp\_0add065d\_f492\_4cd...

**Issue Name :** EF-4 BACKDRAFT OPEN

**Description :** The backdraft damper is no functioning and has failed open.

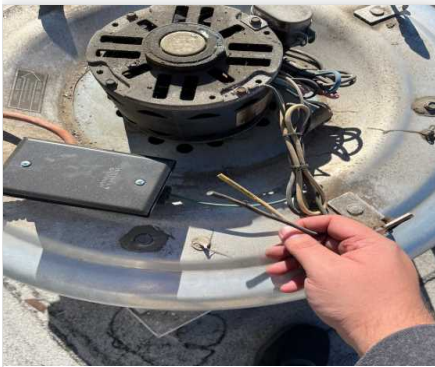
tmp\_6ca3d469\_f13e\_405...

**Issue Name :** EF-5 NOT RUNNING

**Description :** EF-5 is not wired to any power and is not running.

- **12/02/2022 National TAB - Will Turnbough**
  - Serves photo area. Will be capped.

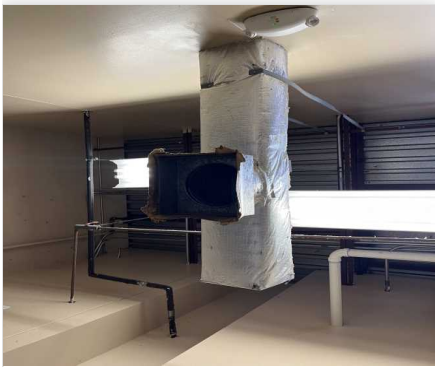
Image\_2022\_11\_30T1209...

**Issue Name :** GRILLE 3-8 MISSING FACE

**Description :** GRILLE 3-8 MISSING GRILLE FACE. GRILLE CANNOT BE DAMPERED AND IT IS MEASURED AT 250% OF DESIGN AIR FLOW.

- **12/02/2022 National TAB - Will Turnbough**
  - Recommend installing grille face with damper so that airflow can be reduced.

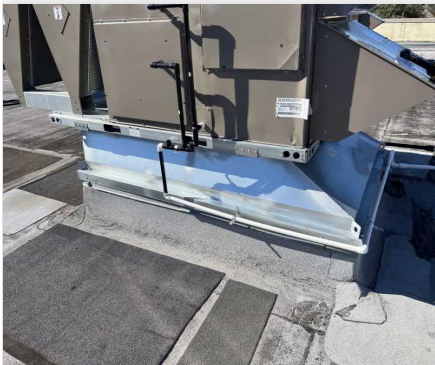
Image\_2022\_11\_30T1209...

**Issue Name :** RTU-2 LOW ON AIR FLOW

**Description :** RTU-2 WAS MEASURED AT 70% OF DESIGN AIR FLOW. STATIC PRESSURE WAS ELEVATED. SUSPECTED RESTRICTION AT CURB ADAPTER.

- **12/02/2022**    **National TAB - Will Turnbough**
  - Unable to change pulleys as the motor is near the FLA rating. The static pressures at the return and supply side of the RTU are elevated (>1" of pressure).

Notes: Airflow appears to be low due to restrictive curb adapter. The static pressures on the return and supply side of the unit are elevated. Motor is at the FLA rating

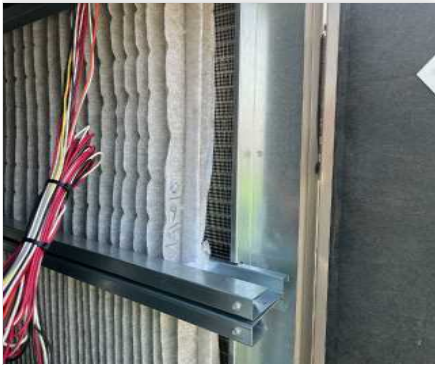
tmp\_215ab308\_9b6b\_471...

**Issue Name :** WRONG FILTERS USED ON RTU 1, 2, 4

**Description :** The filters on RTUs 1, 2, and 4 are the wrong size.

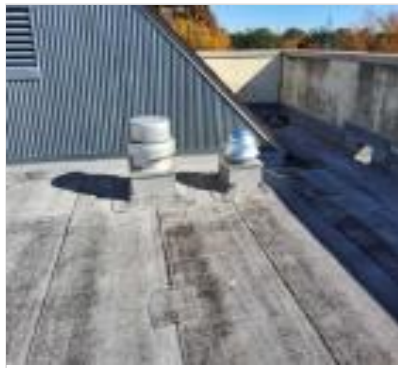
EF-4&5

Fan rotation is correct	Pass
Pulleys are aligned and belts are tensioned properly	DIRECT DRIVE
Speed controller installed and functional (direct drive)	YES
Fan is secured to the curb	Pass
Back draft damper is installed and functional	Fail
No exterior damage to the fan	Pass
No unusual noise or vibration	Pass
Controls are functional	Pass
Additional Comments:	EF-5 is not wired up as shown in issues. EF-4 has a back draft damper that has failed or is not powered so it stuck in the open position.
